NERC

Washington, D.C., Area Low-Voltage Disturbance Event of April 7, 2015

September 2015

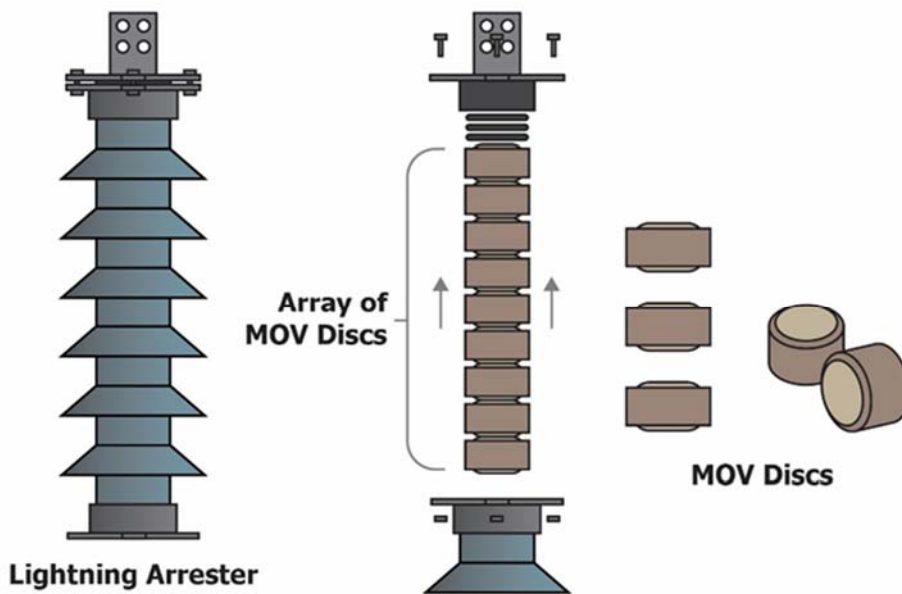
The initiator of this disturbance was an electrical and physical failure of the C-phase 230 kV surge arrester and subsequent fault in the Pepco portion of the Ryceville substation (Ryceville substation is jointly owned by Pepco and SMECO). At approximately 12:39, a C-phase-to-ground fault occurred on the transmission line at the Ryceville substation. The C-phase surge arrester experienced a rapid electrical breakdown of its internal metal-oxide varistor (MOV) stack insulation capabilities, which likely was caused by moisture intrusion due to a premature seal failure, causing the MOV stack to go into “thermal runaway,” which caused a single-phase-to-ground fault.

Figure 2. Lightning (Surge) Arrester Shown Whole and Dissected into Parts to Illustrate Composition

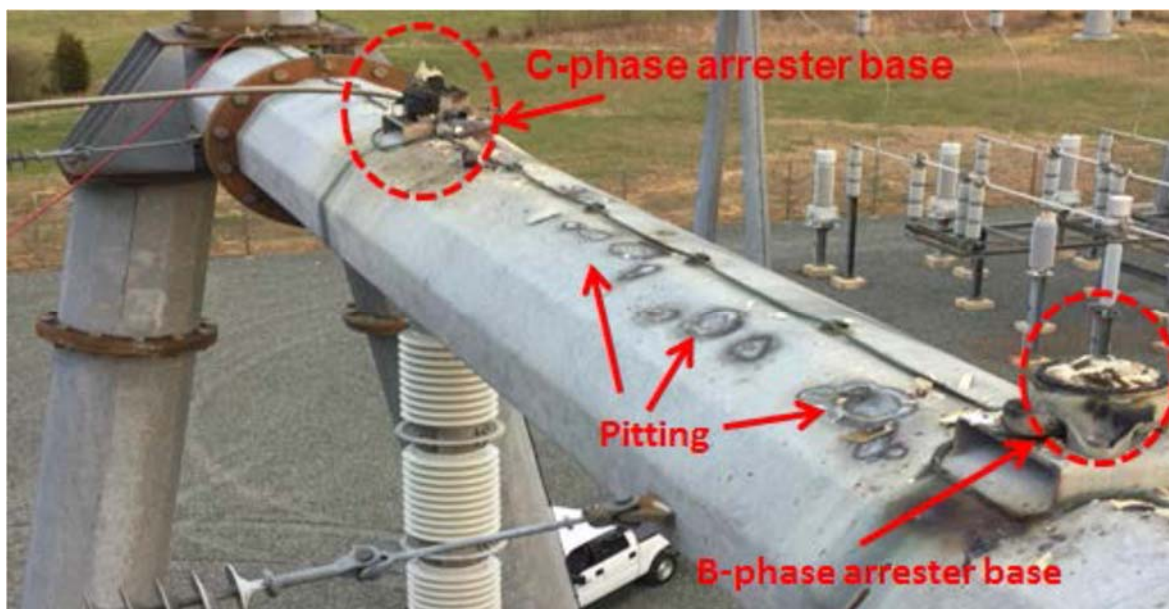
Figure 3 shows the pitting and arcing on the A-frame structure, and the B-phase and C-phase arrester bases showed burning and thermal stress. This damage is consistent with the DFR readings of fault current exceeding 6,000 amps.

Figure 3: C-phase and B-phase Surge Arresters

Burning and pitting was seen on the top of the 230 kV A-frame structure, particularly near the B-phase and C-phase surge arresters. There was also burning and pitting on the inside of the upper portion of the centermost A-frame structure, nearest the remains of the A-phase surge arrester. No damage appeared on the line capacitor-coupled potential device (CCPD) located on the C-phase, nor in the vicinity of where the C-phase physically connects to the A-frame underneath the failed A-phase underhung insulator stack.

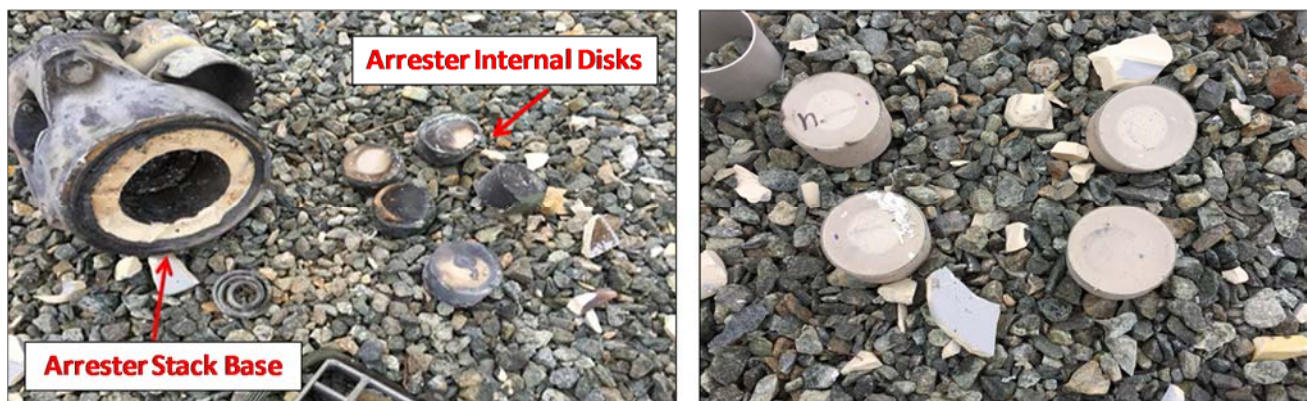
The internal components of the destroyed surge arresters were scattered around the ground below the A-frame. The C-phase arrester components showed clear signs of burning and thermal stress consistent with an electrical failure. The A-phase arrester components showed no noticeable signs of excess thermal stress or burning, which supports the conclusion that the A-phase arrester failed mechanically when the A-phase conductor broke free of the A-frame structure and fell to the ground outside the substation (the top of the arrester has a nontension

connection to the conductor, which went into tension and snapped the arrester when the normal conductor tension was released as the dead-end insulator burned through at the Y-clevis, as described earlier). Figure 4 shows the internal disks from both the C-phase (left) and A-phase (right) arresters.

Figure 4: Internal MOV Disks from C-phase (left) and A-phase (right) Arresters

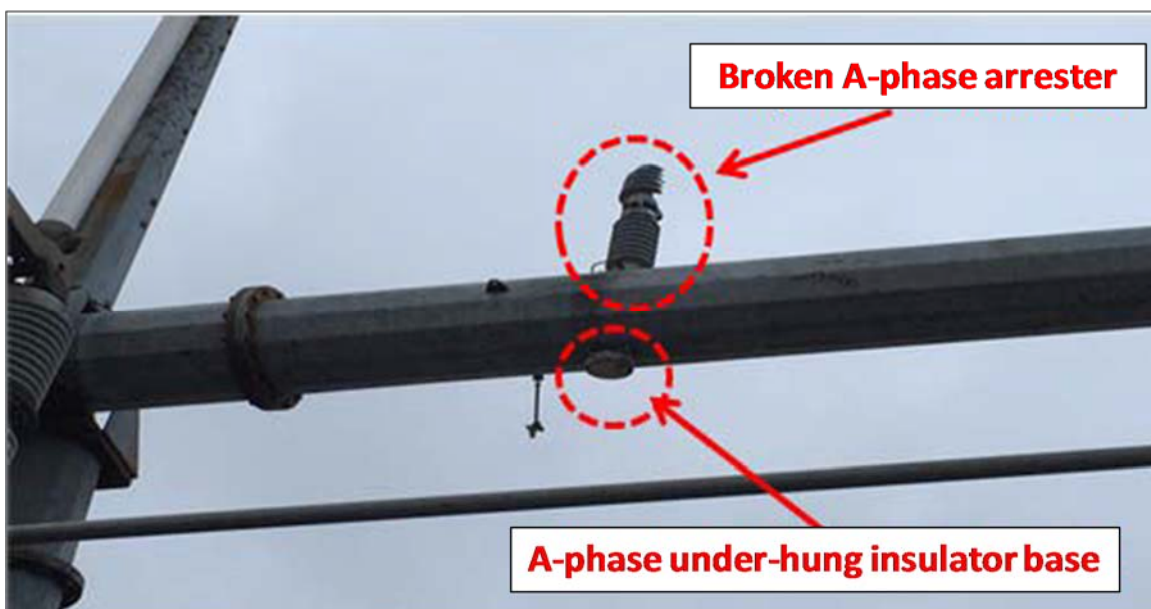
The A-phase underhung insulator was damaged and fell onto the disconnect switch below the A-frame. The A-phase motor-operated disconnect (MOD) switch insulator and bus bar were damaged by the fallen underhung insulator. The A-phase dead-end insulator burned through at the Y-clevis connection and fell into a field outside the substation. The static wire attached to the top center of the A-frame structure broke at its connection to the structure and also dropped into the field outside the substation.

In addition to the damaged arresters, the underhanging insulator for the A-phase was broken off from the A-frame structure, as shown in Figure 5.

Figure 5: Damaged A-phase Surge Arrester and Underhung Insulator

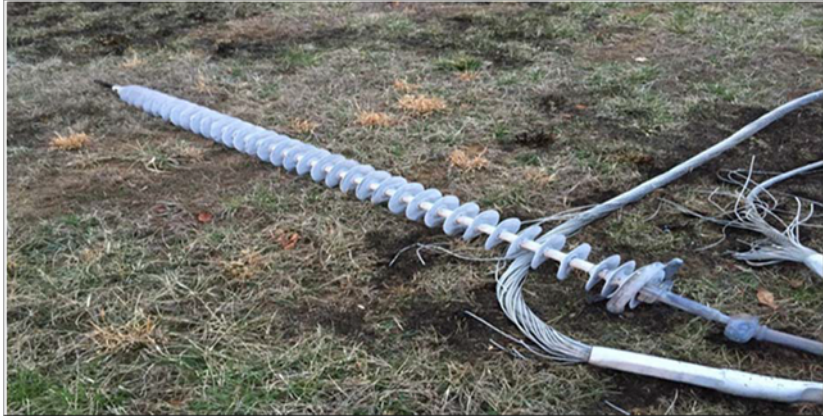
The insulator, still attached to the conductor, was found outside the substation as it had pulled away from the A-frame structure when the normal tension in the conductor released as the insulator burned through. There was evidence of burning at the Y-clevis end where the insulator was connected to the A-frame structure, as shown in Figure 6.

Figure 6: A-phase Dead-End Insulator outside Ryceville Substation

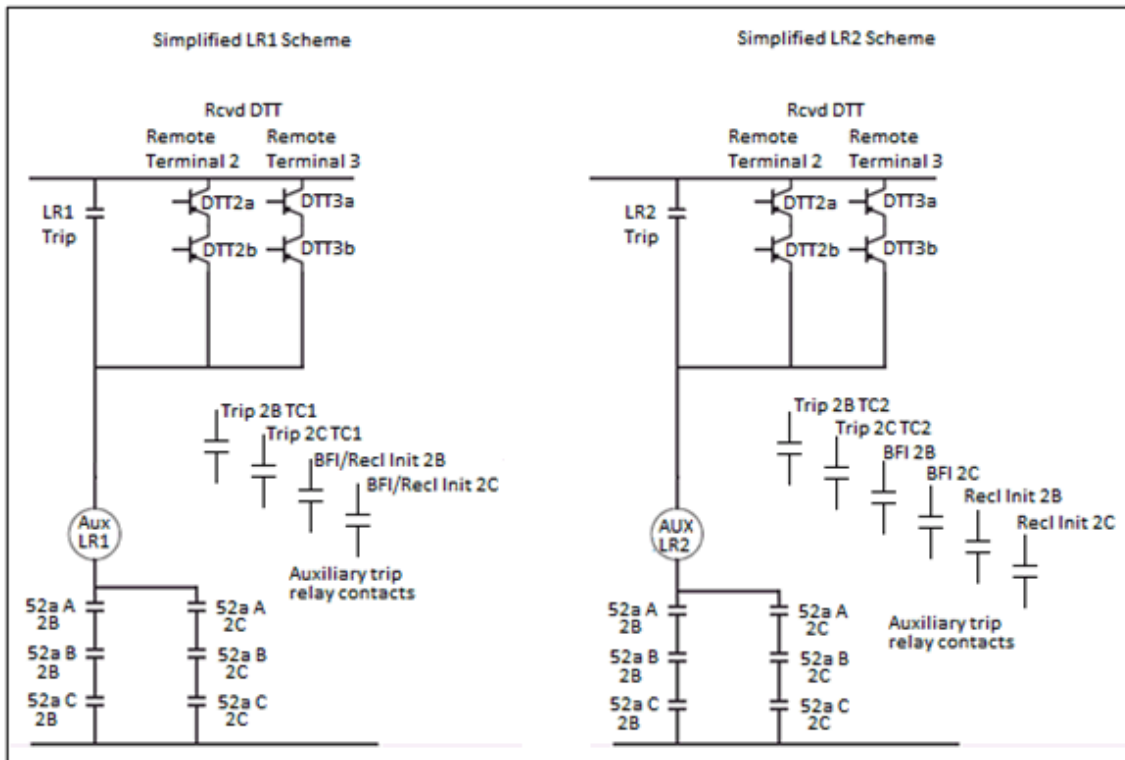
An analysis of the auxiliary tripping circuitry revealed an opportunity for improvement for the LR1 circuit design, shown in Figure 12. The reliability of this tripping circuit can be improved by changing the 52a contacts from a series to a parallel connection.

Figure 12: Chalk Point Dual Redundant Relay Systems

- Use a separate contact from the protective relay to provide the BFI signal.
- Use a dedicated auxiliary relay for breaker failure initiate if a separate contact is not available on the protective relay.
- Connect the protective relay trip contact directly to a breaker failure relay input if the breaker failure relay will accommodate a voltage input.
