JOINT U.S.-CANADA POWER SYSTEM OUTAGE TASK FORCE

**UTILITY VEGETATION MANAGEMENT INITIAL REPORT
December 2003**

INITIAL REPORT

FAULT CHRONOLOGY, OBSERVATIONS AT FIELD SITES AND COMMENTS

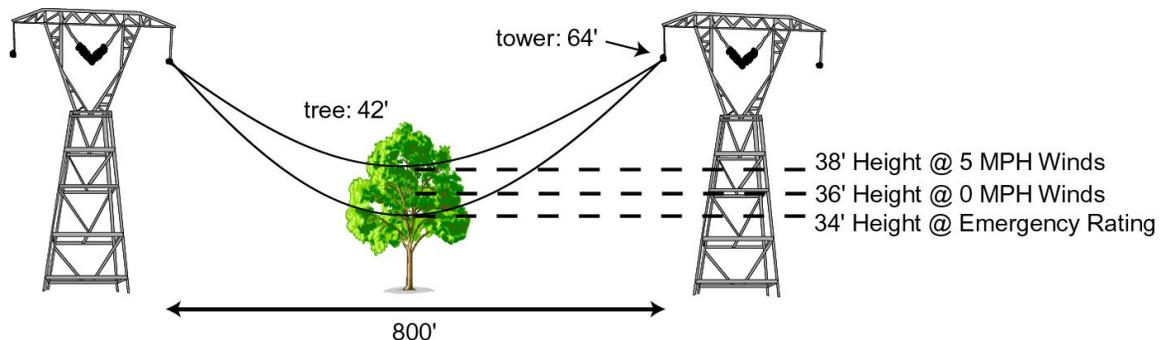
The following graphic provides an example of how conductor height can vary depending on load and wind velocity.

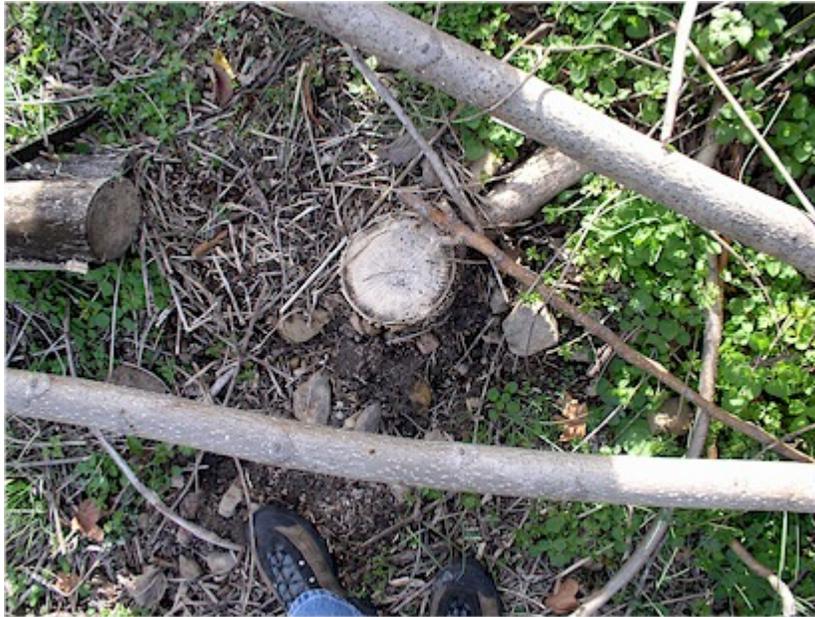
Evidence of tree contact was observed between towers 222 and 223. Conductor height of north phase measured 39 feet at tree location and point of contact. Center phase measured 41 feet and south phase measured 47 feet.

Two ailanthus trees showed evidence of significant fault current damage and were de-barked. One measured 2.5" diameter at ground line, and the other measured 6" diameter at ground line (GPS 293158E 4337745N).

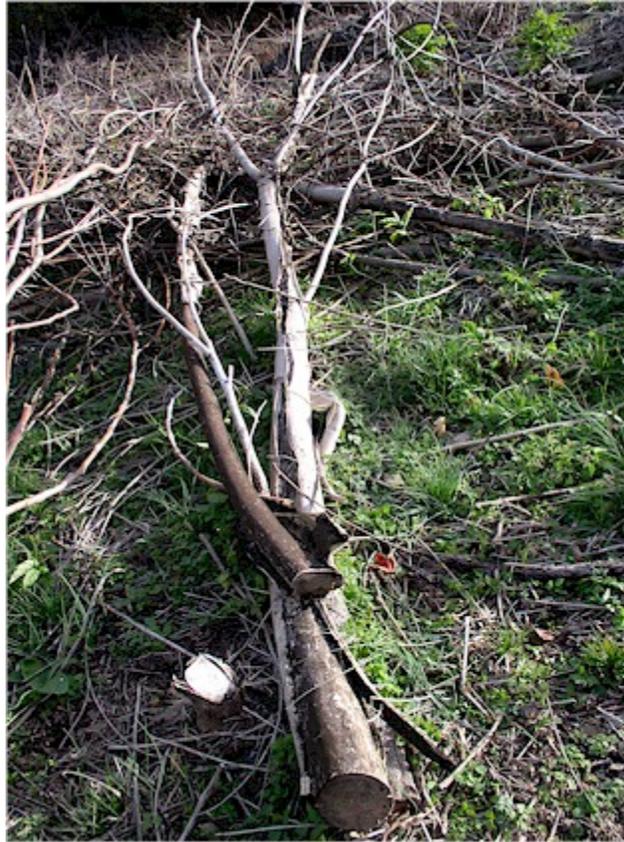
Both trees estimated to be 30 to 35 feet tall. Other trees in the area showed evidence of fault current damage as well.

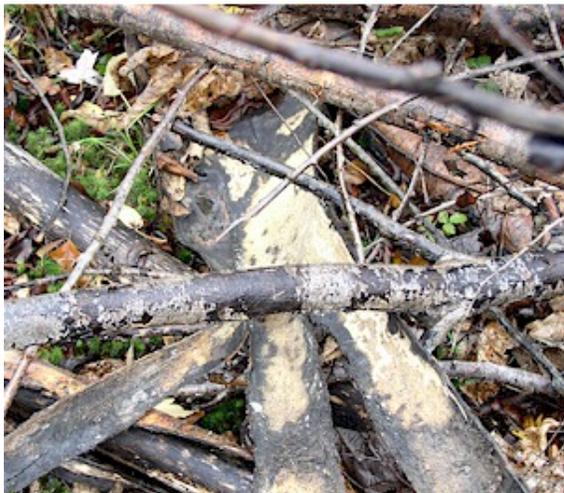
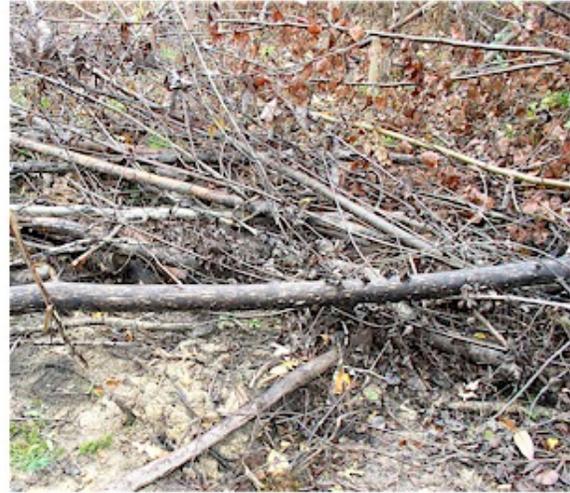
Inspected tree conditions at structure 40376 (20.5%) between towers 40375 and 40376. Trees and vegetation were felled on or after August 14th. Debris and tree parts were inspected on site.

Conductor height measured 44' 9". Tree height measured at 30 feet, although we could not verify location of the stump, or missing section of tree (GPS 444971E 4530949N). Obvious significant fault damage to clustered trees. Charred limbs, and de-barked by fault current.

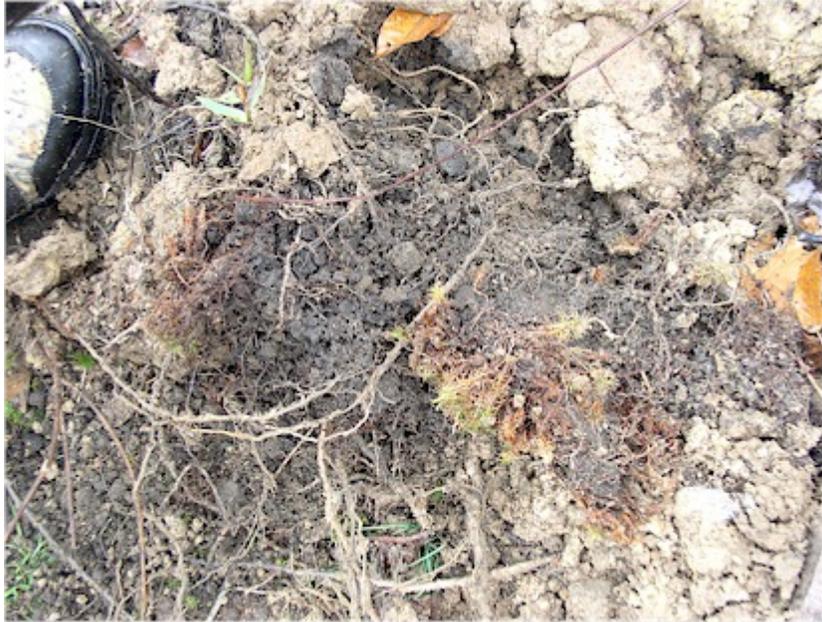
Topsoil in the area of trunk was disturbed, discolored and broken up at site. This would be indicative of a higher magnitude fault or multiple faults.

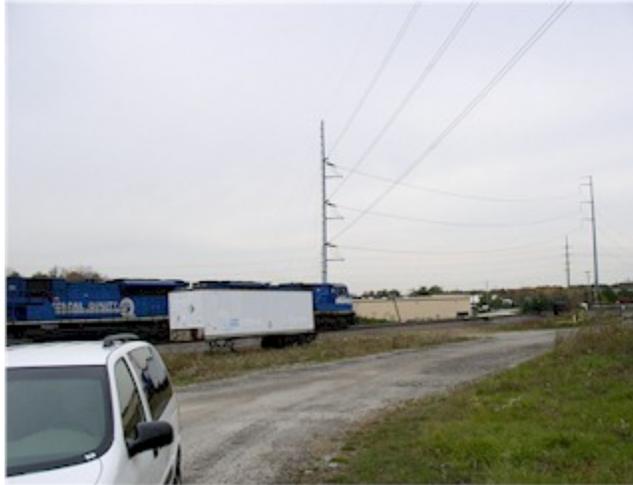
No evidence of vegetation at calculated fault location (11.3%). See photo below.

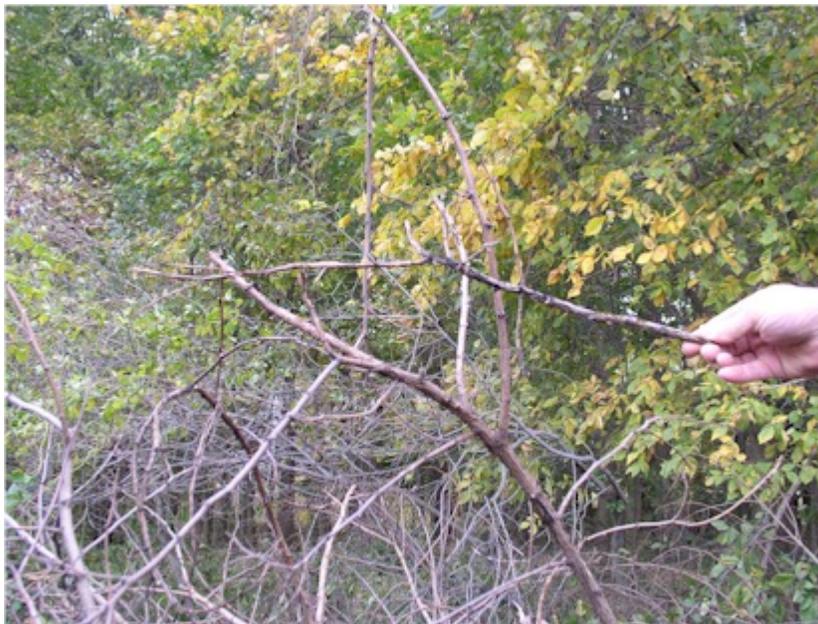
At 17.7%, between towers 42861 and 42860 we inspected vegetation. Trees and brush were felled on or after August 14th. Conductor height measured at 46' 7", tree height measured at 42' (GPS 457168E 4573141N). Locust tree showed evidence of fault current damage. Tree damage indicated a lower level of fault current.

Burn marks were observed at 35' 8" up tree. Portions of the tree had been removed from the site making it difficult to determine exact height of contact, implying that the height is a minimum, and likely 3-4 feet higher than verifiable.

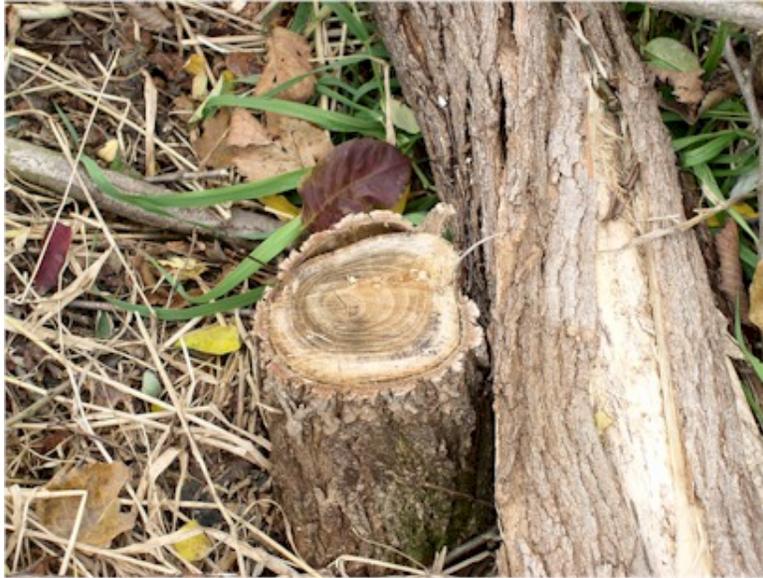
Other vegetation along the right-of-way measured between two and five inches in diameter at ground line. The following photo depicts a tree located in the right-of-way that was over six years old, as indicated by the growth rings.

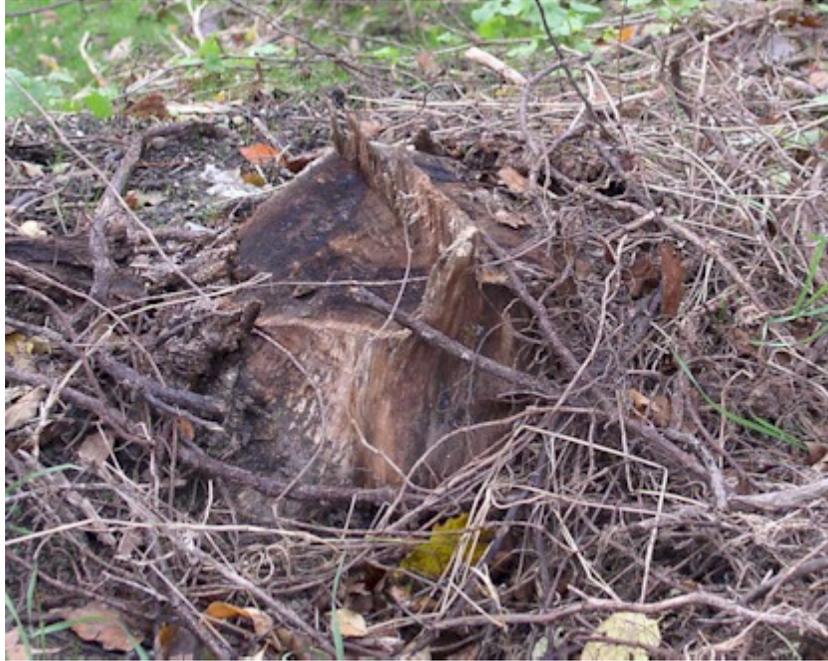
Conductor height measured 48' 9" at fault location. No evidence of tree debris at site. Walnut tree stump measured 14" diameter at ground line (GPS 453104E 4578129N).

South phase, where contact occurred, is lower than center phase due to construction design. Subsequently, FE provided photographs that clearly indicate that the tree was of excessive height.

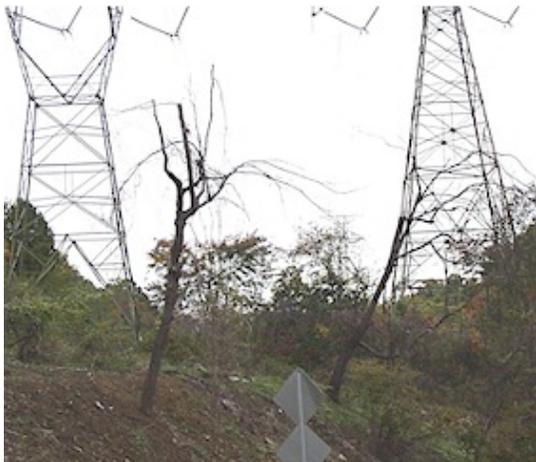
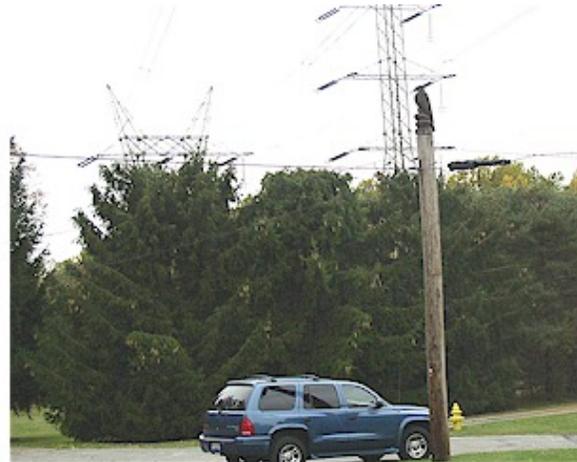
Subsequent clearing left trees and brush that, in our opinion, could have been removed as indicated by the photo below on the left. This photo was taken in the same span as the fault occurred. Other trees were pruned and left in the right-of-way as part of a landscaped area as indicated by the photo on the right. This photo was taken within one span of the fault.

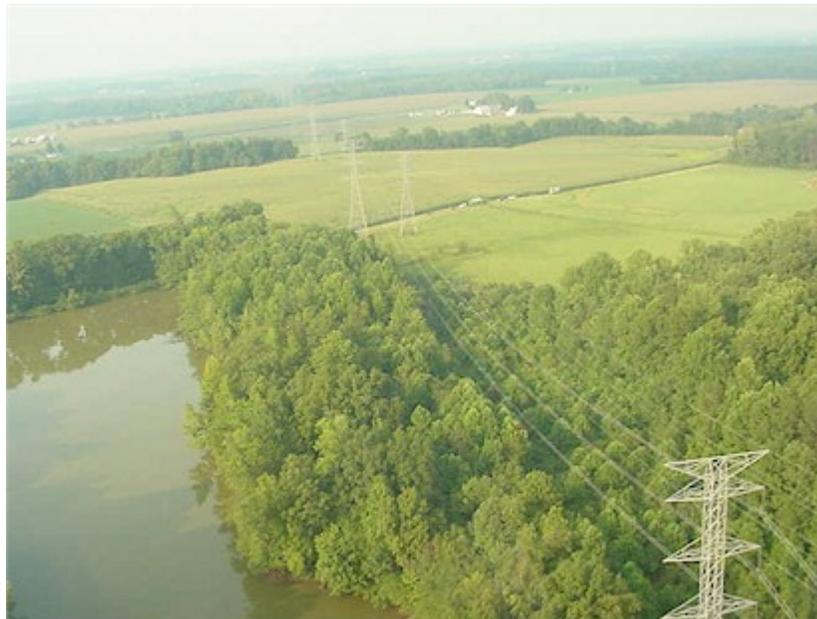
Based on discussions with Cinergy, this transmission line fault occurred as a result of tree contact in one span of the Columbus – Bedford circuit. See photo below.

Apparently work on this span had been halted various times by the owner of the property. The owner of the property had severely limited the ability to achieve necessary clearances, and apply subsequent herbicides to control future growth. While Cinergy does, in fact, have documented rights to perform this work (documented easement), this landowner has successfully halted work from proceeding on several occasions. This included the homeowner obtaining a court granted temporary injunction halting work by Cinergy. Note: the required work was finally completed on October 9, 2003 as depicted in the photo below.
