# San Fernando Disturbance

Southern California Event: July 7, 2020  
Joint NERC and WECC Staff Report

November 2020

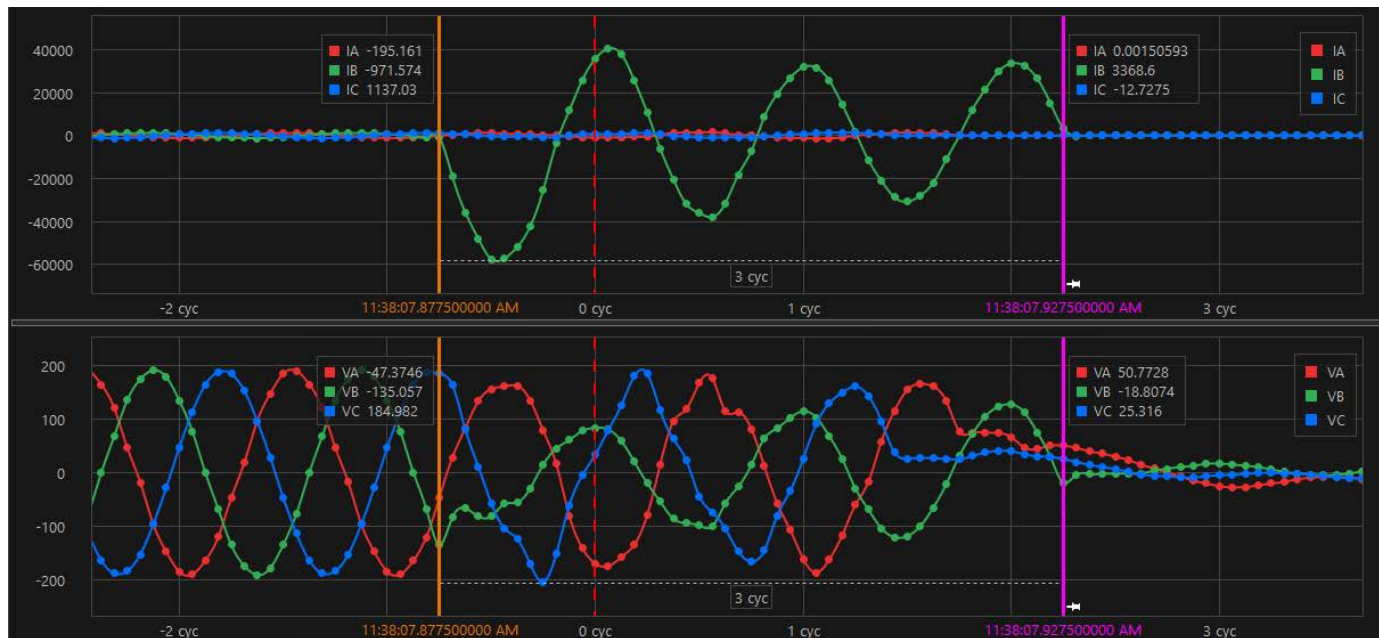
On July 7, 2020, at 11:38:07 a.m. PDT, an overhead static wire failed and fell across three phases on one of two 230 kV parallel circuits on a common tower structure. This initially caused a B-phase-to-ground fault on both circuits that cleared in three cycles (see [Figure 1.1](#)). At the same time, a nearby 230 kV circuit incorrectly<sup>19</sup> operated for an external fault due to incorrect settings. At 11:41 PDT, one of the 230 kV lines tested and held; however, at 11:41:31 PDT the second 230 kV parallel line with the permanent static wire fault tested and relayed out. This caused a bolted three-phase fault that cleared in approximately two cycles (see [Figure 1.2](#) and [Figure 1.3](#)). The three-phase fault significantly depressed BPS voltages across the Southern California area.

Figure 1.1: Event #1—B-Phase-to-Ground Fault on 230 kV Line [Source: LADWP]

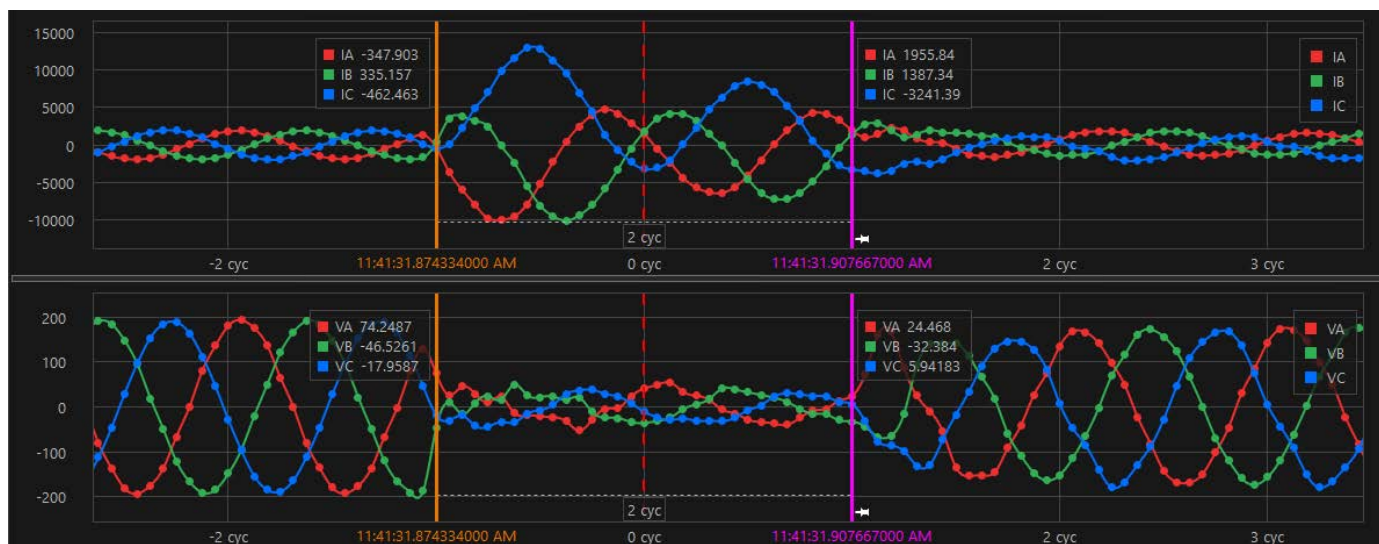
Figure 1.2: Event #2—Three-Phase Fault Observed on Parallel #1 230 kV Circuit Already Returned To Service [Source: LADWP]

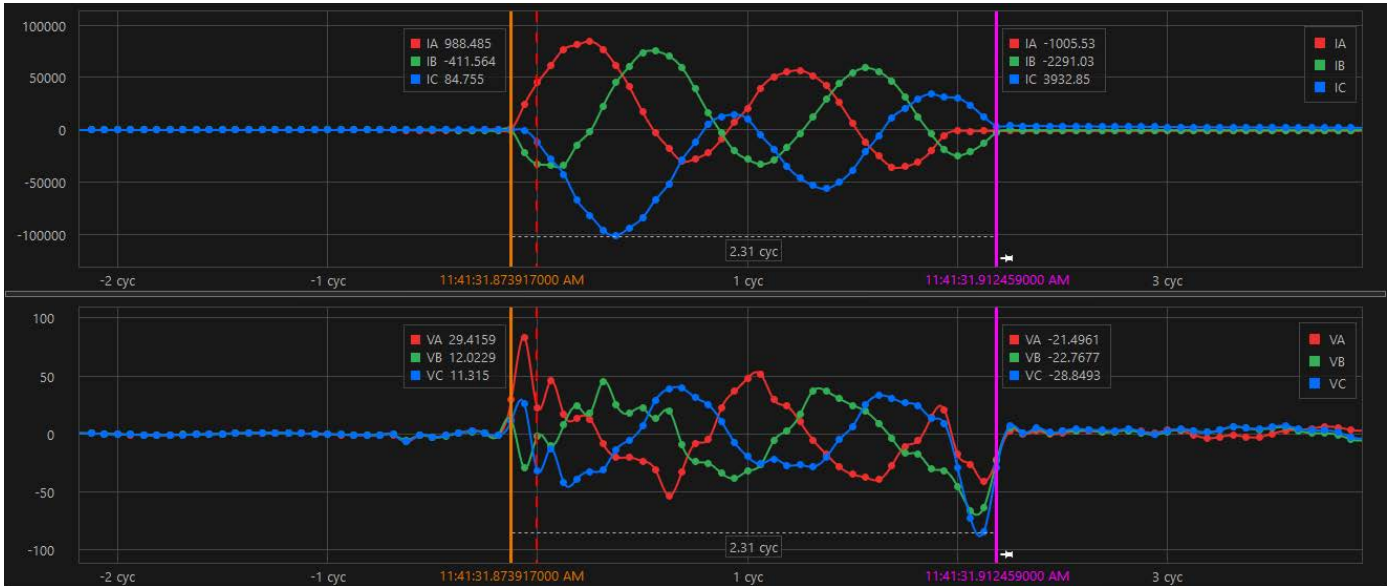
**Figure 1.3: Event #2—Three-Phase Fault for Test on #2 230 kV Circuit [Source: LADWP]**

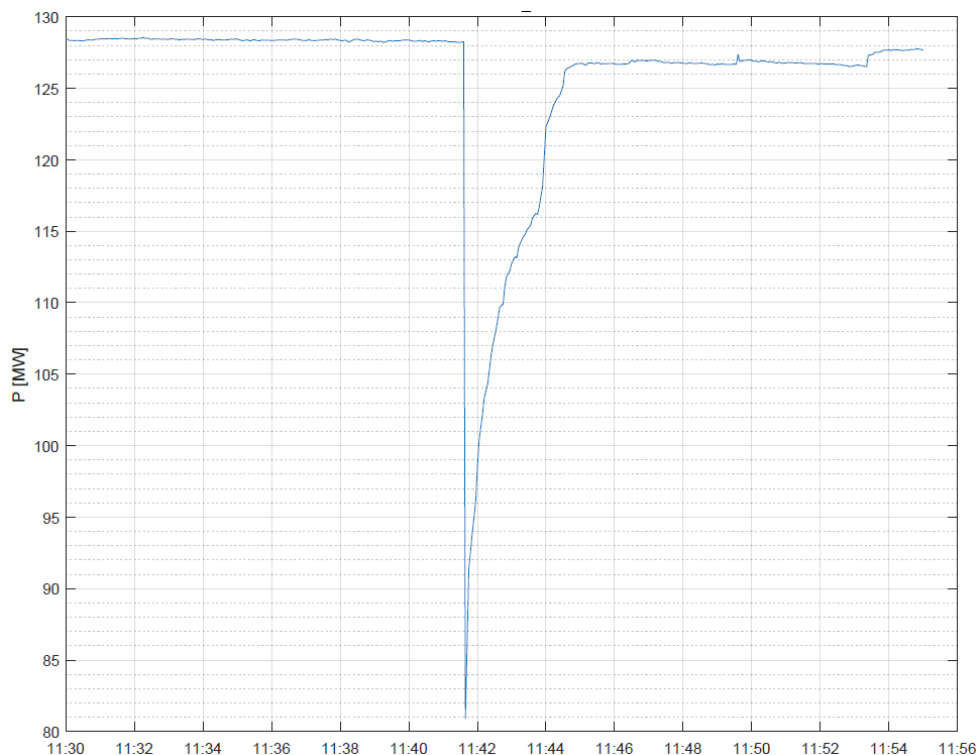
- Delayed Recovery of Active Power during Momentary Cessation:** A number of solar PV plants entered momentary cessation yet their active power recovery did not meet the recovery time of one second as recommended in the NERC reliability guidelines. **Figure 2.1** shows an example of a solar PV plant with a commercial operation date of late 2017 with momentary cessation low voltage threshold of 0.9 pu and active power recovery ramp rate of 10%/second.<sup>26</sup> Active power drops at the time of the fault and requires about 2.5–3 minutes to recover active power. Active power recovery clearly does not return within 10 seconds (assuming 10%/second recovery); this recovery is hindered in some way, possibly by poorly coordinated controls between the plant controller and the individual inverters.

**Figure 2.1: Example of Delayed Recovery of Active Power Following Momentary Cessation**

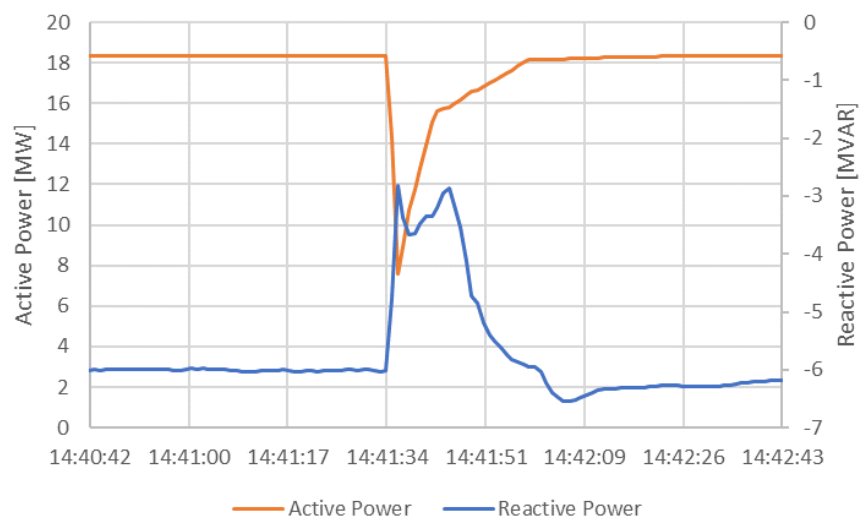
the fault clears within three electrical cycles, and BPS voltages recover quickly to predisturbance levels. Therefore, the sustained increase in reactive power output is slightly unexpected. Studies are needed to ensure that the controls are coordinated.

**Figure 2.2: Example of Delayed Recovery of Active Power Following Momentary Cessation**

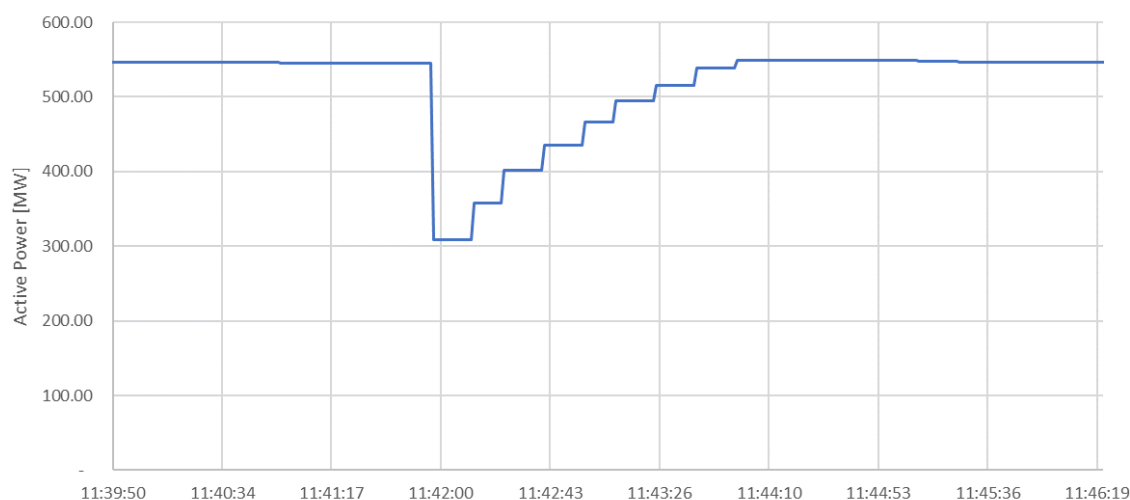
Plants A and B are 250 MW and 300 MW, respectively, and went into commercial operation in December 2014. These facilities include inverters that cannot change momentary cessation settings and are expected to enter momentary cessation at 0.875 pu voltage with a 1.02 second time delay for recovery and an active power recovery ramp rate of 8.2%/second. This facility is known to have the momentary cessation limitations and has been involved in prior disturbances that NERC and WECC have analyzed. [Figure B.1](#) shows the active power recovery of the facility following the second fault event. CAISO reported a drop of 302 MW<sup>29</sup> at the time of the fault event. The plant returns to predisturbance power two minutes after the fault. The GO in this case reported that only a small handful of inverters entered momentary cessation; however, it is clear from the plant output that this was understated by the GO.

**Figure B.1: Plants A and B Combined Active Power Output**

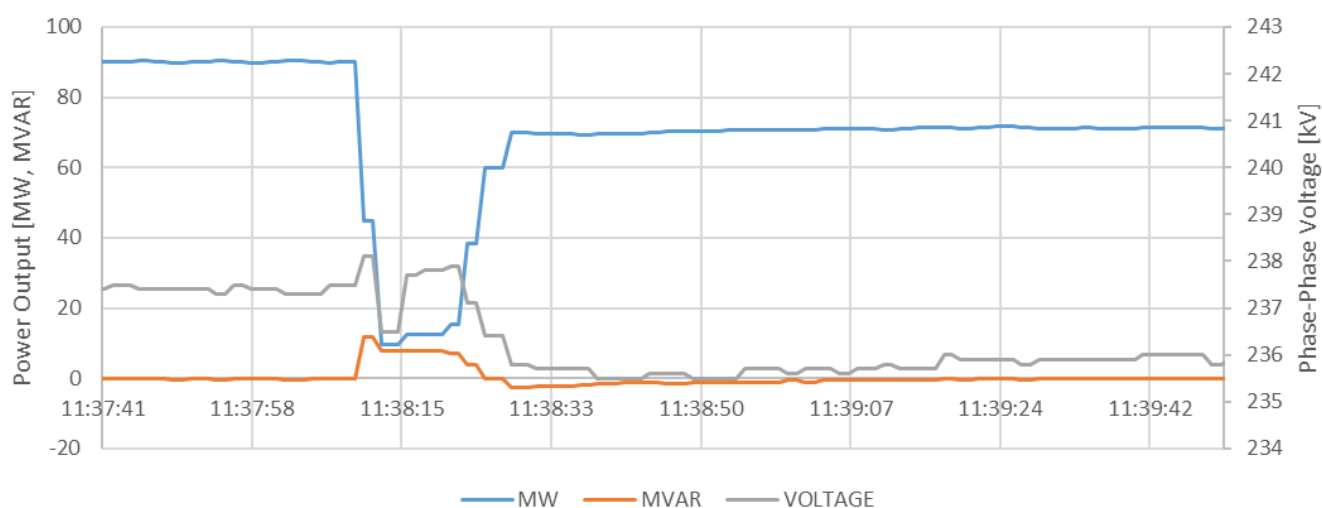
This plant is a 103 MW facility that went into commercial operation in July 2019. The plant consists of inverters that exhibit current injection for large voltage excursions. [Figure B.2](#) shows active and reactive power from the facility (one-second resolution measured at the point of interconnection) for Event #1.<sup>30</sup> Active power drops during and immediately after the fault, and most inverters at the facility enter “ride-through mode” with reactive current priority. While the fault only lasts for less than three cycles, and BPS voltages return to close to nominal values quickly, the facility remains with decreased active power for about 10 seconds before beginning to ramp back to predisturbance levels over about six seconds. The difference in pre- and post-disturbance output is due to six inverters tripping on ac overcurrent protection set at 150% of rated current.<sup>31</sup> This is a systemic tripping mechanism observed for one specific inverter manufacturer in this event and is believed to be related to the management of power electronic switch controls during severe fault events. During follow-up discussions with the facility to discuss mitigating measures, they were not able to provide details on the root cause of tripping nor provided any mitigating actions; therefore, this cause of tripping may persist.

**Figure B.2: Plant C Active Power, Reactive Power, and Voltage for Event #1**

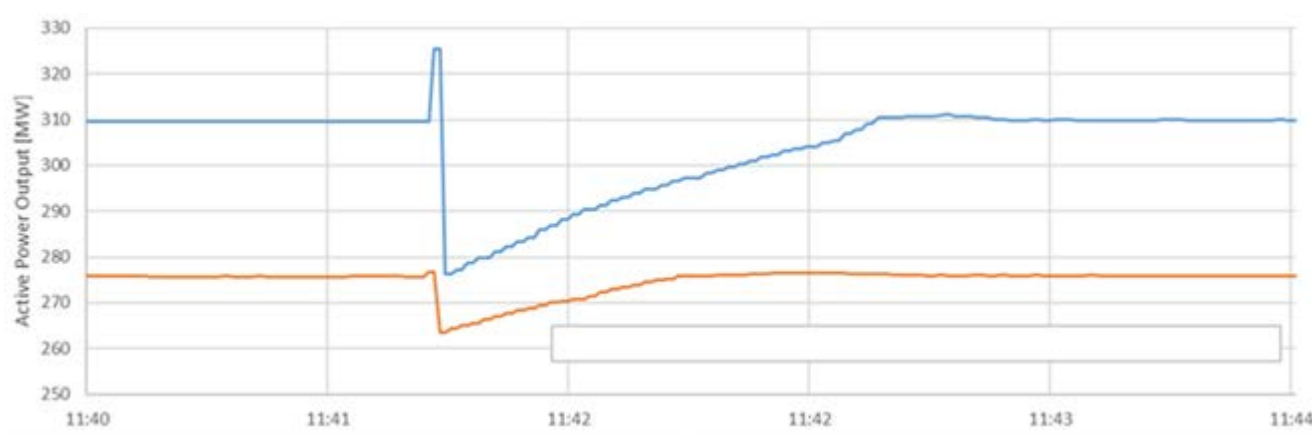
These two plants were reported as one facility by CAISO; however, WECC and NERC (in coordination with the GOs) identified that both facilities were involved in the disturbance. Plant D and Plant E are 310 MW and 276 MW facilities that entered commercial operation in October 2013 and November 2013, respectively. These plants both exhibited an abnormal behavior to Event #2. No inverters tripped or entered momentary cessation; however, the overall response of the plant highlighted some abnormal behavior between the inverter and plant controls. [Figure B.3](#) shows the active power output of the facilities that exhibited a quick rise in active power followed by a rapid reduction in active power to well below predisturbance levels. The plant controller increased its set point to slowly ramp the plant back to predisturbance output with a predefined ramp rate expressed as Watts/second rather than percent/second. Therefore, the times to recovering to predisturbance levels are different between the facilities. Regardless, following the fault events, the plant controller caused strange behavior that led to an unexpected reduction in active power, and then the plant output required minutes to return to expected output levels. This is not the expected or recommended behavior for solar PV facilities; the plant should not have responded abnormally and should also be able to rapidly recover to predisturbance levels following these types of disturbances with no interaction or hindrance from the plant controller. NERC and WECC encouraged this GO to coordinate with their equipment manufacturers to identify a fix to this undesired behavior of the facility.

**Figure B.3: Plants D and E Active Power Output for Event #2**

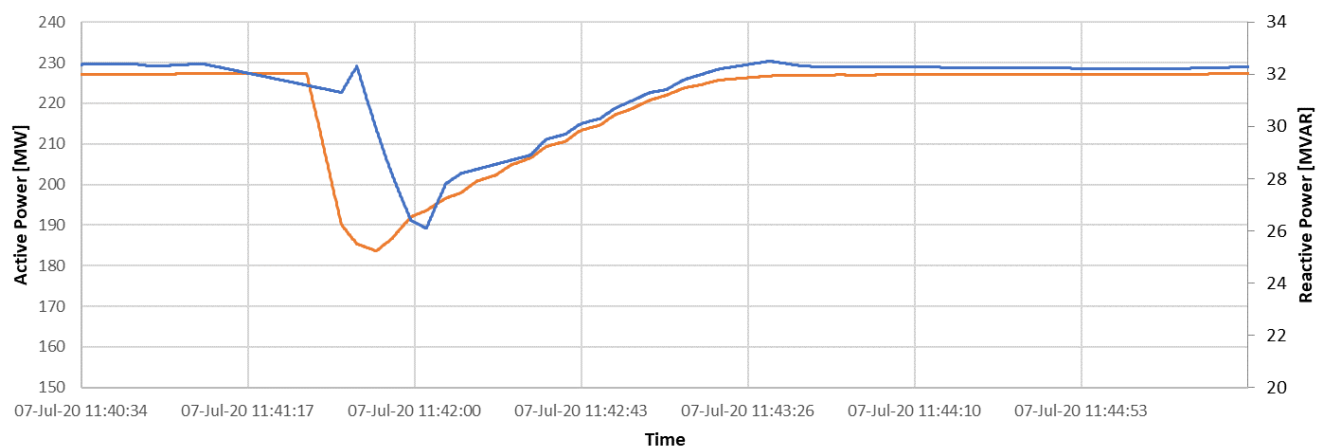
This plant is a 248 MW facility went into commercial operation in 2013–2014 and includes a mix of inverters that enter momentary cessation and provide current injection during voltage excursions. All inverters of the former type entered momentary cessation with settings that cannot be changed. These inverters are set to enter momentary cessation at 0.875 pu voltage, have a 1.02 second delay for recovery of active power after voltage returns to above the threshold value, and also have a 8.2%/second active power recovery ramp rate. One inverter faulted on dc overcurrent. [Figure B.4](#) shows the active power (orange) and reactive power (blue) response from the facility for Event #2. Active power drops from 228 MW to around 184 MW and reactive current support also decreases (due to momentary cessation ceasing current injection). The facility recovers to predisturbance levels in about 1 minute and 40 seconds.

**Figure B.4: Plant F Active and Reactive Power Output for Event #2**

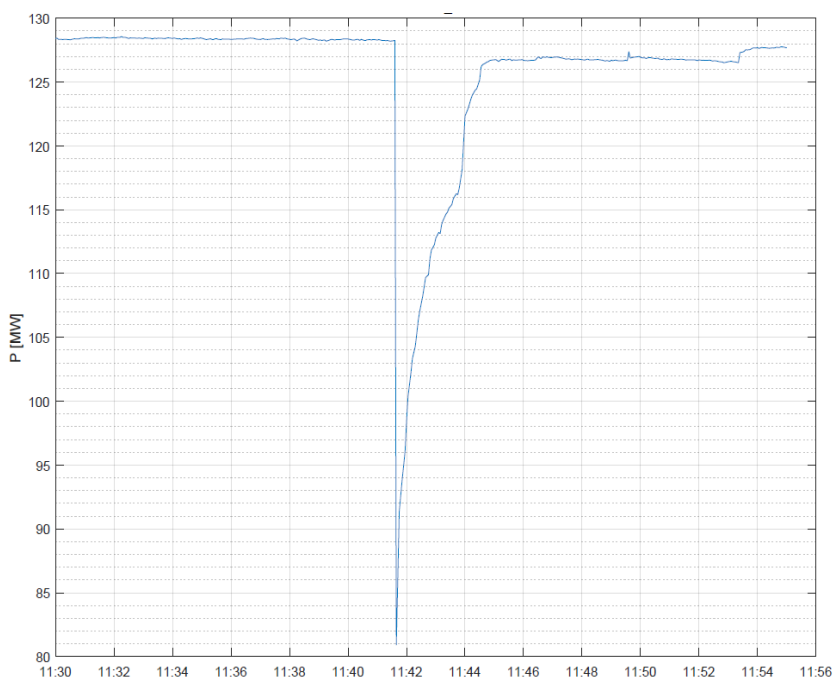
This plant is a 140 MW facility with a commercial operation date of November 2017; its inverters are set to enter momentary cessation at 0.9 pu voltage, and the plant has an active power recovery ramp rate of 10%/second. Twelve inverters tripped on ac overcurrent protection and were distributed throughout the solar PV collector system (i.e., not all located at end of the feeder or near the substation). [Figure B.5](#) shows the active power response of the facility for Event #2. Active power drops at the time of the fault and required about 3 minutes to return to near predisturbance output levels. It is assumed that the inverters at this facility have a 2-minute restart time for this type of inverter fault code, hence the jump in active power at 11:44 PDT. However, it is also clear that the recovery of active power by the inverters (at 10%/second) is hindered since the plant does not recover up to about 116 MW within 10 seconds. This is likely due to poorly coordinated controls between the plant controller and the individual inverters with the plant controller overriding the inverter controls (since voltage is back within acceptable levels within 3 cycles).

**Figure B.5: Plant H Active Power Output for Event #2**

It is assumed that the inverters at this facility have a 2-minute restart time for this type of inverter fault code, hence the jump in active power at 11:44 PDT. However, it is also clear that the recovery of active power by the inverters (at 10%/second) is hindered since the plant does not recover up to about 116 MW within 10 seconds. This is likely due to poorly coordinated controls between the plant controller and the individual inverters with the plant controller overriding the inverter controls (since voltage is back within acceptable levels within 3 cycles).

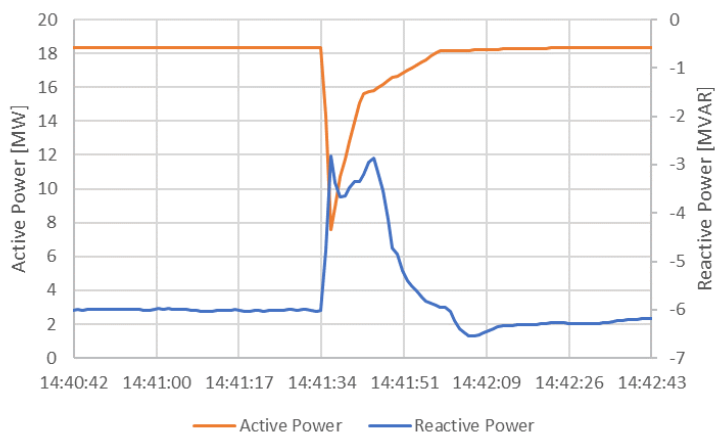
This plant is a 24.5 MW facility that went into commercial operation in September 2018 comprised of inverters that do not use momentary cessation. During the second fault, plant active power output reduced and reactive power consumption decreased ([Figure B.6](#)). As reactive power settled to a new settling point, active power also returned to predisturbance levels; however, this occurred over a 15-second time frame that is not the recommended recovery of active power following a fault event. It is unclear if the overall change in plant reactive power consumption was caused by response of the inverter controls or due to inverter active power reducing (causing less consumption of reactive power inside the facility). Without more detailed data, determining a root cause to the delayed recovery of active and reactive power is not possible.

**Figure B.6: Plant J Active and Reactive Power Output for Event #2**

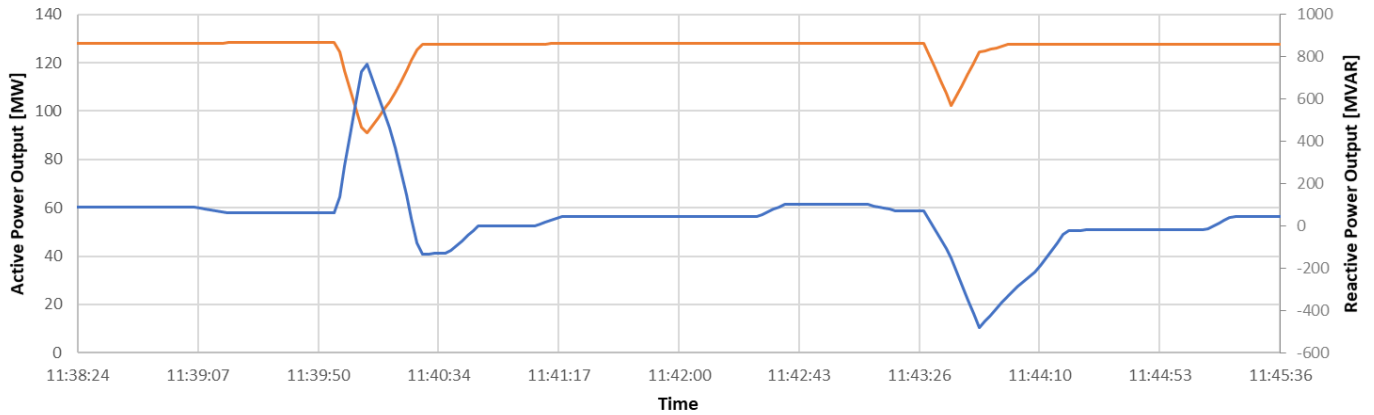
This plant is a 150 MW facility that went into commercial operation in June 2019 and consists of inverters configured for current injection during fault events. [Figure B.7](#) shows the active and reactive power output of the plant for both events (note the time synchronization and reactive power unit errors). The dynamic response of reactive power appears to be abnormal with reactive power increasing for one fault and then decreasing for the more severe fault. This anomaly is currently unexplained. The plant does appear to have a delayed recovery of active power after these low voltage conditions, requiring about 15–30 seconds to return to predisturbance output levels after the fault.

Figure B.7: Plant M Active Power Output

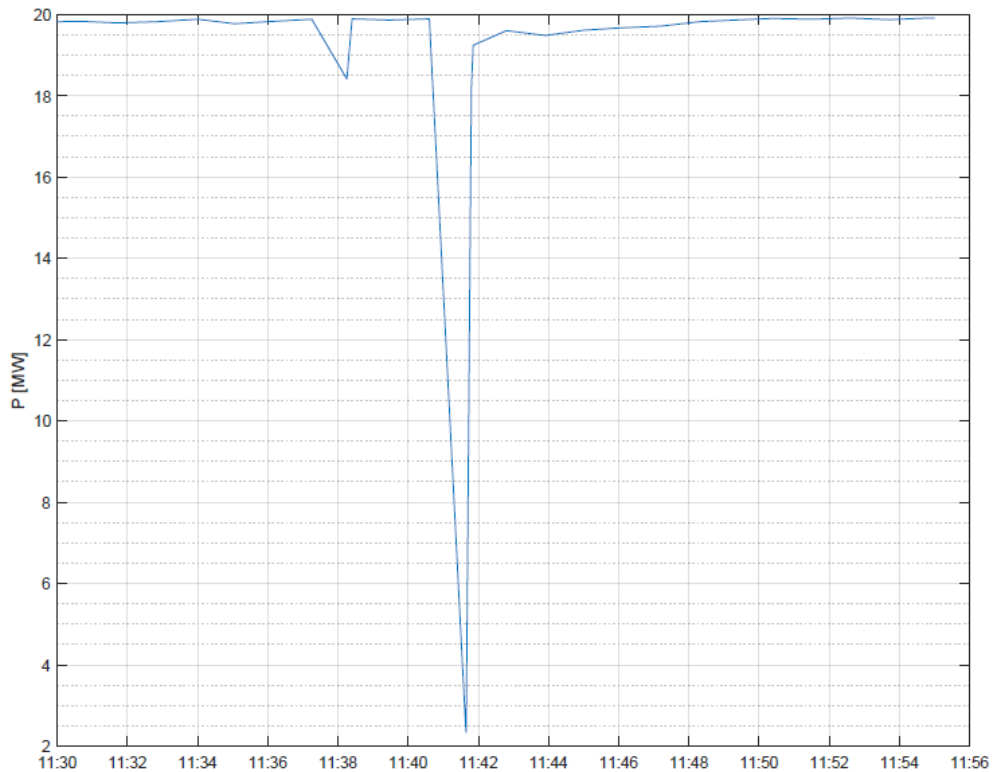
This plant is a 20 MW facility with a commercial operation date of January 2018. It consists of inverters that the GO stated “will continue to operate and inject the power factor and active current as issued by the [inverter] control loop,” indicating that the facility does not employ momentary cessation. The GO was only able to provide 1-minute resolution data that does not provide any useful information about the dynamic behavior of the plant. Furthermore, data collected from PG&E (Figure B.8) shows a significant drop in active power during Event #2 with output returning to predisturbance values after about 1.5 minutes. The discrepancy between information provided by the GO and the plot of active power output do not match; however, no further analysis can be done without additional information from the GO. Regardless, the delayed recovery of active power does not meet the recommendations set forth in the NERC reliability guidelines.

Figure B.8: Plant N Active Power Output

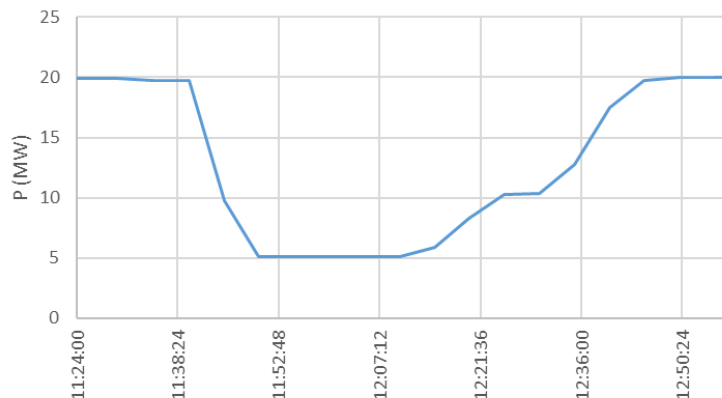
This plant is a 26 MW facility (limited to 20 MW at POI) that went into commercial operation in December 2017. The majority of inverters at the facility tripped on dc low voltage during Event #2 and required manual reset to return to service. [Figure B.9](#) shows the reduction of active power near the event and long-term recovery after the inverters had been reset.

**Figure B.9: Plant O Active Power Output**

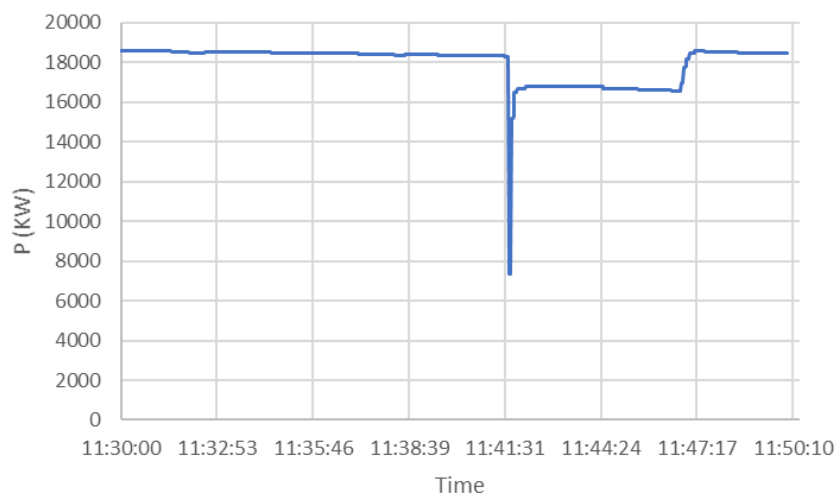
This plant is a 20 MW facility that went into commercial operation December 2019 and is comprised of inverters that use momentary cessation. During this disturbance, 32 inverters entered momentary cessation and 4 inverters tripped on ac low voltage (see [Figure B.10](#)). Momentary cessation settings include a low voltage threshold of 0.86 pu, a return to service delay of 2 cycles, and an active power ramp rate of 50% per second. However, the data provided by the facility showed that the active power returned to predisturbance levels after roughly 10 seconds. Furthermore, the trip setting indicates low voltage was observed for greater than 10 cycles; however, the entity could not determine the trip threshold and received little response from the inverter manufacturer to support these efforts.

**Figure B.10: Plant P Active Power Output**

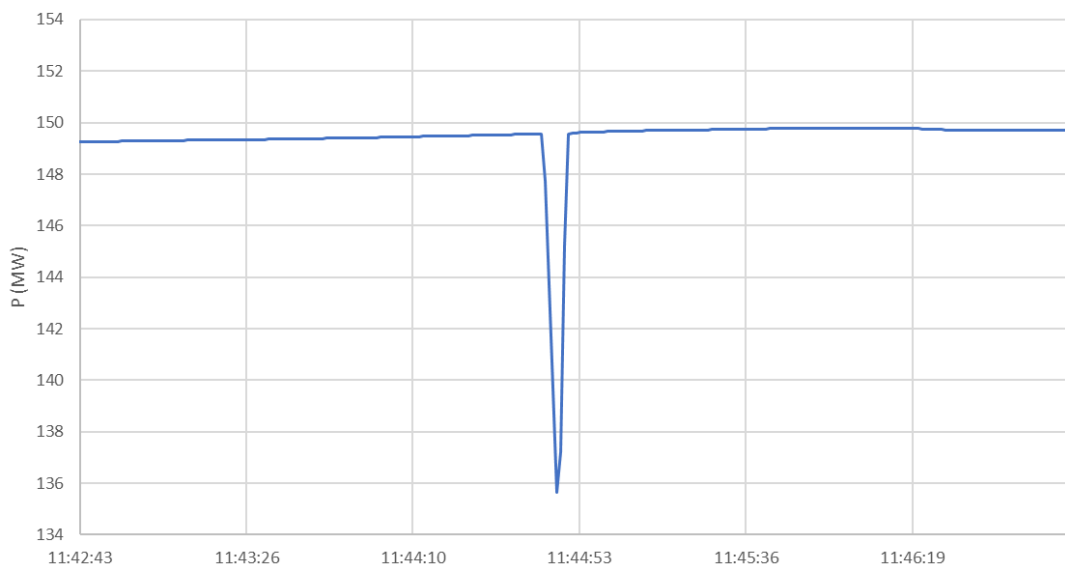
This plant is a 172 MW facility that went into commercial operation in June 2012 (Phase 1) and April 2015 (Phase 2) consisting of some inverters that used momentary cessation and other that did not. During this disturbance, 17 inverters entered momentary cessation. The momentary cessation settings at the time of the event were set to a 0.9 pu low voltage threshold, a 50 ms time delay to start recovery, and a 25%/second active power recovery ramp rate. The settings on these inverters are adjustable and momentary cessation can be eliminated. At the time of this disturbance, the GO or GOP had not made any changes as recommended in the NERC reliability guidelines or NERC alerts, hence the reduction of active power and recovery in about 4 seconds during this event (see [Figure B.11](#)).<sup>32</sup> However, after NERC and WECC discussions with the facility, the GO and GOP have changed the settings at this facility to use reactive current injection during fault events rather than momentary cessation.

**Figure B.11: Plant Q Active Power Output**

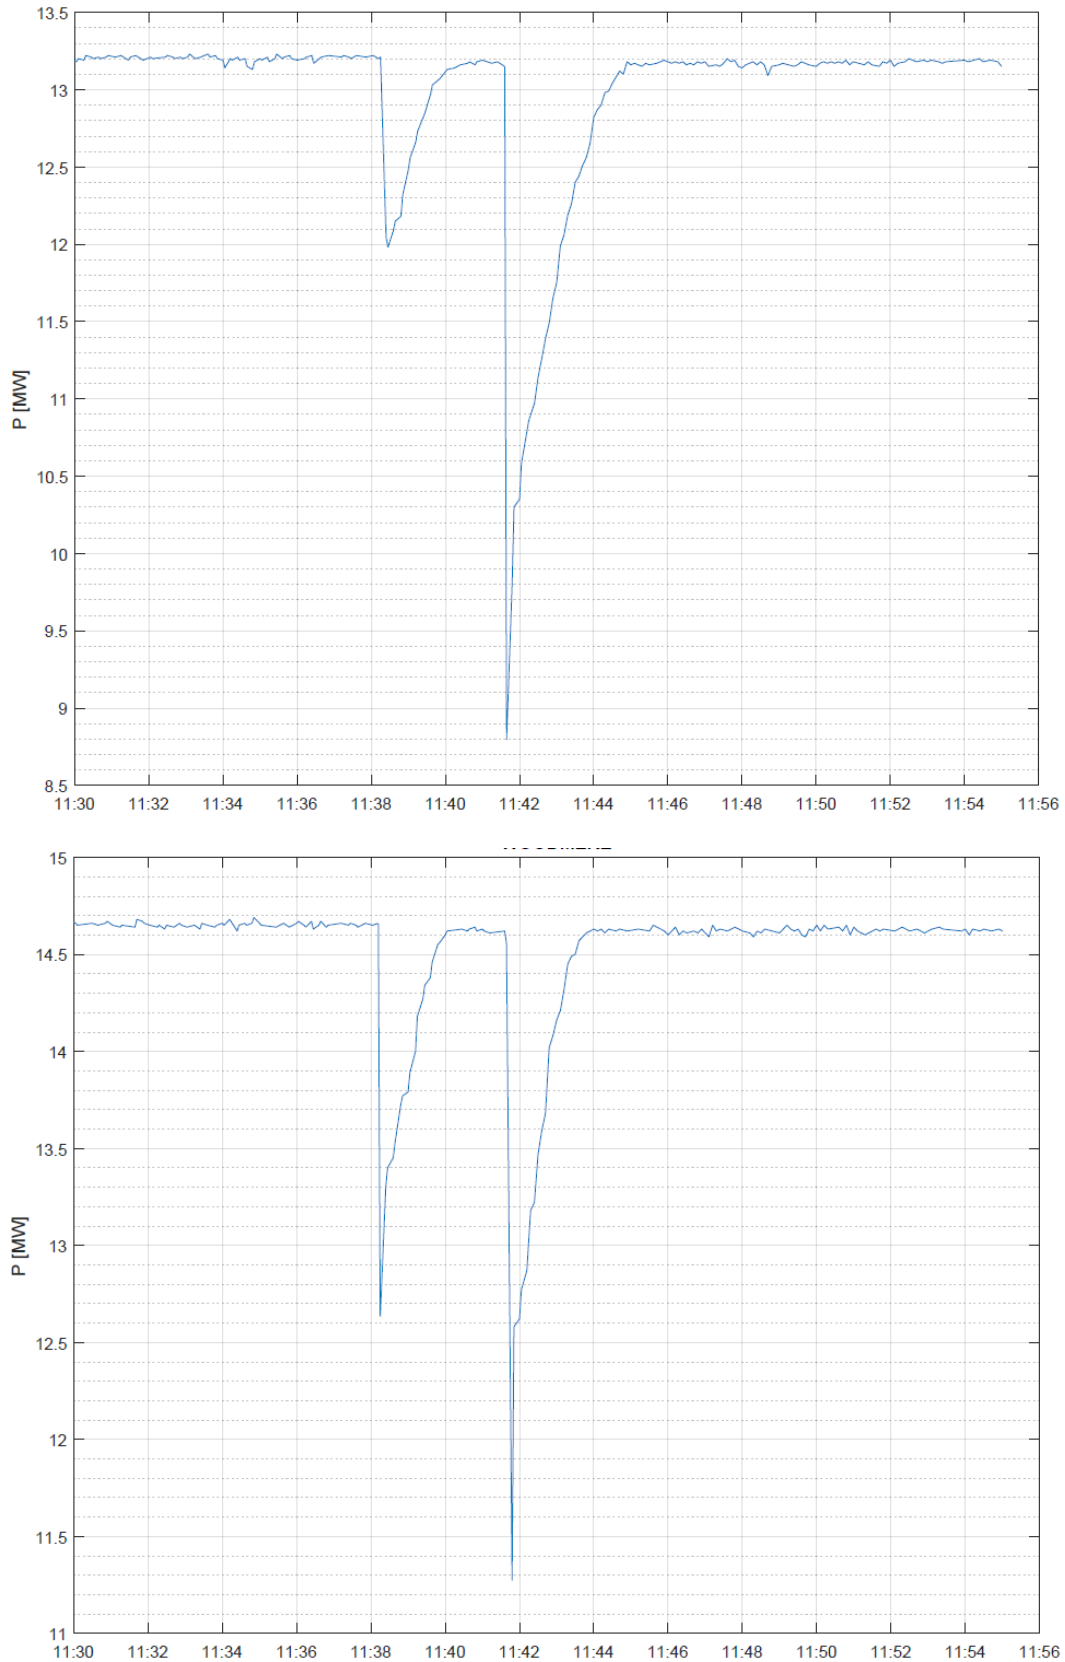
Many other solar PV facilities responded to the fault events described in this report. Many of these facilities are non-BES solar PV generating resources that had a noticeable effect on BPS performance in aggregate. [Figure B.12](#) shows two examples of these facilities and the response from them. It is clear that they mirror the responses of the larger solar PV facilities; this is to be expected since the inverter manufacturer, make, and model are likely similar. The most common reduction of solar PV, as shown in [Figure B.12](#), is caused by inverters entering momentary cessation and returning to service on the order of multiple minutes. Again, this is not the recommended performance of BPS-connected solar PV per the NERC reliability guidelines.

Figure B.12: Active Power Output from Two Smaller Solar PV Facilities during the Disturbance
