U.S.-Canada Power System Outage Task Force

**Final Report on the
August 14, 2003 Blackout
in the
United States and Canada:**

**Causes and
Recommendations**

April 2004

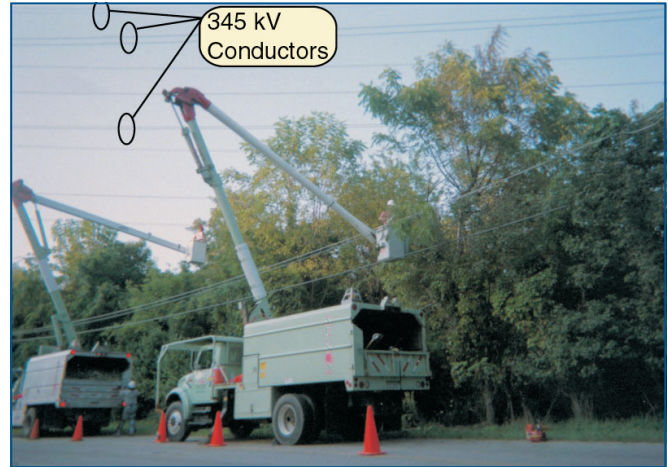
Figure 5.10. Cause of the Hanna-Juniper Line Loss

This August 14 photo shows the tree that caused the loss of the Hanna-Juniper line (tallest tree in photo). Other 345-kV conductors and shield wires can be seen in the background. Photo by Nelson Tree.
