Review of Selected
Electric System Disturbances
in North America

North American
Electric
Reliability
Council

July 1992

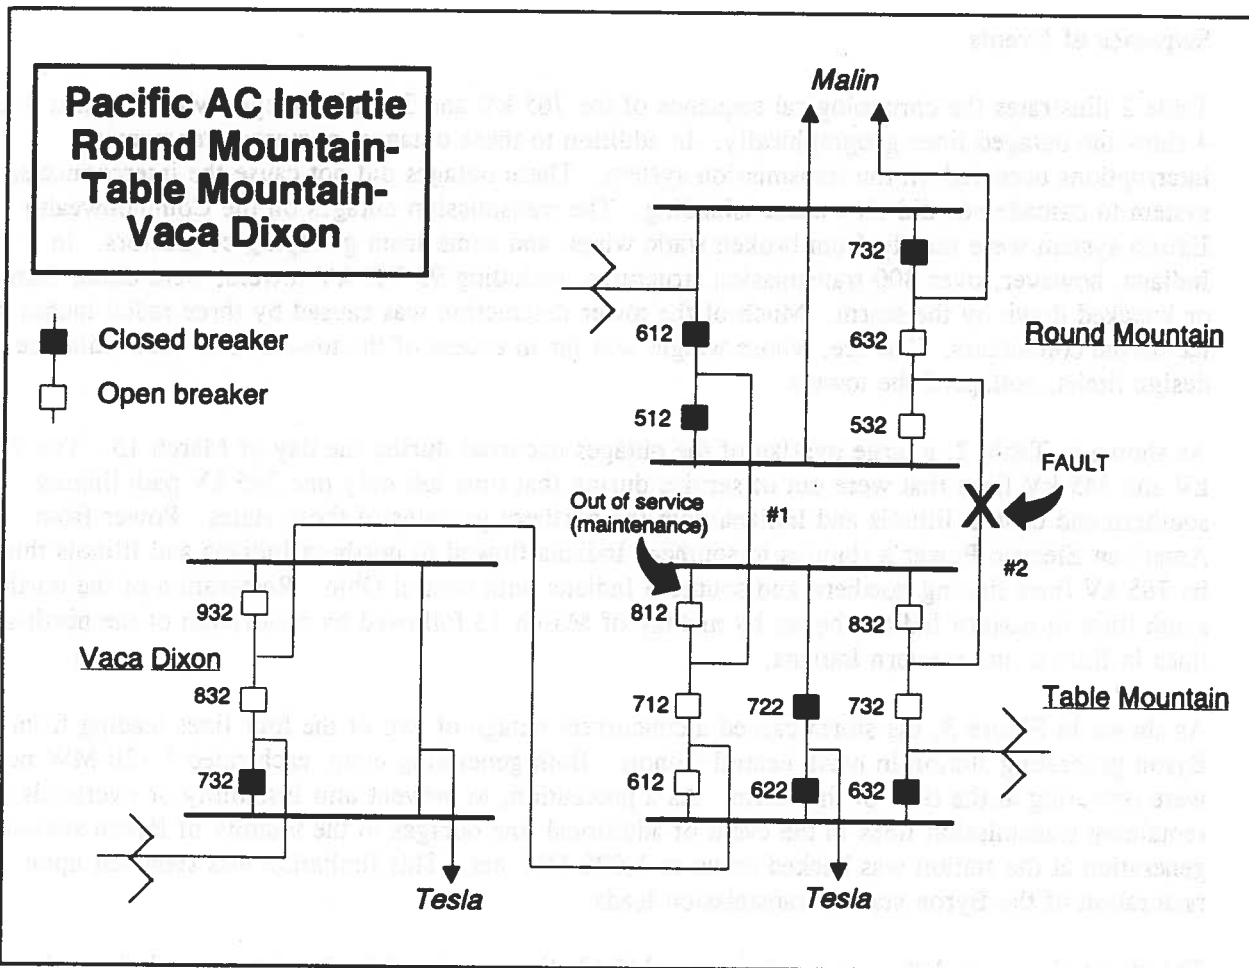
Figure 2 — Pacific AC Intertie Separation — Detail of Round Mountain, Table Mountain, and Vaca Dixon Substations

High-speed reclosing of the Round Mountain-Table Mountain No. 2 500 kV line was not successful due to the permanent fault caused by the tower failure. On the reclose attempt, the Table Mountain-Vaca Dixon 500 kV line relayed by a false trip of the current phase comparison relays.

The false trip of the Table Mountain-Vaca Dixon 500 kV line was caused by a bad connection in a multi-conductor plug connector between the phase comparison relay and its communication equipment at Vaca Dixon. This false operation, coupled with the outage of circuit breaker 812 at Table Mountain, caused the total PACI separation.

Plug connections on the Vaca Dixon relays were repaired. PG&E subsequently investigated the replacement of the connectors used on this type of relay, and found the cost prohibitive. As an alternative, PG&E is developing a procedure for routinely testing the relay with the connectors left intact. PG&E also recommends more frequent testing of these relays.

The bad phase comparison relay logic board at Midway was replaced. PG&E is designing a procedure to detect bad circuit boards during routine testing.

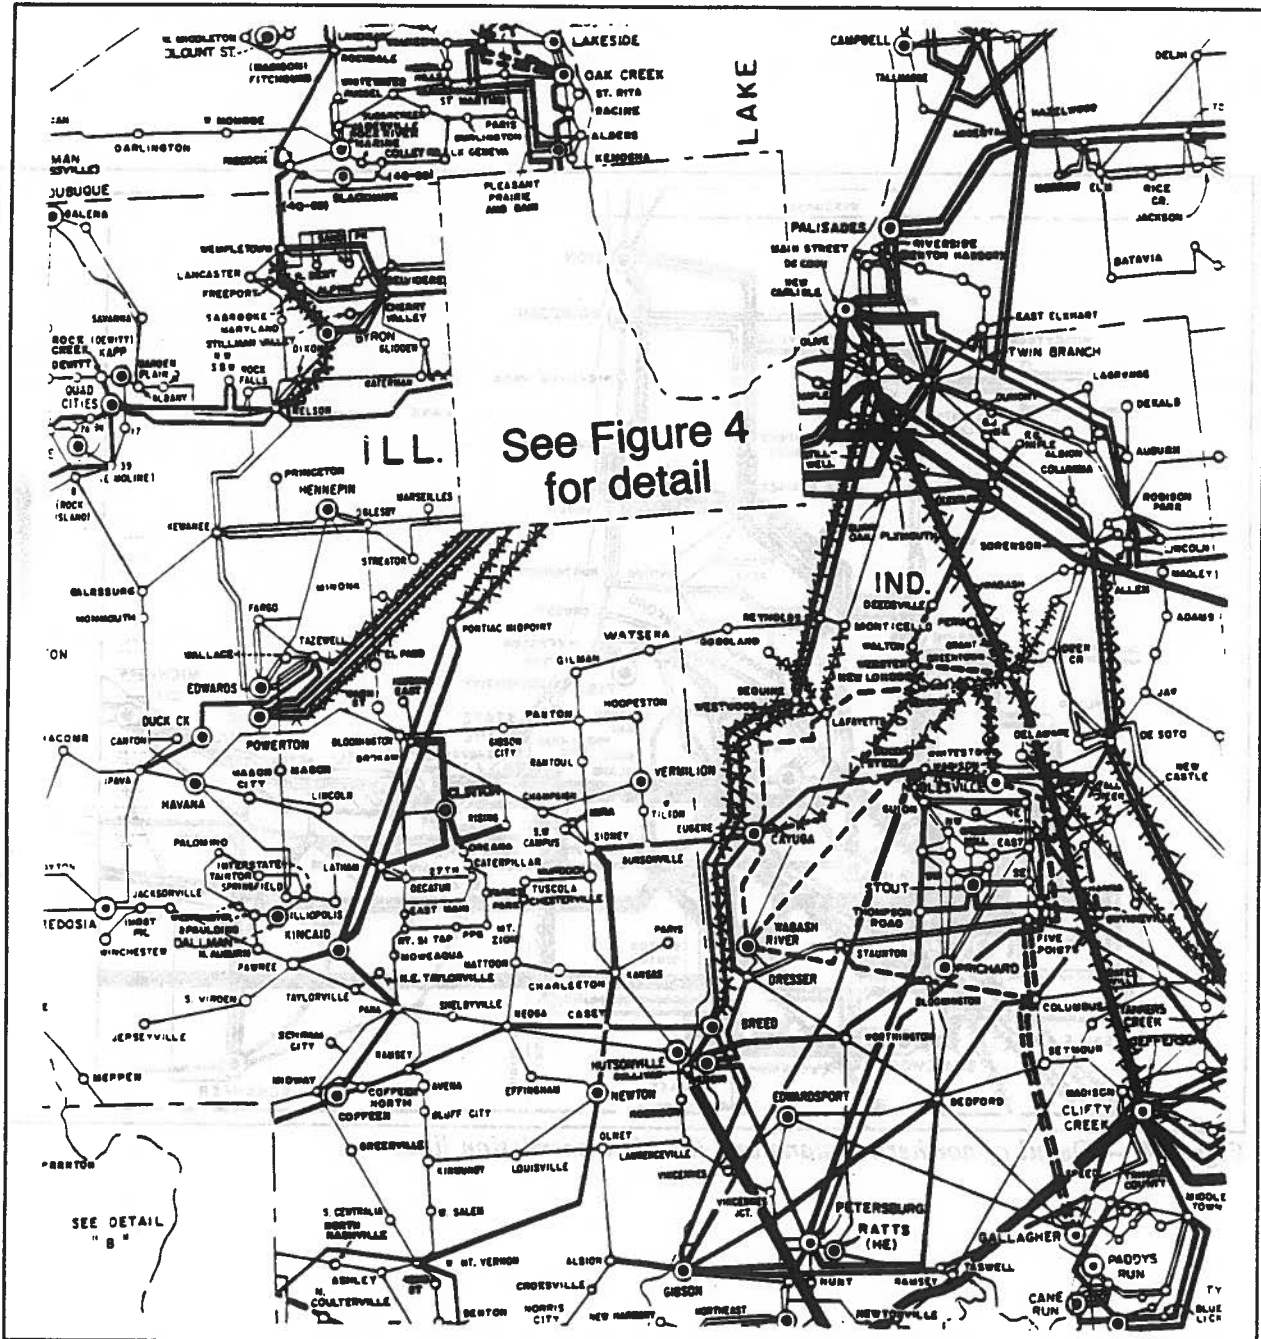
Figure 3 — Transmission lines affected by March 12-13, 1991 Ice Storm

As shown in Figure 3, the storm caused a concurrent outage of two of the four lines leading from Byron generating station in north central Illinois. Both generating units, each rated 1,120 MW net, were operating at the time of the storm. As a precaution, to prevent unit instability or overloads on remaining transmission lines in the event of additional line outages in the vicinity of Byron station, generation at the station was backed down to 1,900 MW net. This limitation was removed upon restoration of the Byron station transmission leads.

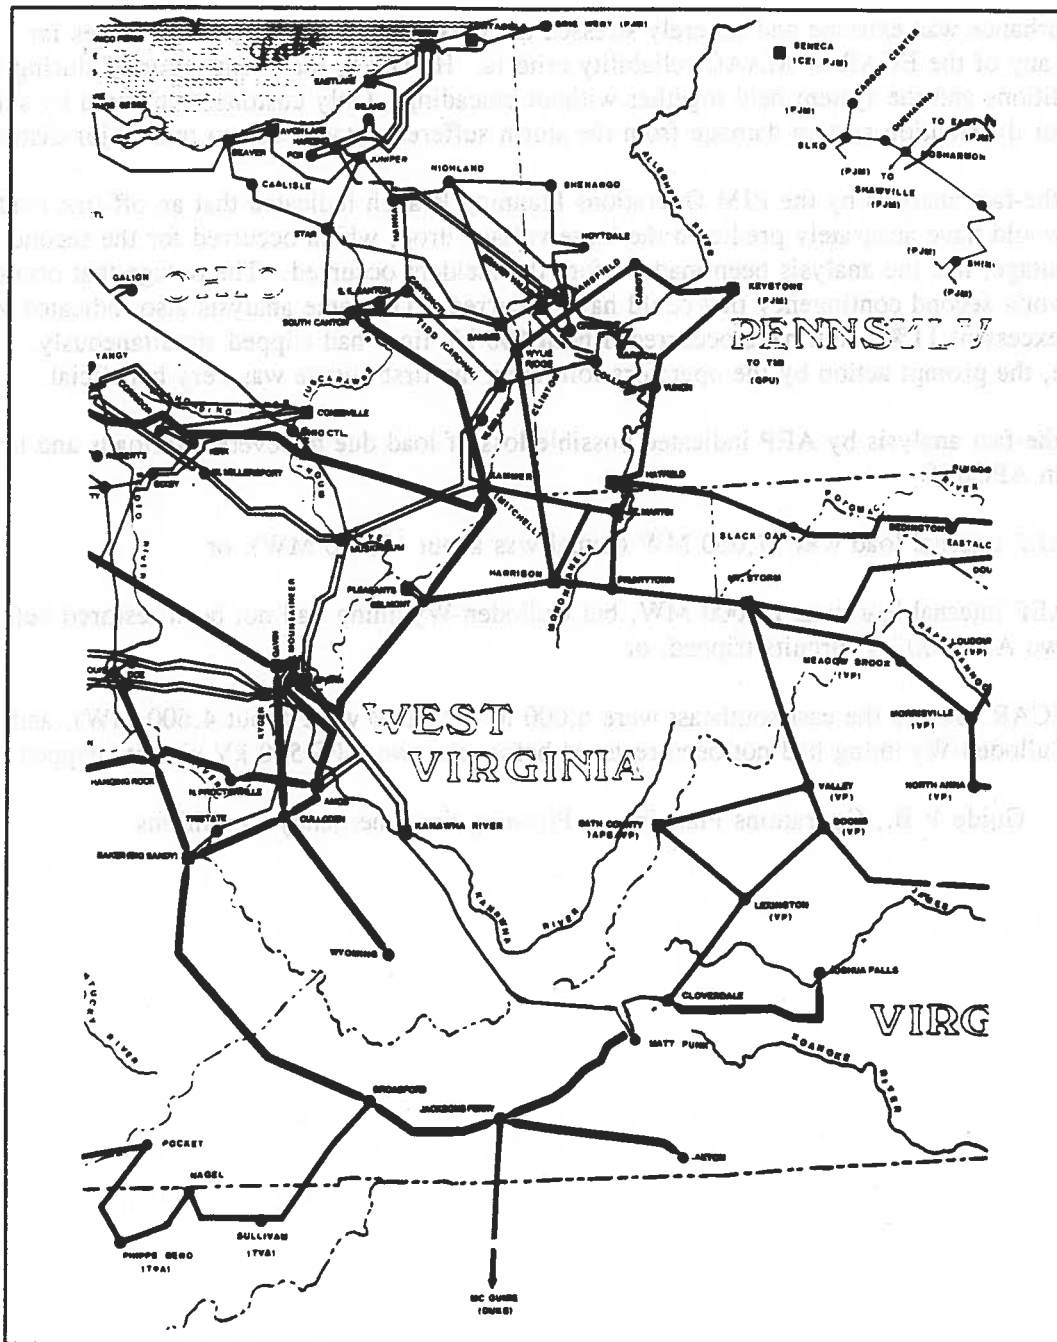
Figure 6 — Severe Thunderstorms — April 9, 1991

Figure 6 shows the transmission system in the areas affected by the storms. At one point, all five 765 kV lines and the Baker 765/345 kV transformer were out of service. However, the Culloden-Wyoming 765 kV line was restored before the 500 kV line outages occurred. The AEP system redispached generation to maintain transmission facilities within acceptable limits. It should be noted that the Amos 765/345 kV, 1,500 MVA transformer failure on January 21 contributed to the increased EHV loadings.

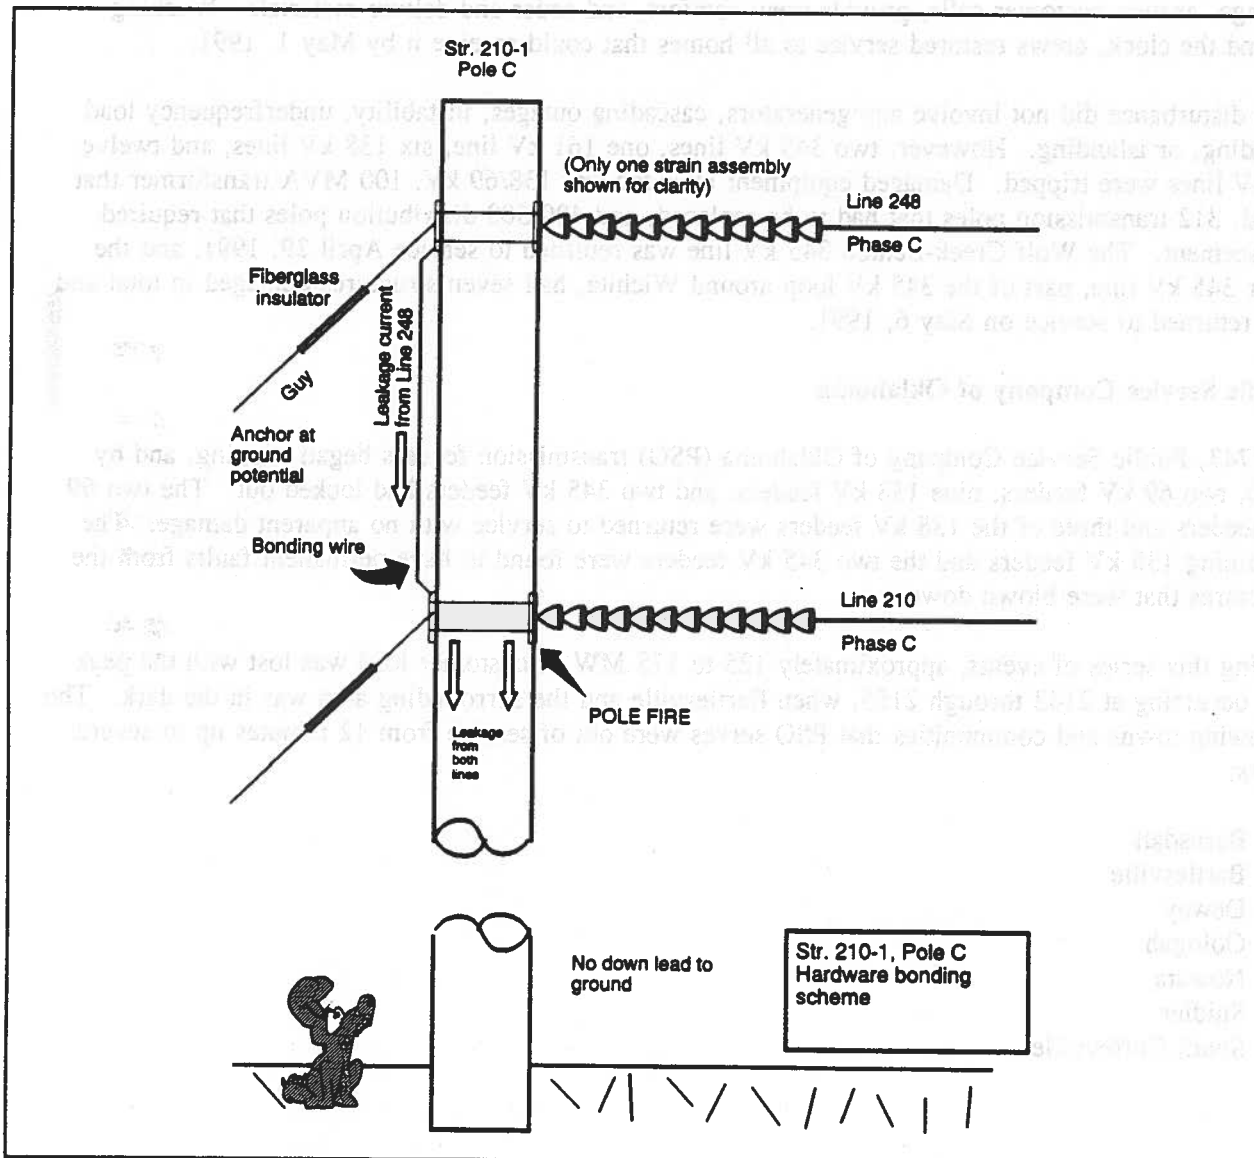
Figure 7 — Pole C at Hayfield Substation

On April 13, 1991 at approximately 2230 EDT, a pole fire burned through pole C of structure 210-1 on the 230 kV Hayfield-Van Dorn line 210. This double-circuit structure is a three-pole double dead-end angle that also carries the 230 kV Glebe-Ox line 248 and is the first structure outside Hayfield Substation. The fire burned through pole C at the attachment location of the lower circuit, line 210, which allowed phase C of line 210 to fall into the 230 kV bus inside Hayfield Substation. The same pole of structure 210-1 burned five years ago on May 15, 1986 at the same location.

Field investigation revealed that the pole hardware for the two phases on pole C was bonded together, as shown in Figure 7, but was not grounded. As a result, the combined leakage current from both phases entered the pole at the attachment location of the lower circuit on its way to ground. The pole fire was caused by the leakage current entering the pole, in conjunction with weather conditions conducive to the development of "hot spots," which eventually began to smolder and burn. Poles A and B of structure 210-1 did not have their pole hardware bonded together.

3. Due to phase conductor-to-guy electrical clearance problems with an adjacent line, the uninsulated guy wires on pole C were later replaced with insulated guy wires, probably on May 22, 1986. A down lead from pole hardware to ground, which would have provided a metal path to ground for leakage current, was not installed. This probably occurred from a shift in attention from the pole fire toward resolving the phase conductor-to-guy clearance problem. Apparently, engineering and field personnel did not recognize that even though the pole hardware for both phases on pole C was bonded together, the metal path to ground for leakage current was lost when the insulated guys were installed.

4. On April 13, 1991, exceptionally heavy pollen contamination combined with wet weather conditions allowed abnormally high amount of leakage current to flow across the phase conductor insulators. As the combined leakage current from lines 210 and 248 flowed to ground through the wood pole, a "hot spot" developed where the leakage current entered the wood pole. The "hot spot" began to smolder and burn, eventually burning completely through the pole.

1. The hardware on each pole of structure 210-1 was bonded together and provided with a metal connection to ground through the use of a down lead and pole ground. (This reflects current structure design that provides leakage current a direct path to ground.)
2. To further ensure future reliability, the three wood poles in structure 210-1 were then replaced with concrete poles.

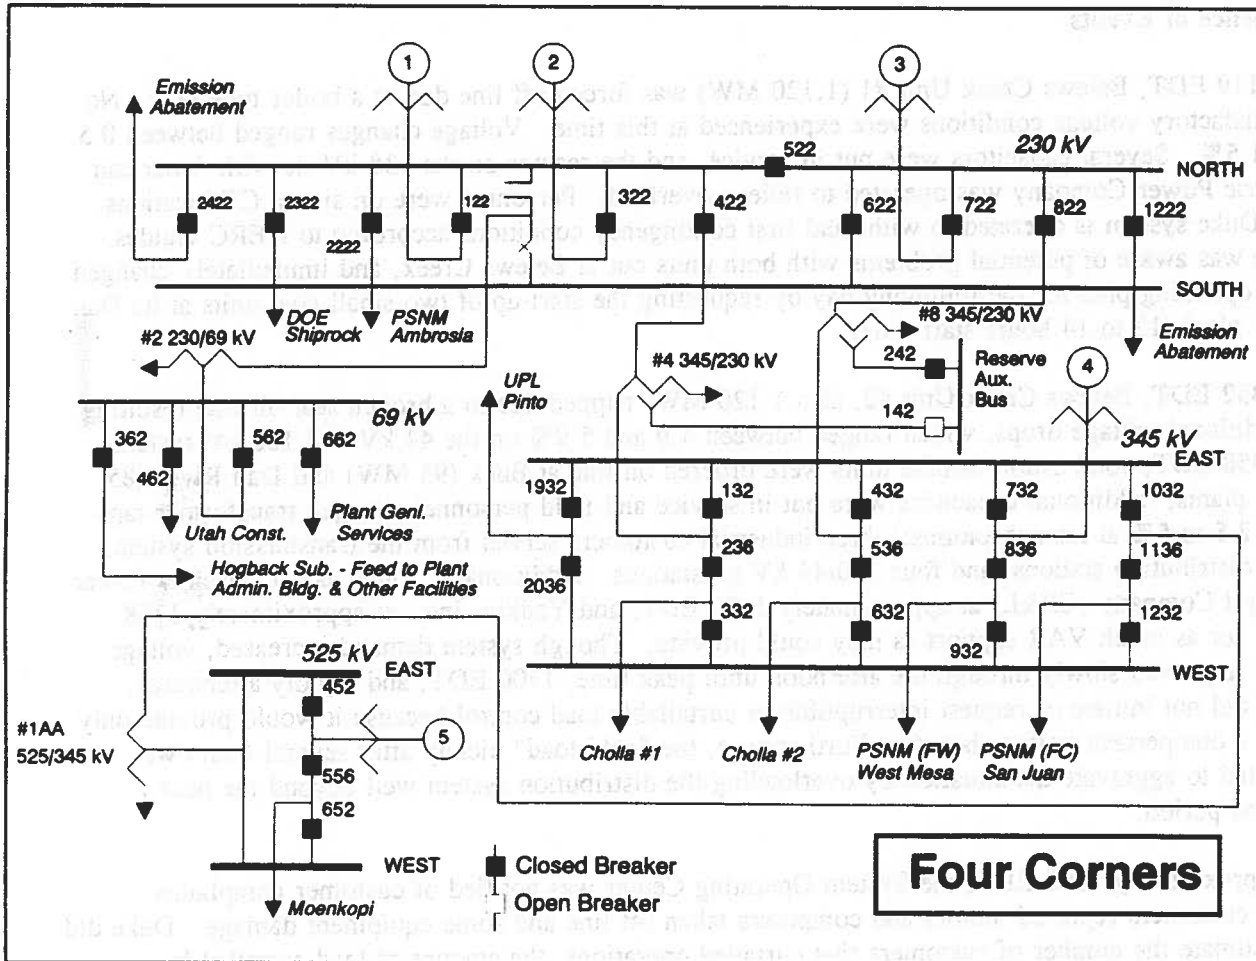
Figure 9 — Four Corners Substation

Operation of breaker failure lockout schemes on both the 230 kV and 345 kV sides of the Four Corners No. 8 345/230 kV transformer resulted in de-energizing the east 345 kV bus, the south 230 kV bus, and the 4,160 volt reserve auxiliary bus. The breaker failure relay on the 230 kV transformer breaker (FC822) operated because the time delay element in the lockout scheme was temporarily removed during a rewiring project. The breaker failure relay on the 345 kV transformer breaker (FC432) operated because the dc trip switches were inadvertently left open and tagged in the breaker control cabinet during previous work.

Most of the outages for this disturbance were caused by the unplanned operation of two breaker failure relays. After reviewing this disturbance, Arizona Public Service Company (AZPS) concluded that "...the impact of temporary modifications on the FC822 breaker failure relay was not clear at the time the modifications were made." Also, the open dc trip switches in breaker FC432 was not an acceptable operating configuration.

1. Direct ring-down telephones between the Energy Control Center and the plant control room should be separated from the local PBX switch.
2. Plant RTUs should be powered from an uninterruptible power supply.
