NORTH AMERICAN ELECTRIC
RELIABILITY CORPORATION

Hurricane Irma Event Analysis Report

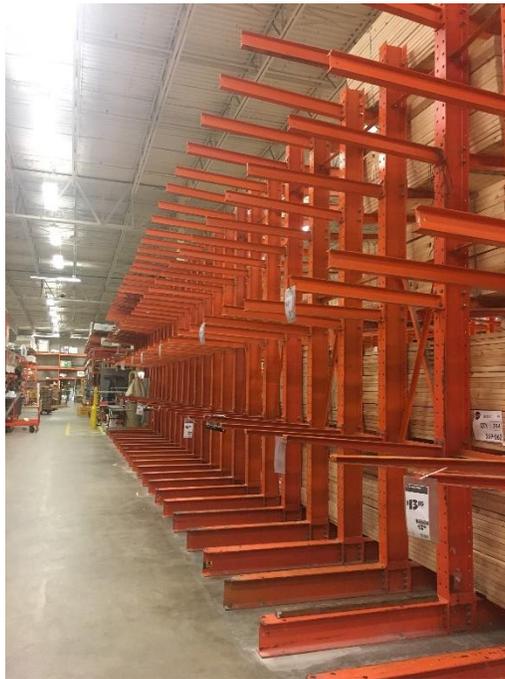
Figure 3.1: Empty shelves at a home improvement center

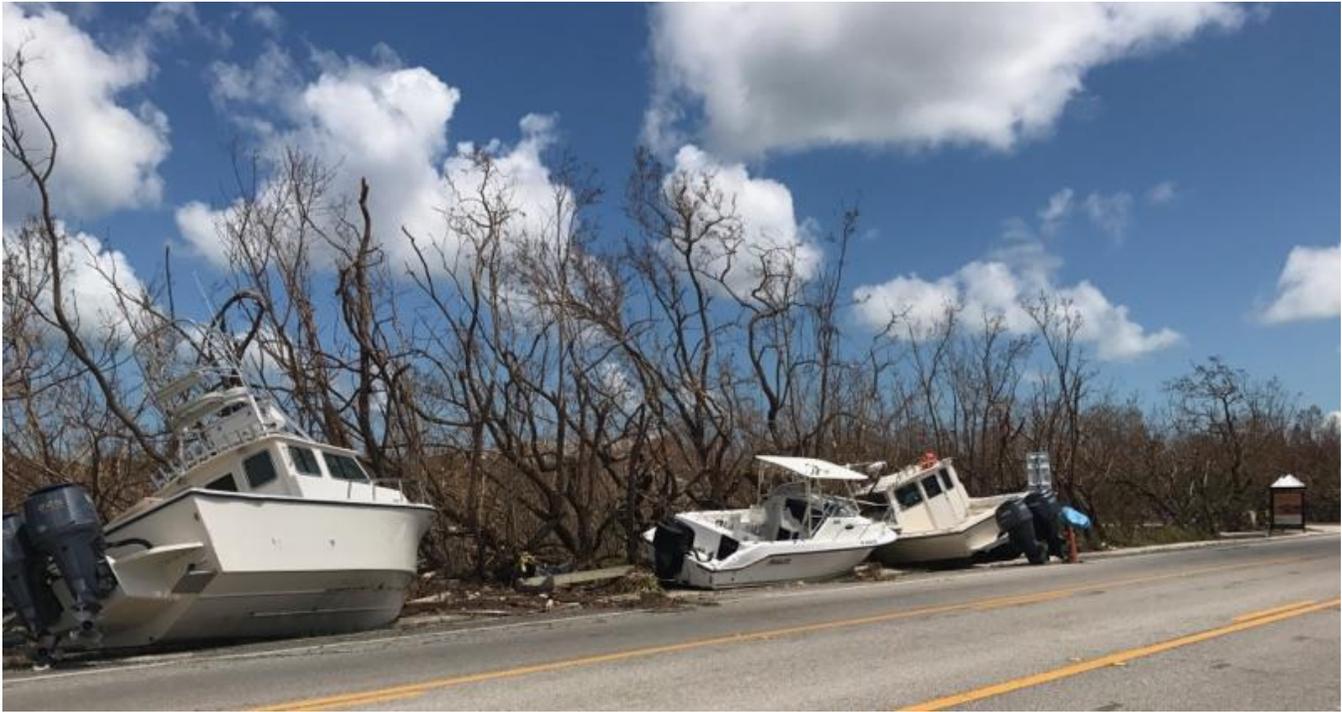
Figure 9.1: Boats washed up on Route 1 in Florida Keys

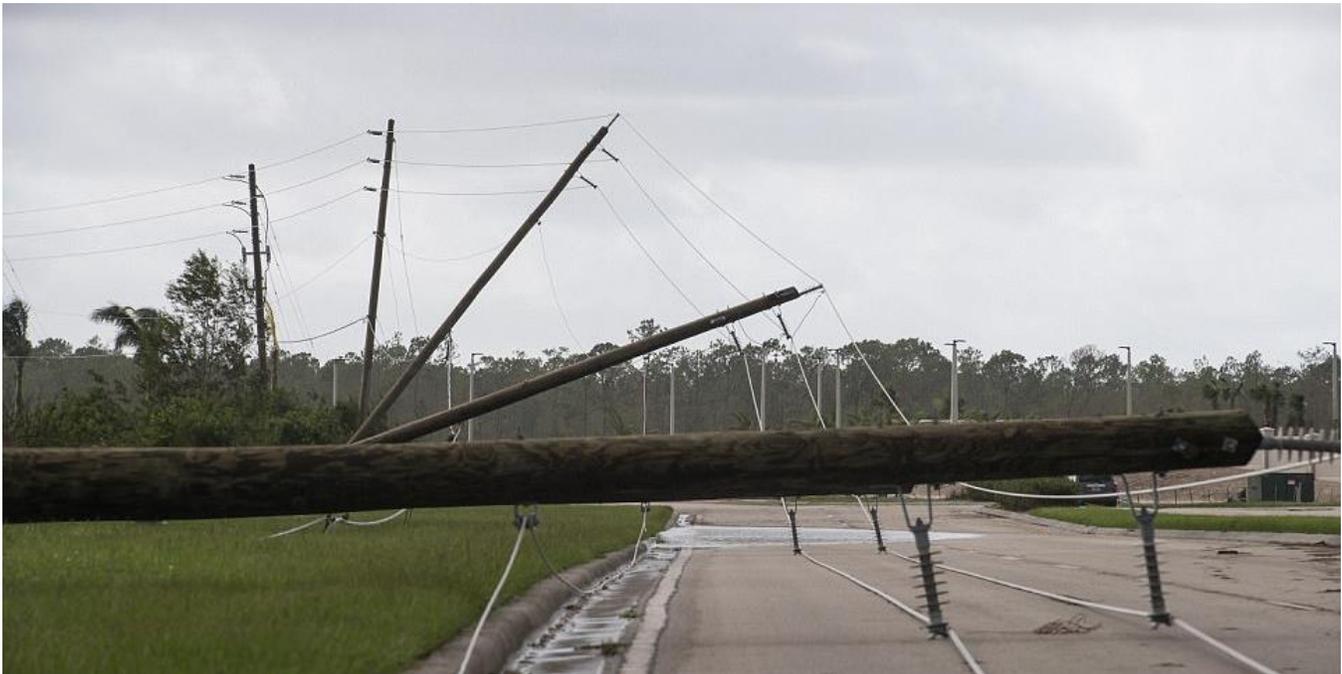
Figure 9.2: Example of damaged high voltage transmission line

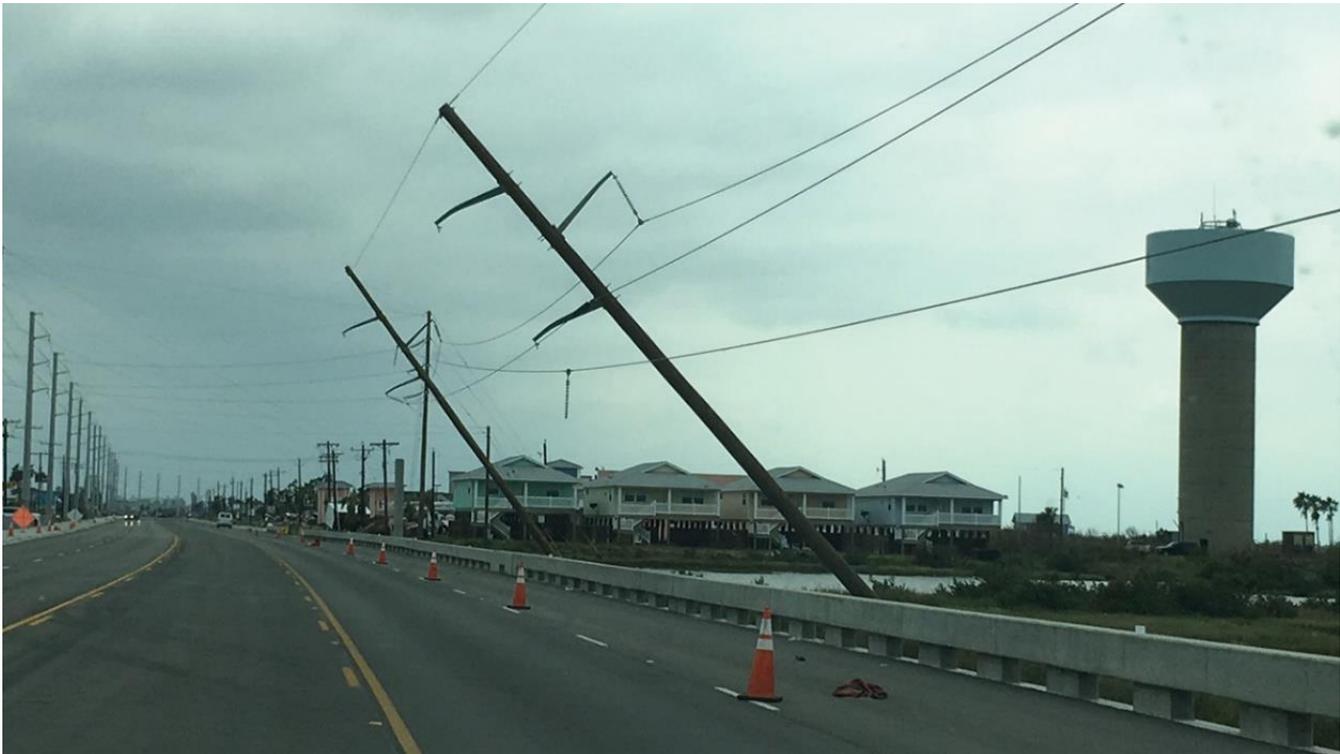
Figure 9.3: Example of damaged high voltage transmission line

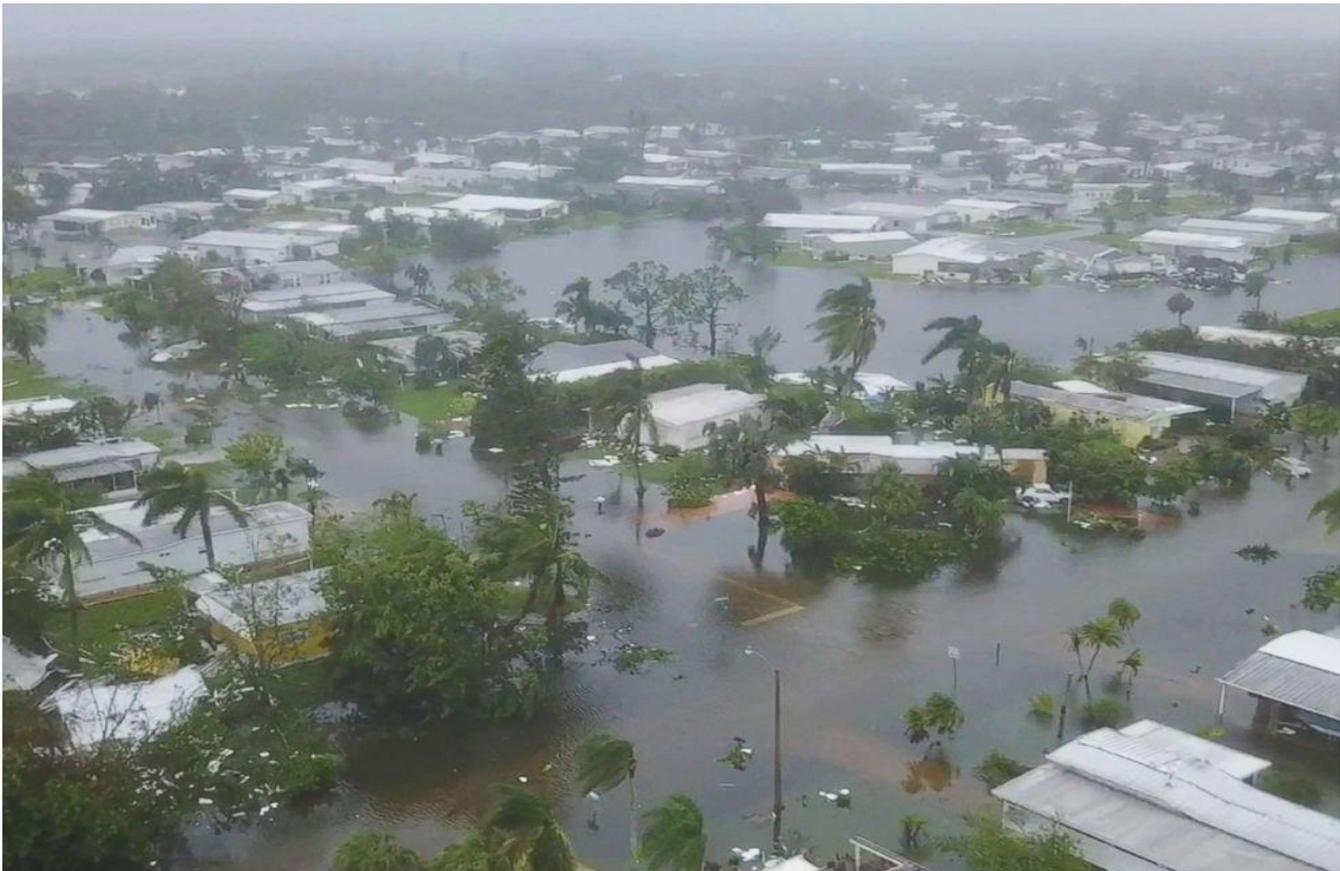
Figure 9.4: Flooding in Southwest Florida

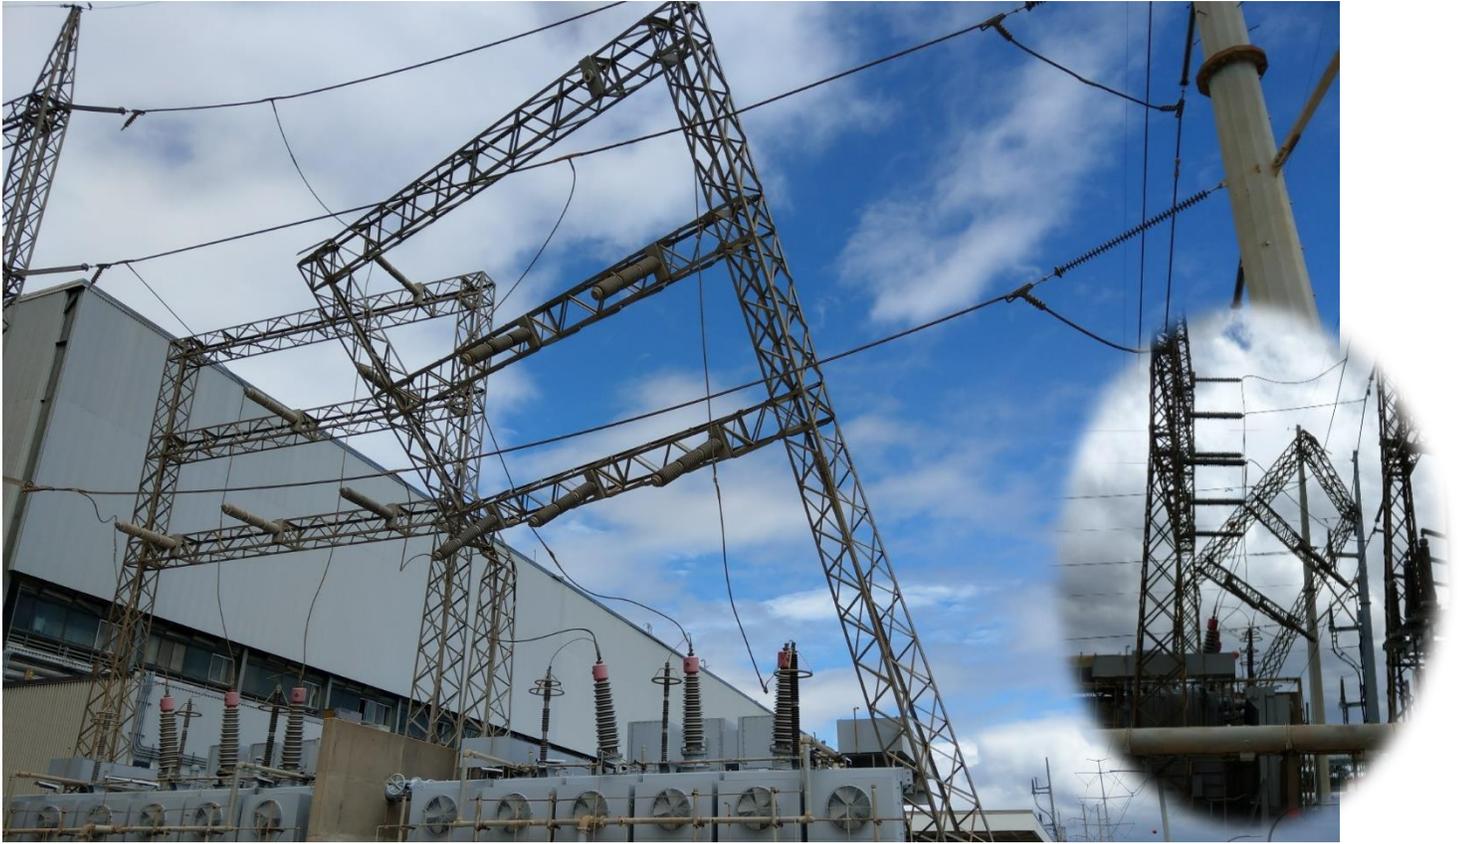
Figure 9.9: Damage at Substation

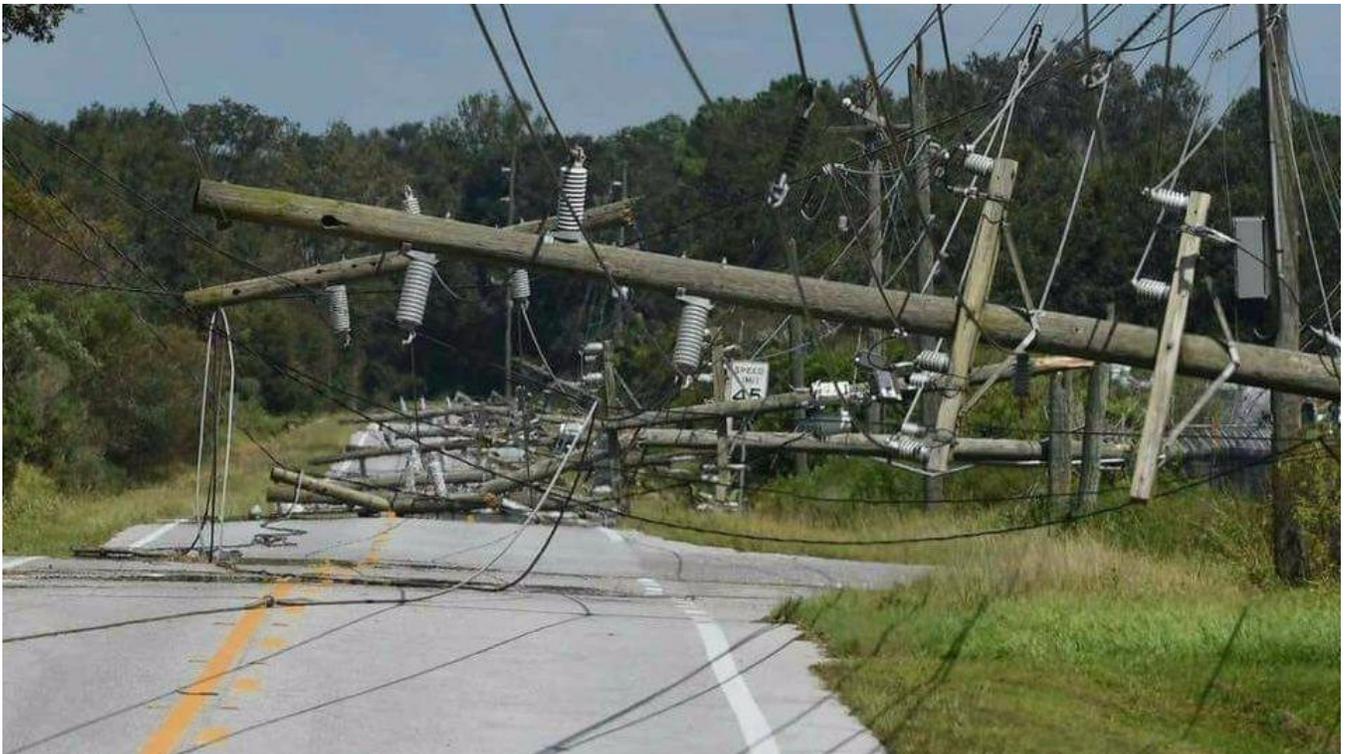
Figure 9.10: Damaged Transmission line with underbuilt distribution

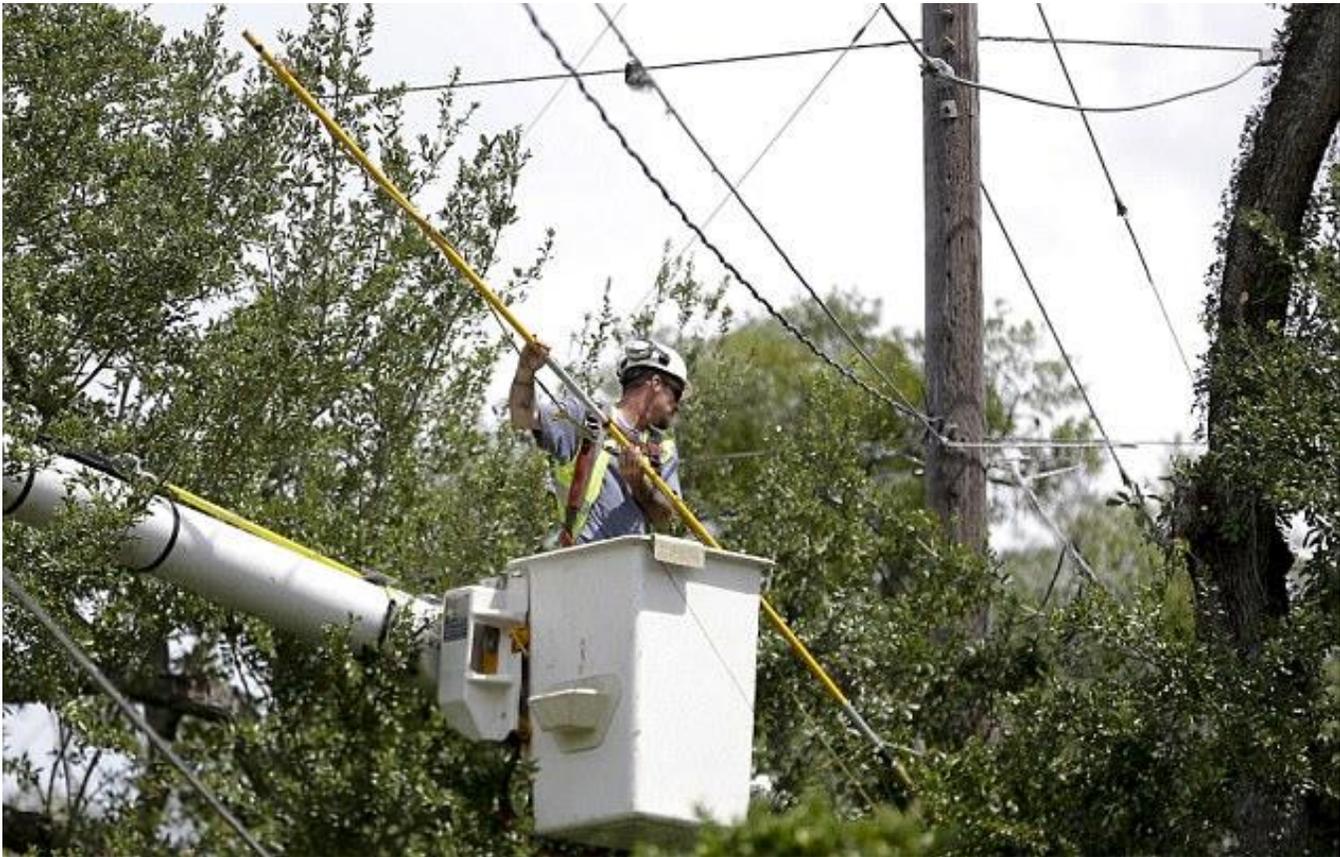
Figure 9.11: Clearing vegetation in Orlando, Florida

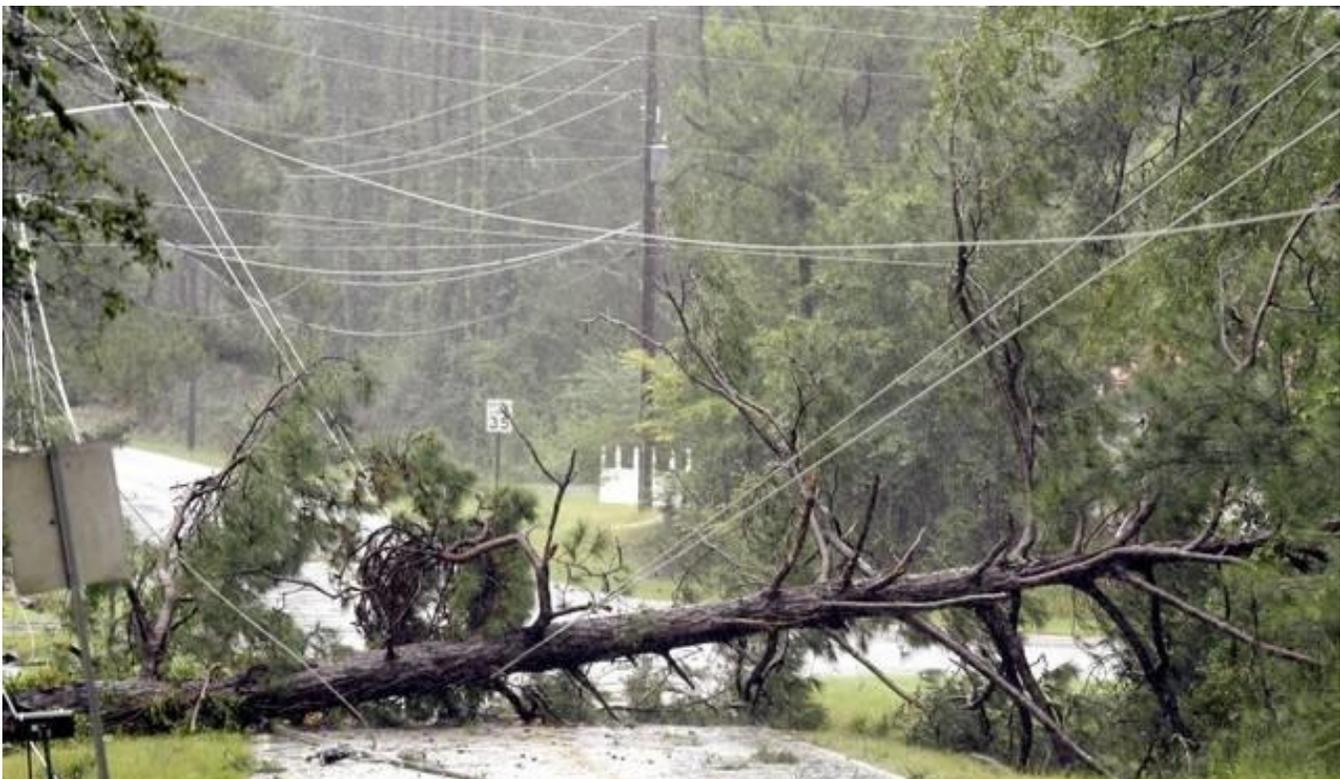
Figure 9.12: Damage in Macon, Georgia

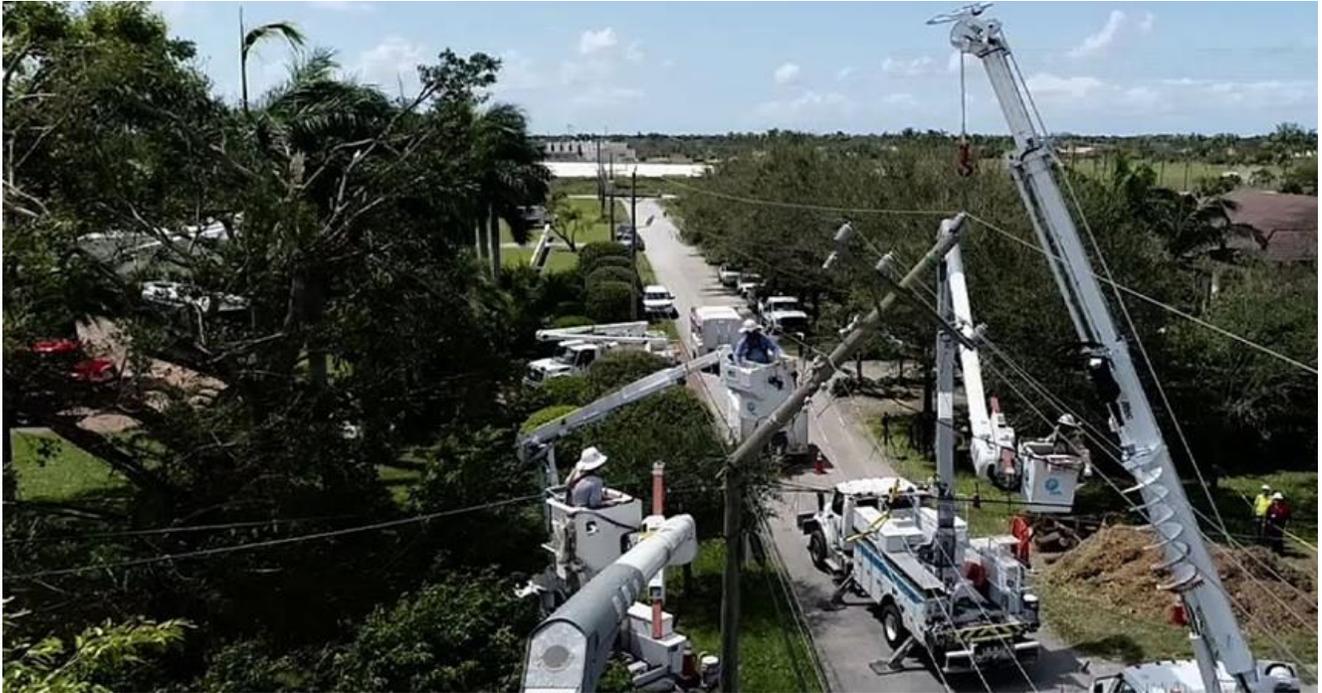
Figure 9.13: Restoration in Progress
