NERC

Washington, D.C., Area Low-Voltage Disturbance Event of April 7, 2015

September 2015

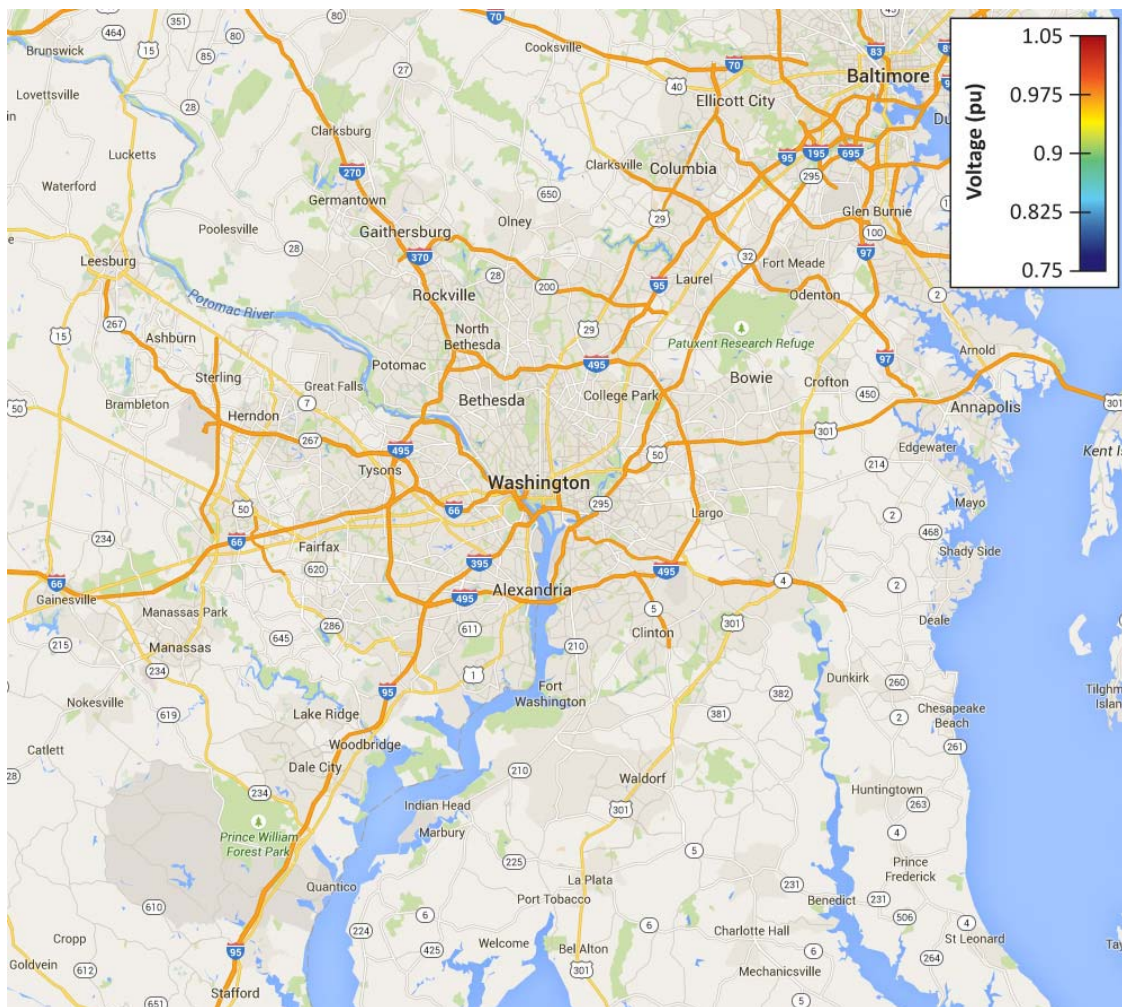
Figure 7. Pre-Disturbance Voltage Levels were Normal⁸

Prior to the disturbance, no abnormalities existed within the system aside from scheduled maintenance of several nearby circuits, transformers, and buses. These maintenance outages were analyzed and found to be inconsequential to the cause of the outage. All generators supplying energy to the system were running as expected given the relatively light load and market conditions at the time. No irregularities in equipment had been revealed in previous scheduled inspections of related equipment.

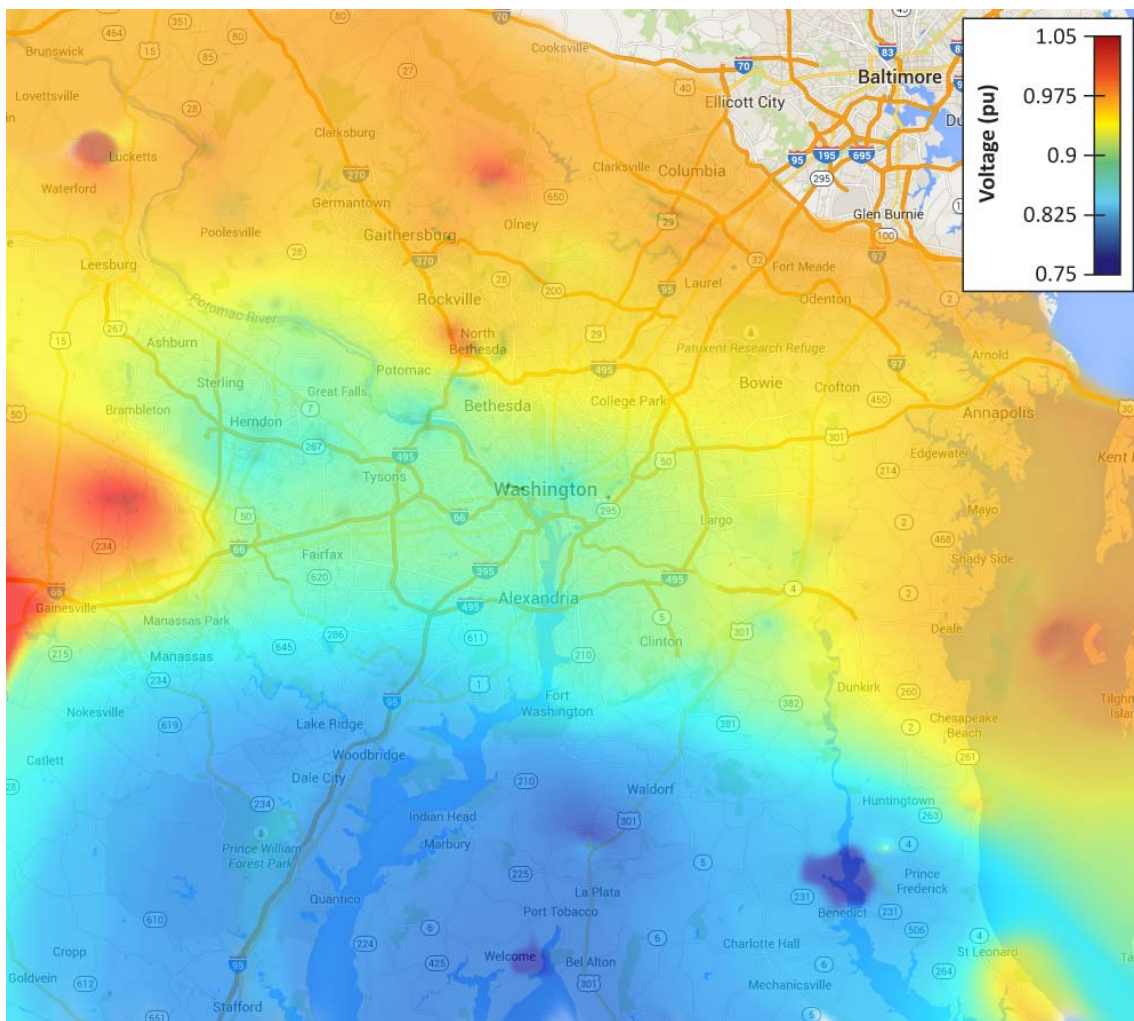
Figure 8. Noticeable Depression in Voltage due to Chalk Point Breaker Remaining Closed

Due to this fault, as designed, breakers at the Chalk Point, Ryceville, and Morgantown stations opened automatically to de-energize the line, preventing further equipment damage or spreading of the disturbance. From a design perspective, these breakers intentionally attempt to reclose after a short delay to automatically restore the line from brief system abnormalities, such as momentary faults or surges in voltage that historically account for a majority of faults. The breakers are designed to reclose once and reopen immediately if the fault is still present. One of the Chalk Point breakers, however, did not reopen after it reclosed to check for the fault's persistence.

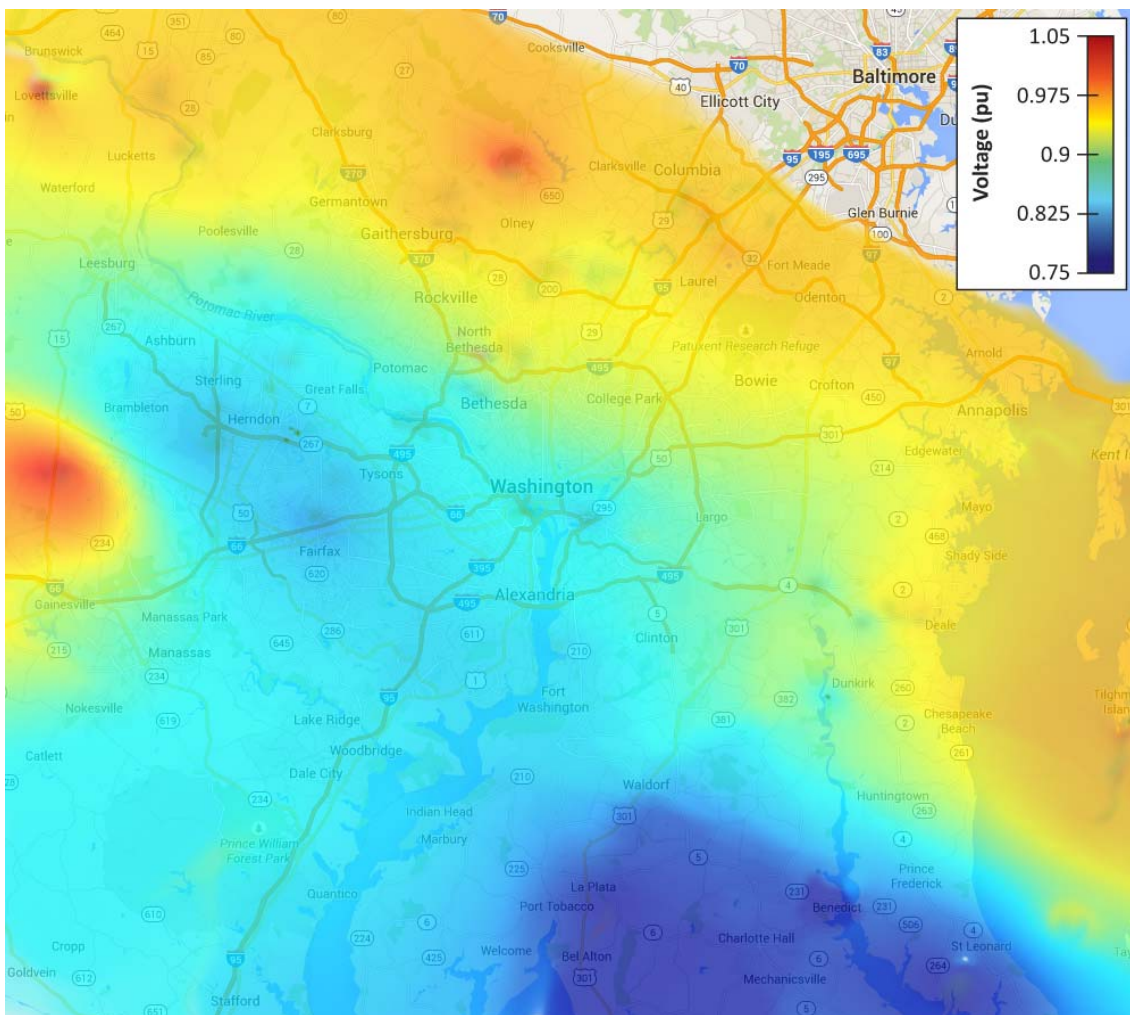
Figure 9: Further Voltage Depression Following Brandywine and Calvert Cliffs Generator Trips

Approximately seven seconds after the fault migrated to the B-phase of the line, the continued arcing and ionized air around the fault migrated to the A-phase line, creating a three-phase-to-ground fault. This evolution of the fault caused even greater voltage degradation within the surrounding area. Approximately eight seconds after the evolution to a three-phase fault, Calvert Cliffs generating Units 1 and 2 began to shut down, as designed, in response to the severely low voltages, for nuclear safety and to prevent possible equipment damage.

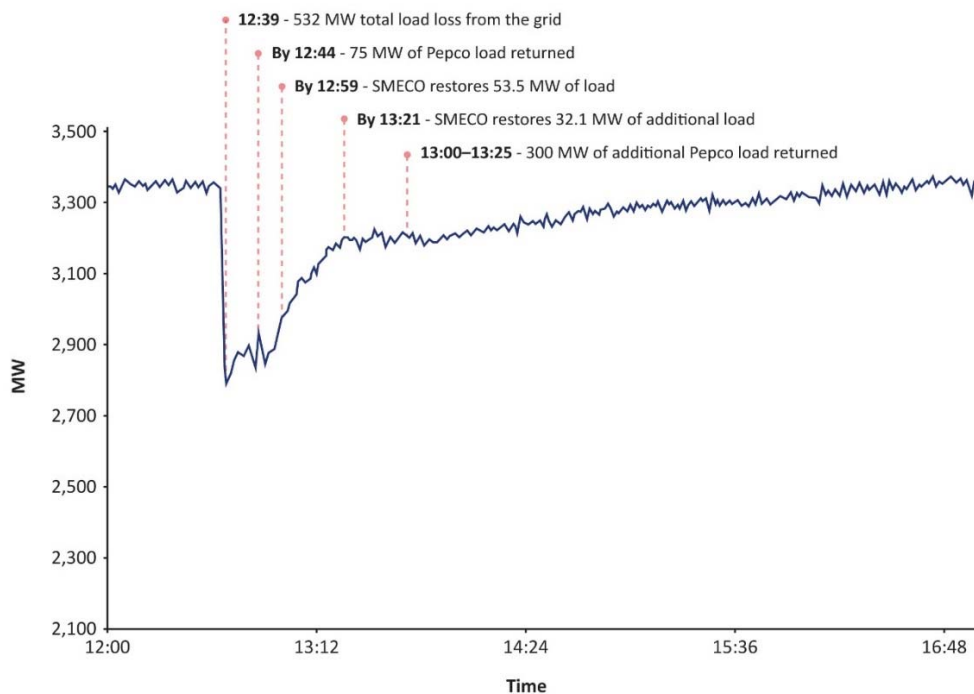
Figure 10: Pepco Net System Load (Includes SMECO Load), April 7, 2015¹⁰

This disturbance impacted approximately 532 MW of load, 445 MW of which was native Pepco load (approximately 13 percent of their total load at the time of the disturbance), and 87 MW of which was SMECO load (about 28 percent of SMECO total load at the time of the disturbance) that is served from the Pepco transmission system (based on 310 MW SMECO system load prior to the event). Numerous federal, state, and local government facilities and commercial customers were impacted. Figure 10 shows Pepco's net system load, including SMECO load, from 12:00 to 17:00 EDT, on April 7, 2015.

As previously mentioned, this disturbance impacted approximately 532 MW of load, 445 MW of native Pepco load (approximately 13 percent of their total load), and 87 MW on SMECO load (approximately 28 percent of their total load) that is served from the Pepco transmission system. All load was restored by 14:21 EDT, just under two hours after the start of the disturbance.

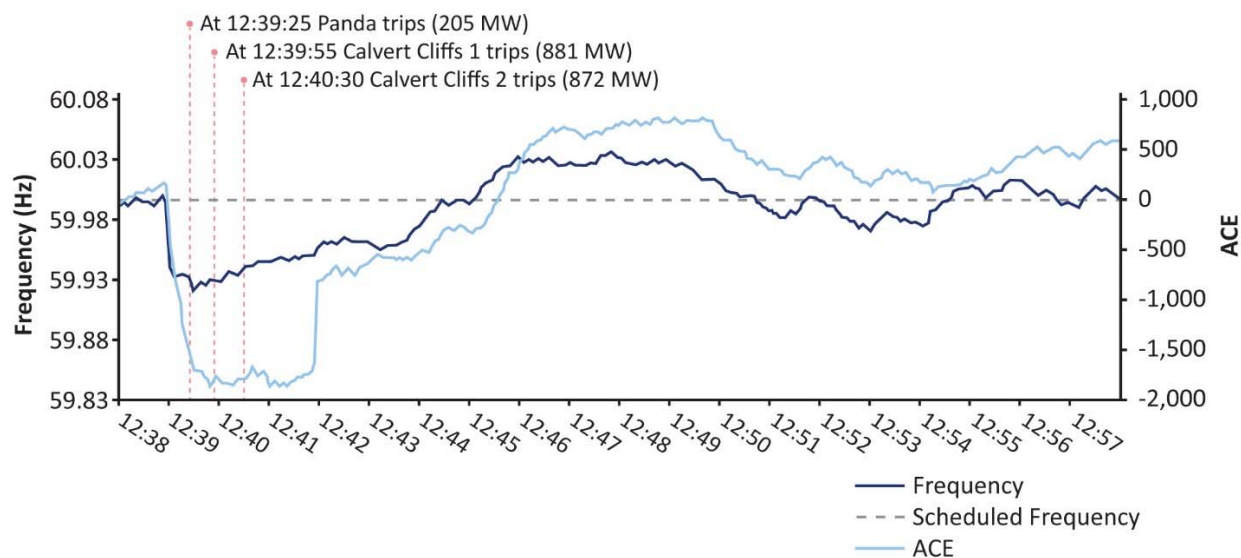
Figure 11: Eastern Interconnection Frequency and PJM ACE Recovery

During the fault on the Chalk Point – Ryceville 230 kV line, PJM lost 1,958 MW of generation from its Balancing Authority Area, including the Brandywine Power Facility combined-cycle plant and Calvert Cliffs Units 1 and 2.

PJM’s ACE dropped 1,981 MW as a net result of the generation and apparent load loss. In response to the frequency and ACE deviations, PJM deployed 100 percent synchronous reserves across its BA footprint and entered into a Simultaneous Activation of Reserve Event with 900 MW of assistance brought in from the Northeast. PJM ACE recovered to 0 MW in six minutes and 44 seconds. Eastern Interconnection frequency and PJM ACE are shown in Figure 11.
