# San Fernando Disturbance

Southern California Event: July 7, 2020  
Joint NERC and WECC Staff Report

November 2020

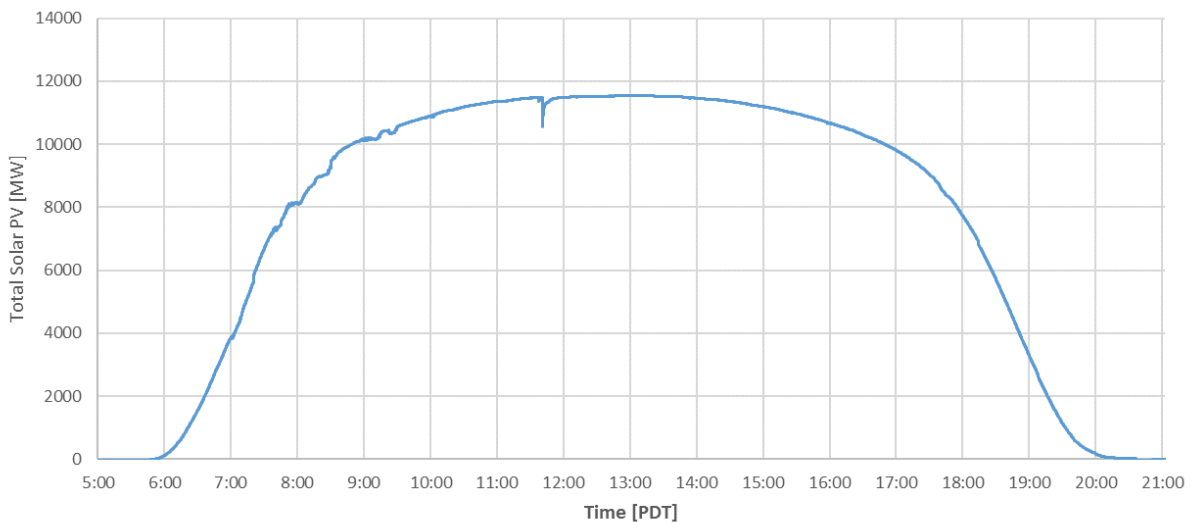
**Figure I.2: CAISO Solar PV Profile for July 7, 2020 [Source: CAISO]**

Figure I.2 shows the CAISO solar PV power output profile for July 7, 2020. The disturbance occurred very close to the time of maximum solar PV output for that day. The disturbance is clearly visible in the total solar PV power output; however, the magnitude of the reduction is not the primary concern. Figure I.3 and Figure I.4 show the solar PV reduction observed by CAISO broken down by its areas within California. The SCE Inland and Imperial Valley areas experienced the majority of solar PV reduction during this event.

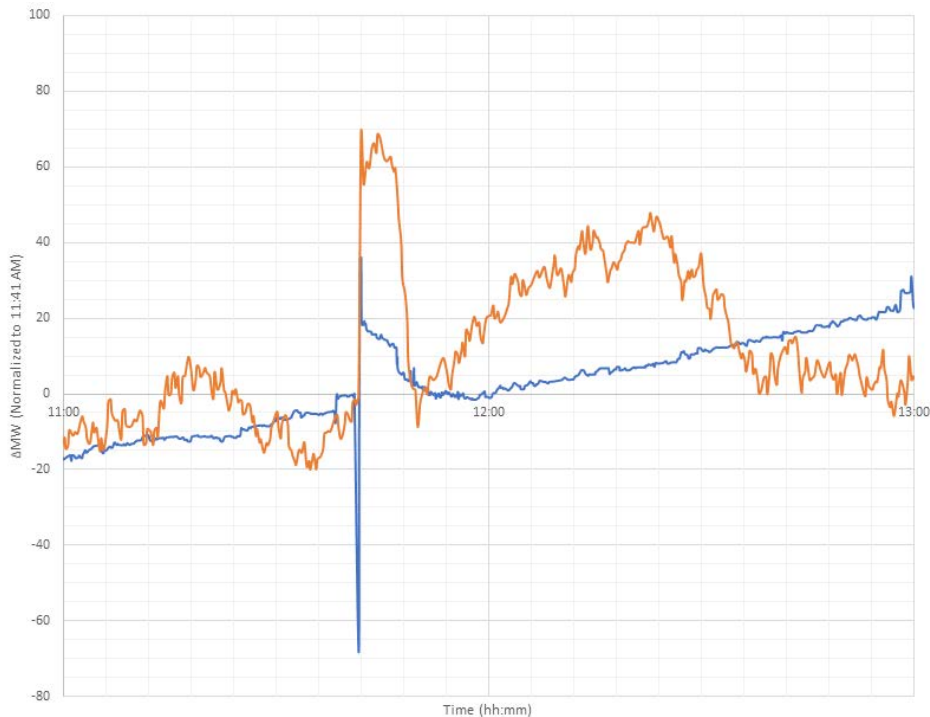
**Figure 1.9: Net Load Increase Observed by SCE [Source: SCE]**

The Angeles Forest disturbance was the first fault event for which NERC identified a discernible change in net demand that was attributed to the tripping of DERs.<sup>21</sup> The same techniques to determine possible DER tripping were employed in this analysis, and SCE identified some possible DER tripping as observed in [Figure 1.9](#). Each time-series plot in [Figure 1.9](#) represents a subtransmission interface near the fault location. The net load increases persist for about five to seven minutes, indicative of legacy DER settings that include a restart time delay of around this time. Net load values return to predisturbance levels soon thereafter as the predominantly solar PV DERs ramp back up to their maximum available power output.

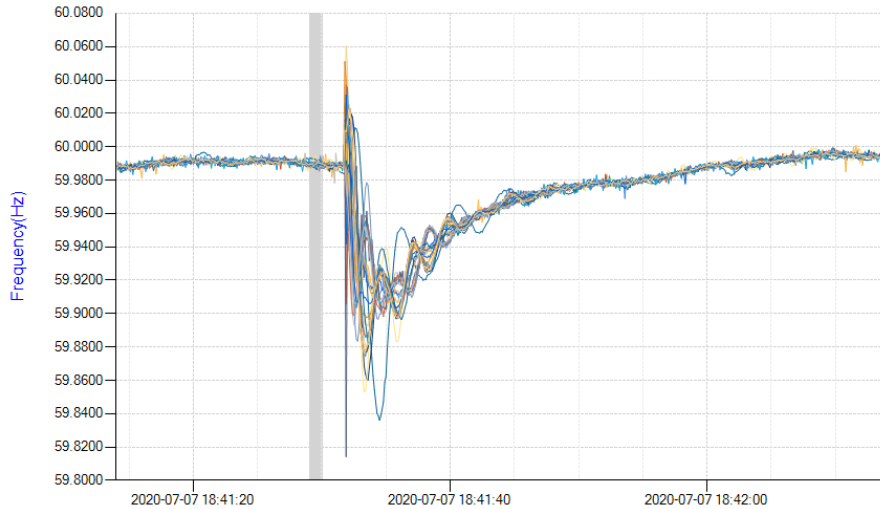
Figure 1.10: FNET Frequency Measurements for Event #2 [Source: UTK/ORNL]

Figure 1.10 shows system frequency measurements for Event #2 exhibiting an initial spike at the time of the fault followed by a drop in system frequency to a mean value of about 59.9 Hz<sup>22</sup> caused by the loss of solar PV resources. Figure 1.11 also shows the relative phase angles from the frequency recording devices with post-fault angle differences reaching about 37 degrees across the system.<sup>23</sup>

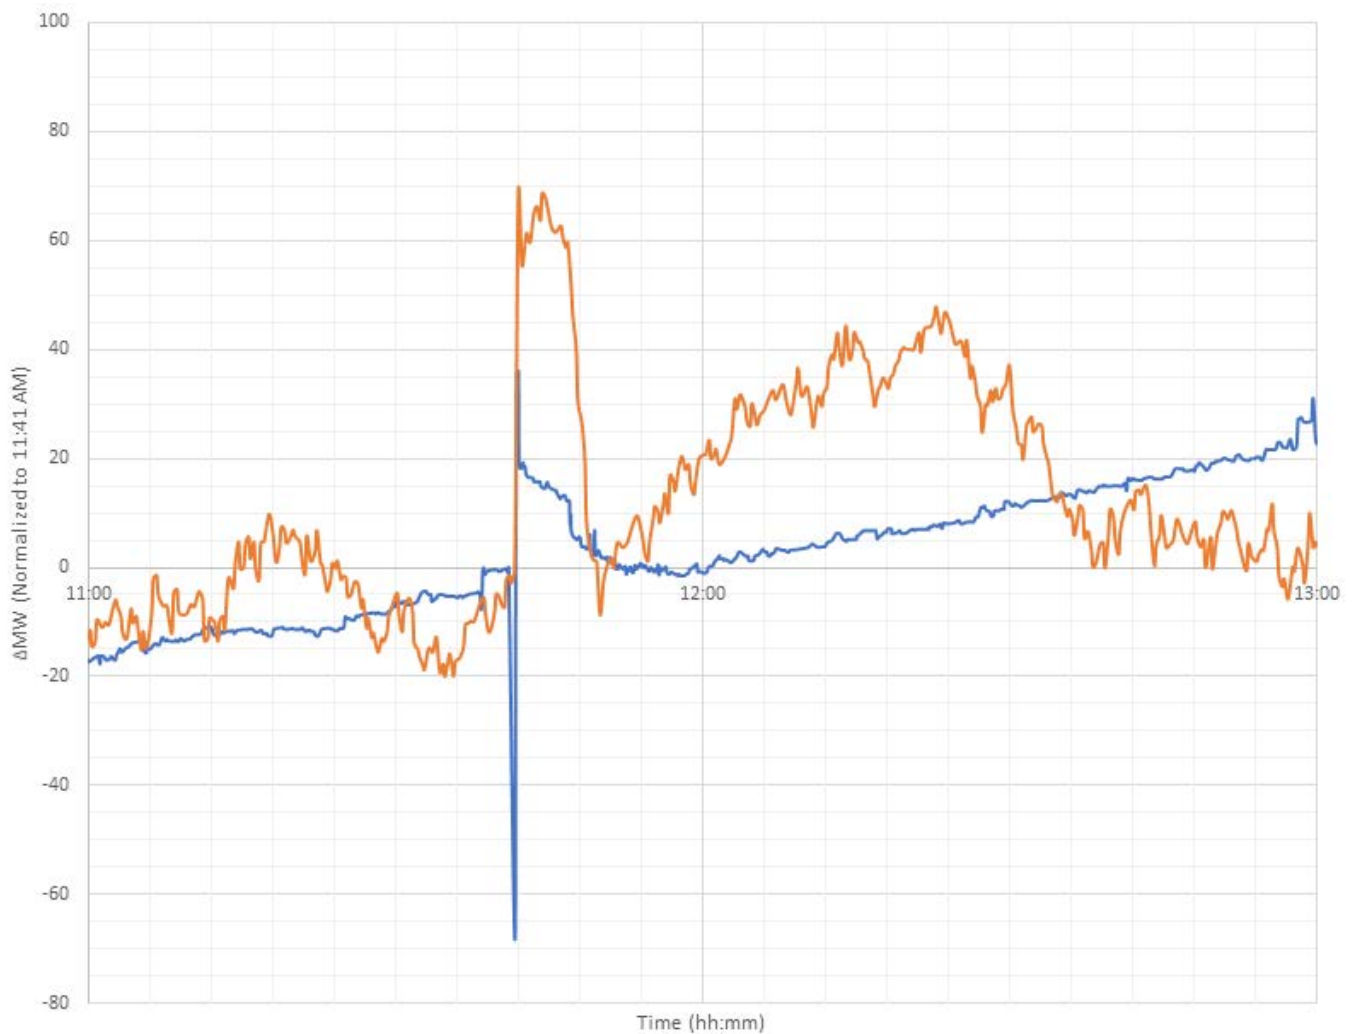
**Figure 2.3: Net Load Increase Observed by SCE [Source: SCE]**

SCE evaluated the performance of all subtransmission load points for this disturbance. Similar to previous events, SCE observed an increase in net load at the time of the fault events, particularly Event #2, in areas with high penetrations of DERs. The net load increases were identified at only two subtransmission systems fed directly from 230 kV BPS buses located relatively close to the fault location. **Figure 2.3** shows the increases observed for these load points (time divisions are six minutes). Net loads at these locations increased by about 60 MW and 20 MW for Event #2. The net load increase persisted for about five to seven minutes, indicative of DER tripping and an automatic reconnection time specified in legacy IEEE 1547 standards.<sup>27</sup> This is also consistent with the performance from previous events in this local area. These areas where net load increases were observed include high penetrations of residential rooftop solar installations, commercial installations, and utility-scale solar PV plants in the 1–10 MW range.

TOs, BAs, RCs, and other transmission entities are encouraged to review load SCADA points following grid disturbances to identify any impacts that DERs may be having on BPS performance. This is increasingly important as DERs in many areas across North America continue to increase. NERC System Planning Impacts from DERs Working Group (SPIDERWG) should continue providing industry with guidance on how to perform this type of analysis and deduce DER performance with available data.

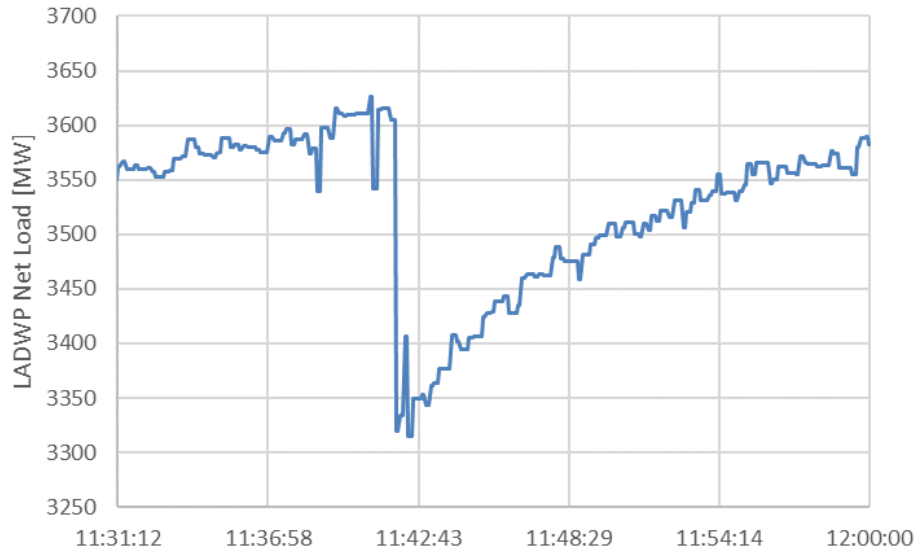
Figure 2.4: LADWP Net Load during Disturbance [Source: LADWP]

LADWP reviewed their net load quantities (shown in **Figure 2.4**) and determined that they did not experience any net load increase. Rather, LADWP experienced a reduction in net load that is attributed to possible tripping of voltage-sensitive end-use loads.
