U.S.-Canada Power System Outage Task Force

**Final Report on the
August 14, 2003 Blackout
in the
United States and Canada:**

**Causes and
Recommendations**

April 2004

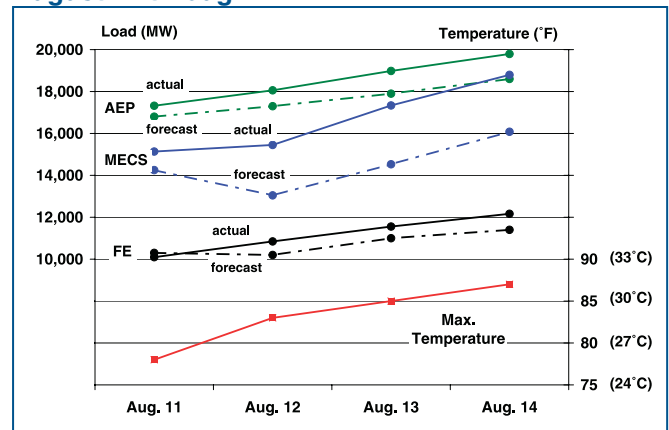
Figure 4.2. Load Forecasts Below Actuals, August 11 through 14

August 11 and 14. Figure 4.2 shows forecast and actual power demands for AEP, Michigan Electrical Coordinated Systems (MECS), and FE from August 11 through August 14. Variances between actual and forecast loads are not unusual, but because those forecasts are used for day-ahead planning for generation, purchases, and reactive power management, they can affect equipment availability and schedules for the following day.

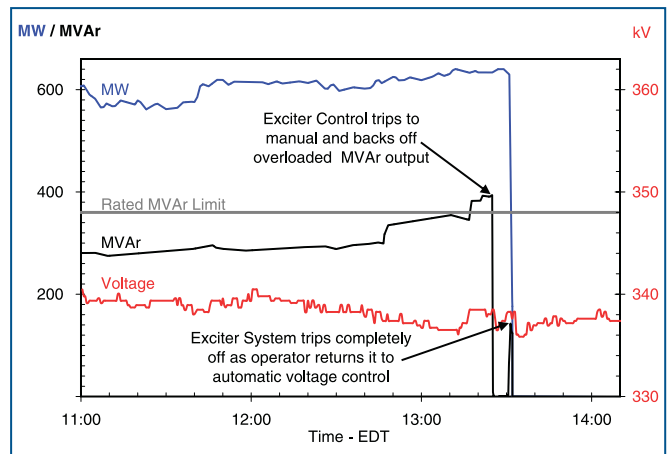
Figure 4.3. MW and MVar Output from Eastlake Unit 5 on August 14

- ◆ Eastlake Unit 5 is a 597 MW (net) generating unit located west of Cleveland on Lake Erie. It is a major source of reactive power support for the Cleveland area. It tripped at 13:31 EDT. The cause of the trip was that as the Eastlake 5 operator sought to increase the unit's reactive power output (Figure 4.3), the unit's protection system detected that VAR output exceeded the unit's VAR capability and tripped the unit off-line. The loss of the Eastlake 5 unit did not put the grid into an unreliable state—i.e., it was still able to withstand safely another contingency. However, the loss of the unit required FE to import additional power to make up for the loss of the unit's output (612 MW), made voltage management in northern Ohio more challenging, and gave FE operators less flexibility in operating their system (see details on pages 45-46 and 49-50).

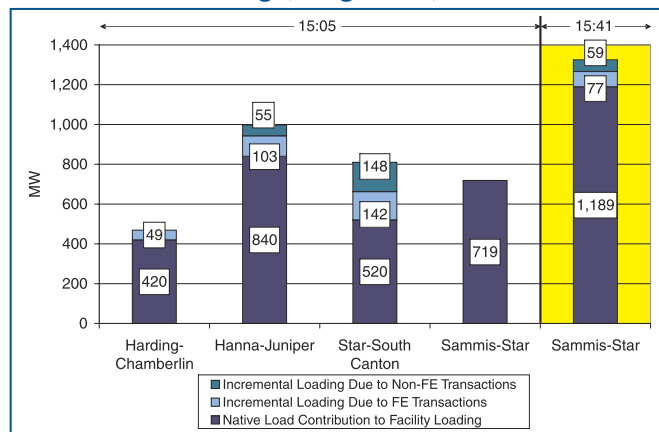
Figure 4.6. Impacts of Transactions Flows on Critical Line Loadings, August 14, 2003

Figure 4.6 shows how all of the transactions flowing across the Cleveland-Akron area on the afternoon of August 14 affected line loadings at key FE facilities, organized by time and types of transactions. It shows that before the first transmission line failed, the bulk of the loading on the four critical FirstEnergy circuits—Harding-Chamberlin, Hanna-Juniper, Star-South Canton and Sammis-Star—was to serve Cleveland-Akron area native load. Flows to serve native load included transfers from FE’s 1,640 MW Beaver Valley nuclear power plant and its Seneca plant, both in Pennsylvania, which have been traditionally counted by FirstEnergy not as imports but rather as in-area

generation, and as such excluded from TLR curtailments. An additional small increment of line loading served transactions for which FE was either the importer or exporter, and the remaining line loading was due to through-flows initiated and received by other entities. The Star-South Canton line experienced the greatest impact from through-flows—148 MW, or 18% of the total line loading at 15:05 EDT, was due to through-flows resulting from non-FE transactions. By 15:41 EDT, right before Star-South Canton tripped—without being overloaded—the Sammis-Star line was serving almost entirely native load, with loading from through-flows down to only 4.5%.

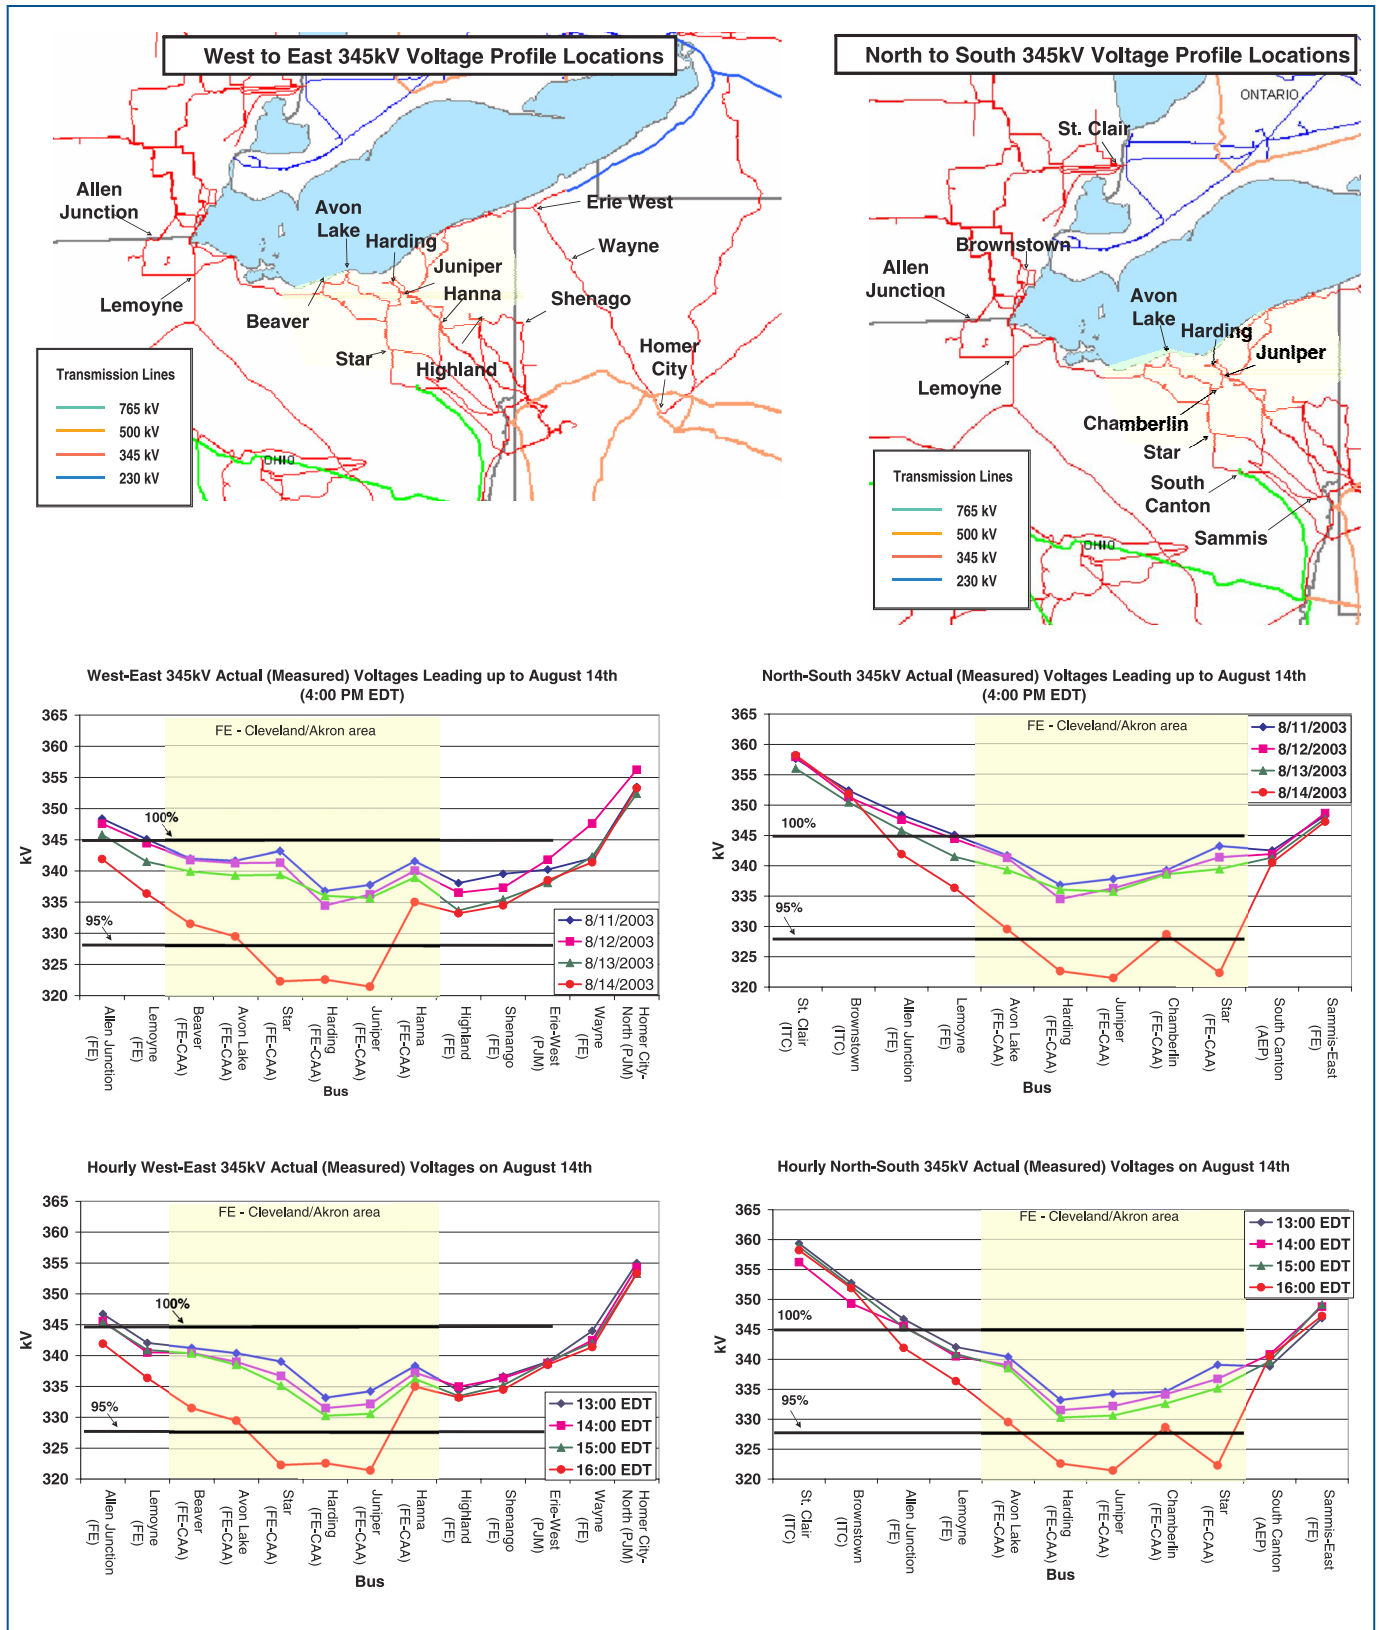
Figure 4.7. Actual Voltages Across the Ohio Area Before and On August 14, 2003

Figure 4.7 shows the profile of voltage levels at key buses from southeast Michigan across Ohio into western Pennsylvania from August 11 through 14 and for several hours on August 14. These transects show that across the area, voltage levels were consistently lower at the 345-kV buses in the Cleveland-Akron area (from Beaver to Hanna on the west to east plot and from Avon Lake to Star on the north to south plot) for the three days and the 13:00 to 15:00 EDT period preceding the blackout. Voltage was consistently and considerably higher at the outer ends of each transect, where it never dropped below 96% even on August 14. These profiles also show clearly the decline of voltage over the afternoon of August 14, with voltage at the Harding bus at 15:00 EDT just below 96% before the Harding-Chamberlin line tripped at 15:05 EDT, and dropping down to around 93% at 16:00 EDT after the loss of lines and load in the immediate area.

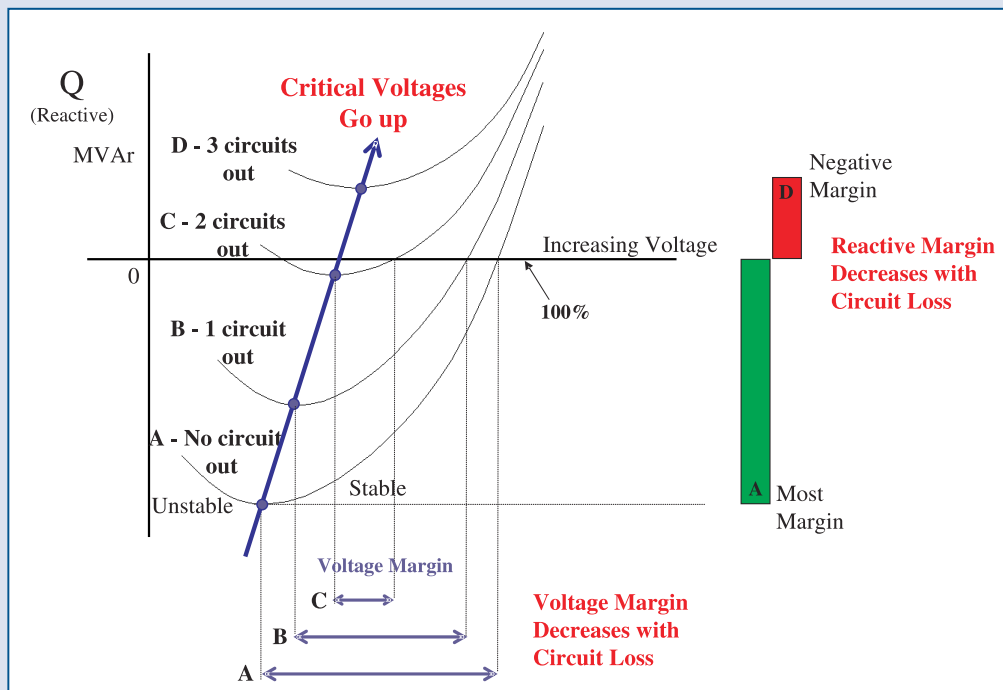
V-Q (Voltage-Reactive Power) Curves

The illustration below shows a series of V-Q curves. The lowest curve, A, reflects baseline conditions for the grid with all facilities available. Each higher curve represents the same loads and transfers for the region modeled, but with another contingency event (a circuit loss) occurring to make the system less stable. With each additional contingency, the critical voltage rises (the point on the horizontal axis corresponding to the lowest point on the curve) and the reactive margin decreases (the difference between the reactive power at the critical voltage and the zero point on the vertical axis). This means the system is closer to instability.

V-Q analyses and experience with heavily loaded power systems confirm that critical voltage levels can rise above the 95% level traditionally considered as normal. Thus voltage magnitude alone is a poor indicator of voltage stability and V-Q analysis must be carried out for several critical buses in a local area, covering a range of load and generation conditions and known contingencies that affect voltages at these buses.

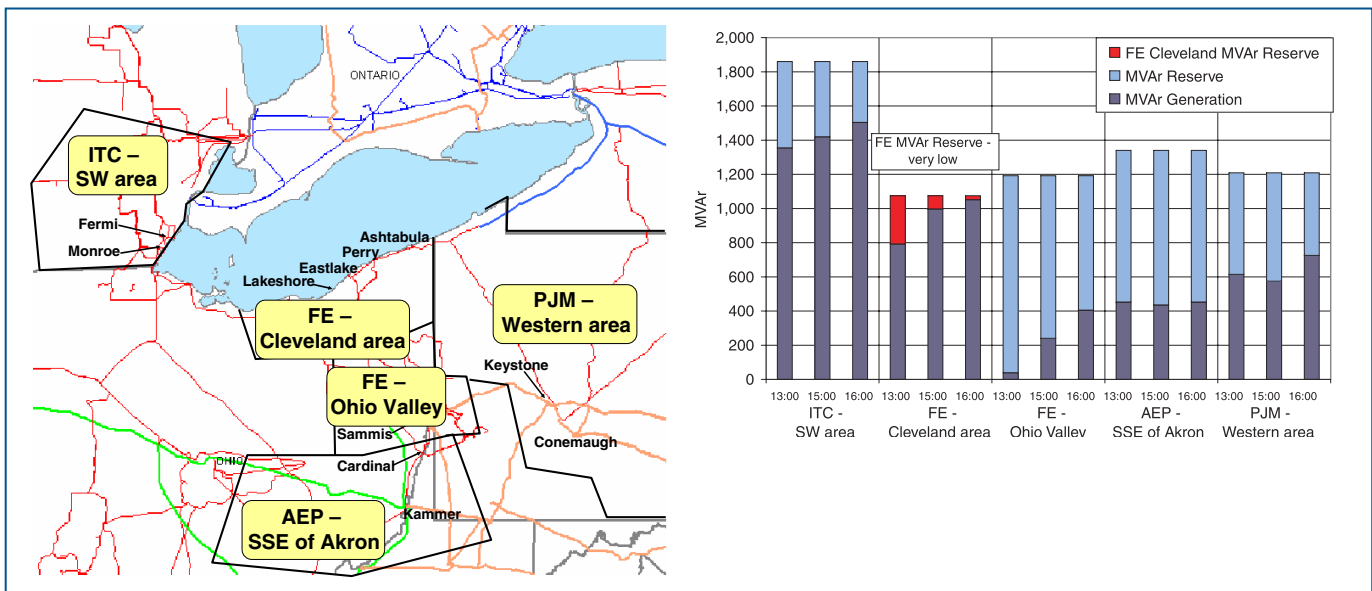
Figure 4.8. Reactive Reserves Around Ohio on August 14, 2003, for Representative Generators in the Area

local sources, these healthy reserves nearby could not support the Cleveland-Akron area's reactive power deficiency and growing voltage problems. Even FE's own generation in the Ohio Valley had reactive reserves that could not support the sagging voltages inside the Cleveland-Akron area.

An important consideration in reactive power planning is to ensure an appropriate balance between static and dynamic reactive power resources across the interconnected system (as specified in NERC Planning Standard 1D.S1). With so little generation left in the Cleveland-Akron area on August 14, the area's dynamic reactive reserves were depleted and the area relied heavily on static compensation to respond to changing system conditions and support voltages. But a system relying on static compensation can experience a gradual voltage degradation followed by a sudden drop in voltage stability—the P-V curve for such a system has a very steep slope close to the nose, where voltage collapses. On August 14, the lack of adequate dynamic reactive reserves, coupled with not knowing the critical voltages and maximum import capability to serve native load, left the Cleveland-Akron area in a very vulnerable state.

Recommendation
23, page 160

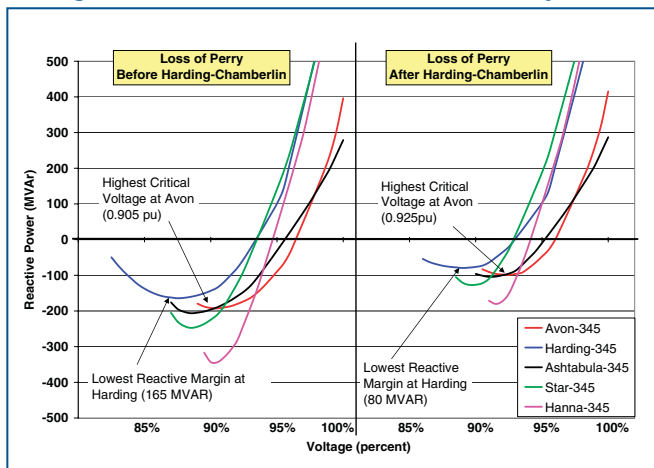
Figure 4.9. Loss of the Perry Unit Hurts Critical Voltages and Reactive Reserves: V-Q Analyses

To examine the impact of this worst contingency on the Cleveland-Akron area on August 14, Figure 4.9 shows the V-Q curves for key buses in the Cleveland-Akron area at 15:05 EDT, before and after the loss of the Harding-Chamberlin line. The curves on the left look at the impact of the loss of Perry before the Harding-Chamberlin trip, while the curves on the right show the impact had the nuclear plant been lost after Harding-Chamberlin went out of service. Had Perry gone down *before* the Harding-Chamberlin outage, reactive margins at key FE buses would have been minimal (with the tightest margin at the Harding bus, read along the Y-axis) and the critical voltage (the point before voltage collapse, read along the X-axis) at

the Avon bus would have risen to 90.5%—uncomfortably close to the limits which FE considered as an acceptable operating range. But had the Perry unit gone off-line *after* Harding-Chamberlin, reactive margins at all these buses would have been even tighter (with only 60 MVAR at the Harding bus), and critical voltage at Avon would have risen to 92.5%, worse than FE’s 90% minimum acceptable voltage. The system at this point would be very close to voltage instability. If the first line outage on August 14, 2003, had been at Hanna-Juniper rather than at Harding-Chamberlin, the FirstEnergy system could not have withstood the loss of the Perry plant.

Recommendation
23, page 160

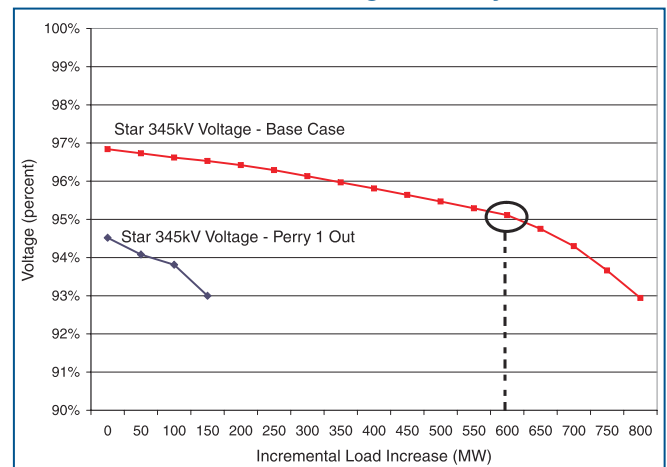
Figure 4.10. Impact of Perry Unit Outage on Cleveland-Akron Area Voltage Stability

load level of 13,229 MW for the control area (in August 2002). Therefore the investigation team looked at what might have happened in the Cleveland-Akron area had loads neared the historic peak—approximately 625 MW higher than the 6,715 MW peak load in the Cleveland-Akron area in 2003. Figure 4.10 uses P-V analysis to show the impact of increased load levels on voltages at the Star bus with and without the Perry unit before the loss of the Harding-Chamberlin line at 15:05 EDT. The top line shows that with the Perry plant available, local load could have increased by 625 MW and voltage at Star would have remained above 95%. But the bottom line, simulating the loss of Perry, indicates that load could only have increased by about 150 MW before voltage at Star would have become unsolvable, indicating no voltage stability margin and depending on load dynamics, possible voltage collapse.

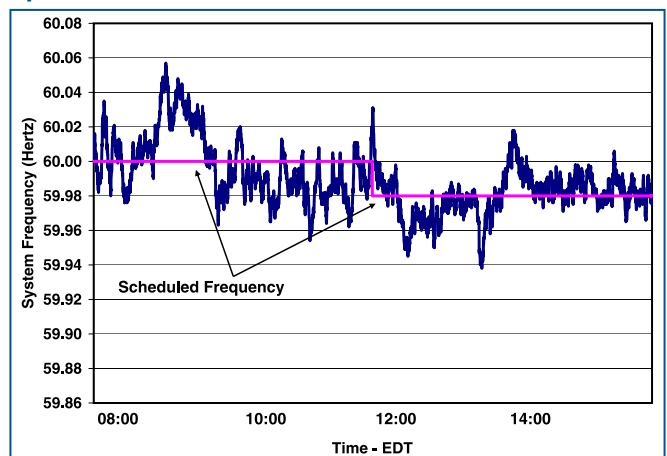
Figure 4.11. Frequency on August 14, 2003, up to 16:09 EDT

Figure 4.11 shows Eastern Interconnection frequency on August 14, 2003. Frequency declines or increases from a mismatch between generation and load on the order of about 3,200 MW per 0.1 Hertz (alternatively, a change in load or generation of 1,000 MW would cause a frequency

The largest deviations in frequency occur at regular intervals. These intervals reflect interchange

schedule changes at the peak to off-peak schedule changes (06:00 to 07:00 and 21:00 to 22:00, as shown in Figure 4.12) and on regular hourly and half-hour schedule changes as power plants ramp up and down to serve scheduled purchases and interchanges. Frequency tends to run high in the early part of the day because extra generation capacity is committed and waiting to be dispatched for the afternoon peak, and then runs lower in the afternoon as load rises relative to available generation and spinning reserve. The investigation team concluded that frequency data collection and frequency management in the Eastern Interconnection should be improved, but that frequency oscillations before 16:09 EDT on August 14 had no effect on the blackout.

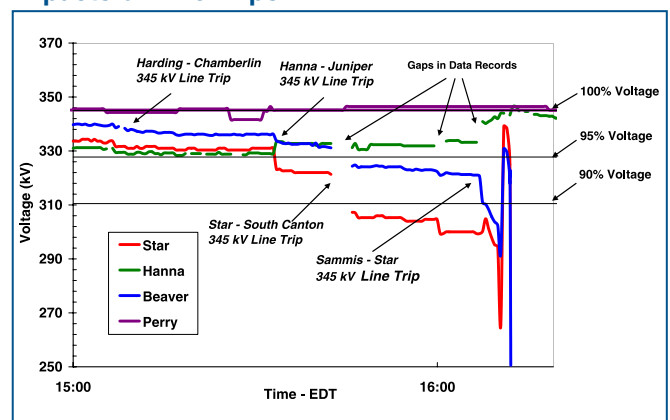
Figure 5.6. Voltages on FirstEnergy's 345-kV Lines: Impacts of Line Trips

From 15:05:41 EDT to 15:41:35 EDT, three 345-kV lines failed with power flows at or below each transmission line's emergency rating. These line trips were not random. Rather, each was the result of a contact between a line and a tree that had grown so tall that, over a period of years, it encroached into the required clearance height for the line. As each line failed, its outage increased the loading on the remaining lines (Figure 5.5). As each of the transmission lines failed, and power flows shifted to other transmission paths, voltages on the rest of FE's system degraded further (Figure 5.6).

A short-circuit occurred on the Harding-Chamberlin 345-kV line due to a contact between the line conductor and a tree. This line failed with power flow at only 44% of its normal and emergency line rating. Incremental line current and temperature increases, escalated by the loss of Harding-Chamberlin, caused more sag on the Hanna-Juniper line, which contacted a tree and failed with power flow at 88% of its normal and emergency line rating. Star-South Canton

contacted a tree three times between 14:27:15 EDT and 15:41:33 EDT, opening and reclosing each time before finally locking out while loaded at 93% of its emergency rating at 15:41:35 EDT. Each of these three lines tripped not because of excessive sag due to overloading or high conductor temperature, but because it hit an overgrown, untrimmed tree.²²

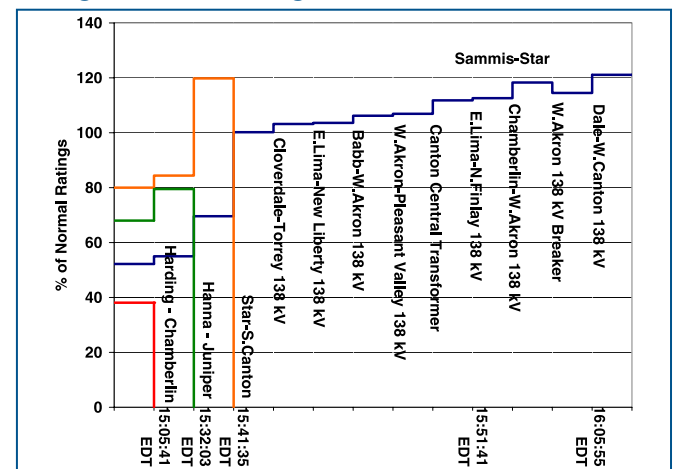
Figure 5.12. Cumulative Effects of Sequential Outages on Remaining 345-kV Lines

the loss of the Harding-Chamberlin 345-kV line. Figure 5.12 shows the line loadings estimated by investigation team modeling as the 345-kV lines in northeast Ohio began to trip. Showing line loadings on the 345-kV lines as a percent of normal rating, it tracks how the loading on each line increased as each subsequent 345-kV and 138-kV line tripped out of service between 15:05 EDT (Harding-Chamberlin, the first line above to stair-step down) and 16:06 EDT (Dale-West Canton). As the graph shows, none of the 345- or 138-kV lines exceeded their normal ratings until after the combined trips of Harding-Chamberlin and Hanna-Juniper. But immediately after the second line was lost, Star-South Canton's loading jumped from an estimated 82% of normal to 120% of normal (which was still below its emergency rating) and remained at the 120% level for 10 minutes before tripping out. To the right, the graph shows the effects of the 138-kV line failures (discussed in the next phase) upon the two remaining 345-kV lines—i.e., Sammis-Star's loading increased steadily above 100% with each succeeding 138-kV line lost.

- ◆ The Star-Juniper 345-kV line, whose loadings would exceed emergency limits if the Hanna-Juniper 345-kV line were lost; and

- ◆ The Hanna-Juniper and Harding-Juniper 345-kV lines, whose loadings would exceed emergency limits if the Perry generation unit (1,255 MW) were lost.

Operationally, once FE’s system entered an N-1 contingency violation state, any facility loss beyond that pushed them farther into violation and into a more unreliable state. After loss of the Harding-Chamberlin line, to avoid violating NERC criteria, FE needed to reduce loading on these three lines within 30 minutes such that no single contingency would violate an emergency limit; that is, to restore the system to a reliable operating mode.

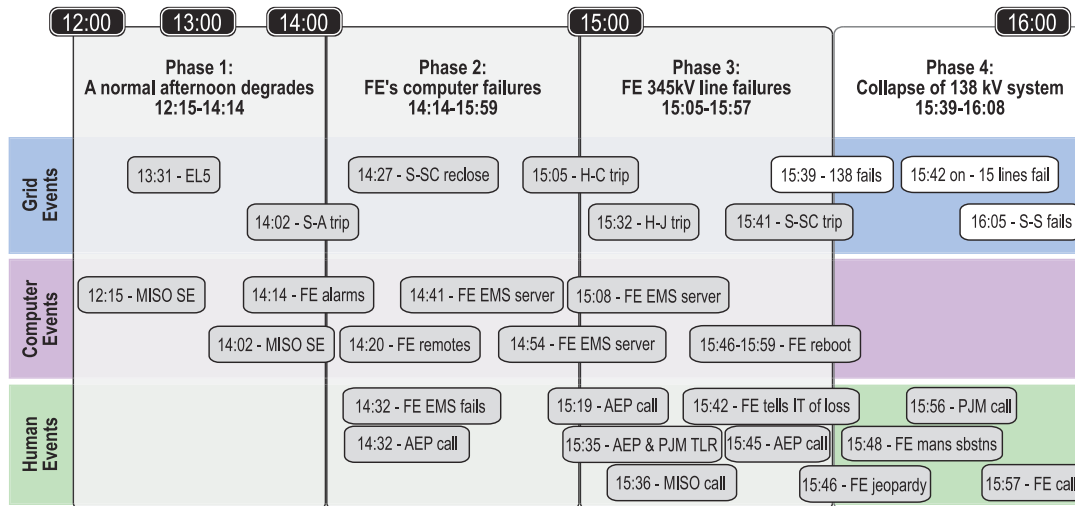
Figure 5.13. Timeline Phase 4

As each of FE’s 345-kV lines in the Cleveland area tripped out, it increased loading and decreased voltage on the underlying 138-kV system serving Cleveland and Akron, pushing those lines into overload. Starting at 15:39 EDT, the first of an eventual sixteen 138-kV lines began to fail (Figure 5.13). Relay data indicate that each of these lines eventually ground faulted, which indicates that it sagged low enough to contact something below the line.

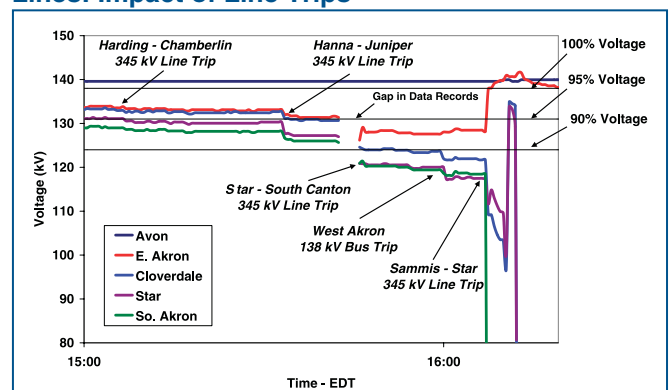
Figure 5.14. Voltages on FirstEnergy’s 138-kV Lines: Impact of Line Trips

Figure 5.14 shows how actual voltages declined at key 138-kV buses as the 345- and 138-kV lines were lost. As these lines failed, the voltage drops caused a number of large industrial customers with voltage-sensitive equipment to go off-line automatically to protect their operations. As the 138-kV lines opened, they blacked out customers in Akron and the areas west and south of the city, ultimately dropping about 600 MW of load.

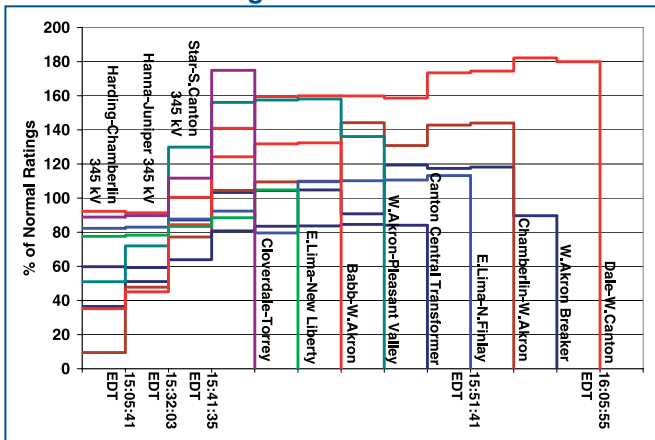
Figure 5.15. Simulated Effect of Prior Outages on 138-kV Line Loadings

The investigation team examined whether load shedding before the loss of the Sammis-Star 345-kV line at 16:05:57 EDT could have prevented this line loss. The team found that 1,500 MW of load would have had to be

dropped within the Cleveland-Akron area to restore voltage at the Star bus from 90.8% (at 120% of normal and emergency ampere rating) up to 95.9% (at 101% of normal and emergency ampere rating).⁴⁴ The P-V and V-Q analysis reviewed in Chapter 4 indicated that 95% is the minimum operating voltage appropriate for 345-kV buses in the Cleveland-Akron area. The investigation team concluded that since the Sammis-Star 345 kV outage was the critical event leading to widespread cascading in Ohio and beyond, if manual or automatic load-shedding of 1,500 MW had occurred within the Cleveland-Akron area before that outage, the blackout could have been averted.

Figure 5.15, derived from investigation team modeling, shows how the power flows shifted across FE's 345- and key 138-kV northeast Ohio lines as the line failures progressed. All lines were loaded within normal limits after the Harding-Chamberlin lock-out, but after the Hanna-Juniper trip at 15:32 EDT, the Star-South Canton 345-kV line and three 138-kV lines jumped above normal loadings. After Star-South Canton locked out at 15:41 EDT within its emergency rating, five 138-kV and the Sammis-Star 345-kV lines were overloaded. From that point, as the graph shows, each subsequent line loss increased loadings on other lines, some loading to well over 150% of normal ratings before they failed. The Sammis-Star 345-kV line stayed in service until it tripped at 16:05:57 EDT.

Recommendations
8, page 147; 21, page 158; 23, page 160
