Review of Selected
Electric System Disturbances
in North America

North American
Electric
Reliability
Council

July 1992

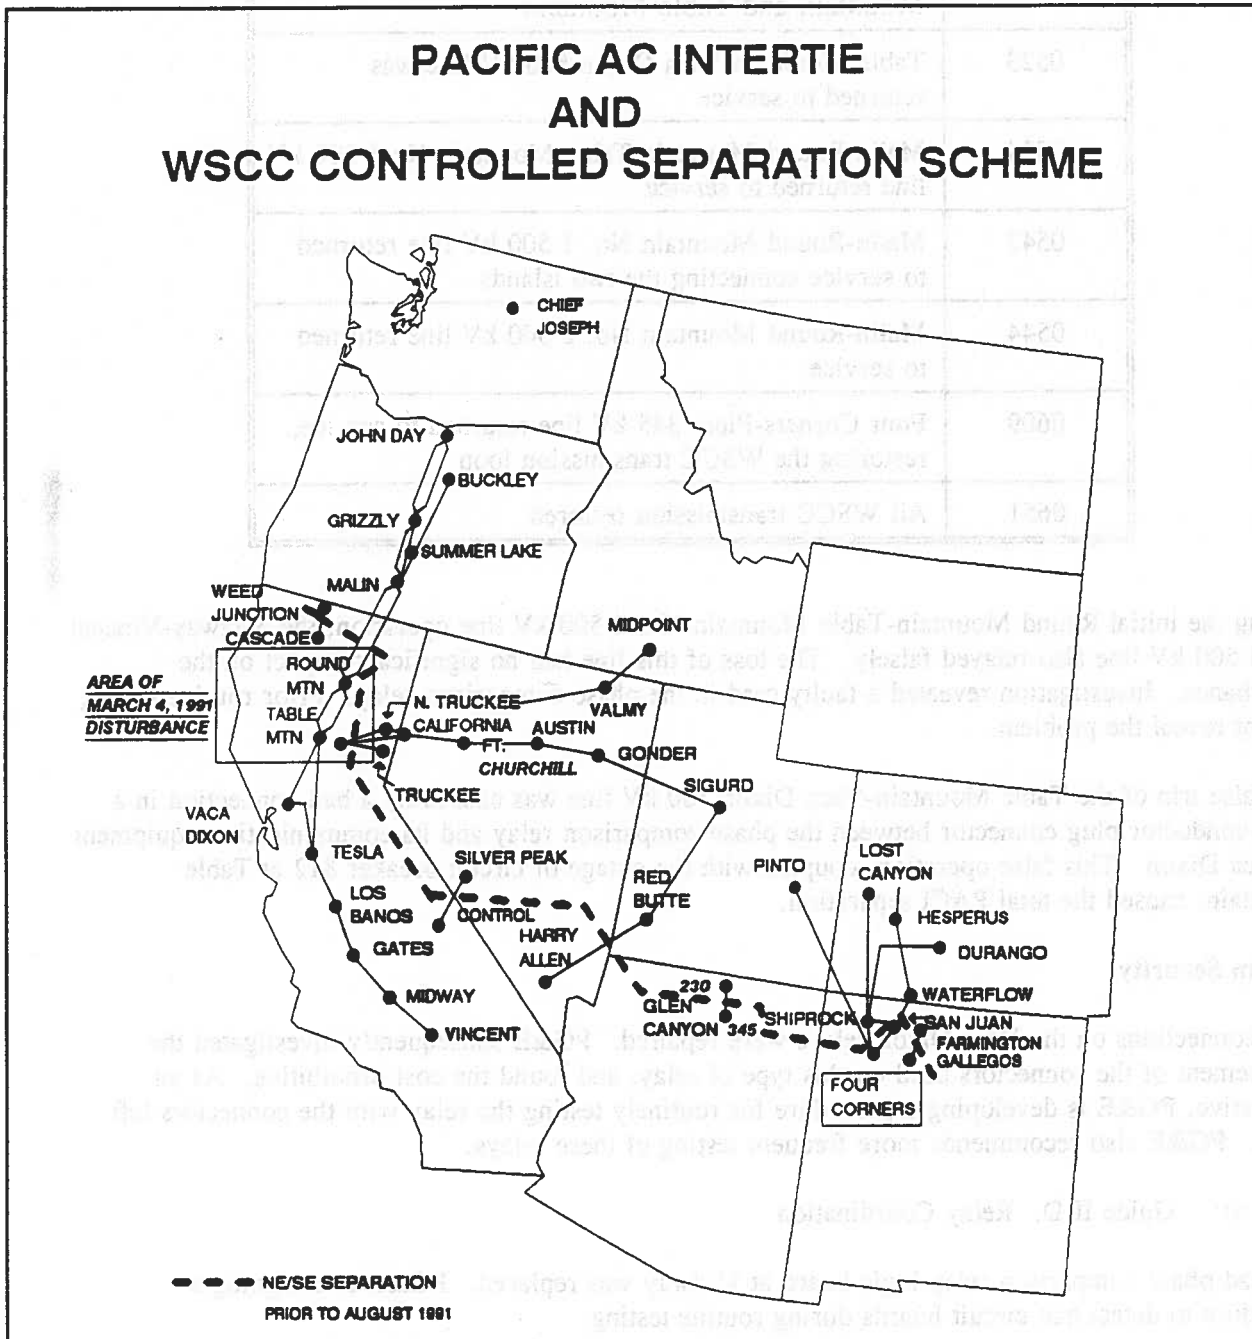
Figure 1 — Pacific AC Intertie and WSCC Controlled Separation Scheme

Prior to the disturbance, Table Mountain circuit breaker 812 was out of service for a scheduled overhaul. With this breaker out of service, the false operation of the Table Mountain-Vaca Dixon line open-ended the Round Mountain-Table Mountain No. 1 500 kV line, causing a total PACI separation between Round Mountain and Table Mountain Substations. See Figures 1 and 2.

The bad phase comparison relay logic board at Midway was replaced. PG&E is designing a procedure to detect bad circuit boards during routine testing.

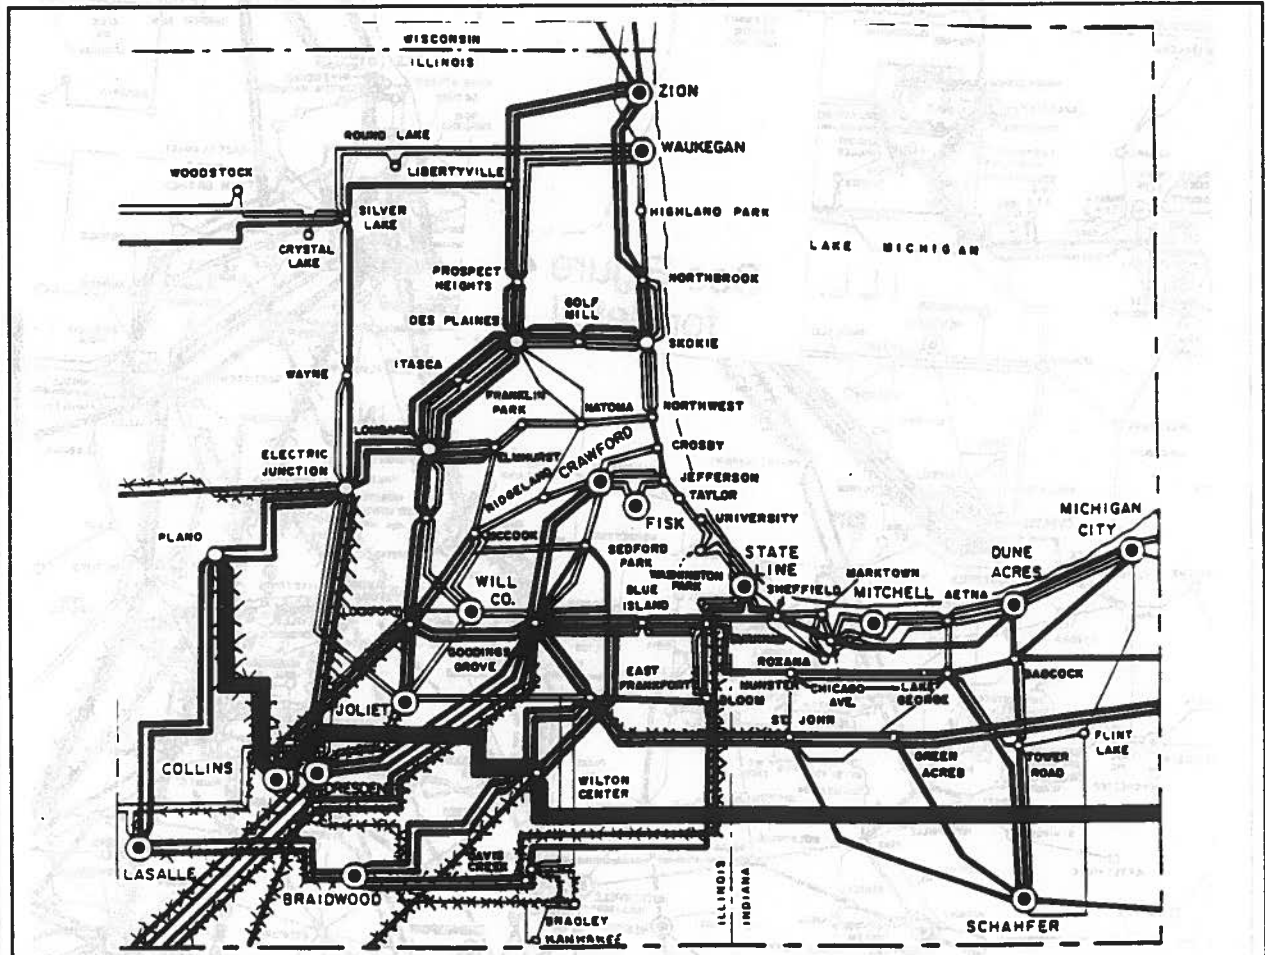
Figure 4 — Detail of northern Indiana and Illinois transmission lines

Table 2 illustrates the chronological sequence of the 765 kV and 345 kV outages while Figures 3 and 4 show the outaged lines geographically. In addition to these outages, numerous momentary interruptions occurred on the transmission system. These outages did not cause the interconnected system to cascade nor did they cause islanding. The transmission outages on the Commonwealth Edison system were mostly from broken static wires, and some from galloping conductors. In Indiana, however, over 300 transmission structures, including 95 765 kV towers, were either damaged or knocked down by the storm. Much of the tower destruction was caused by three radial inches of ice on the conductors. The ice, whose weight was far in excess of the towers' one inch radial ice design limits, collapsed the towers.

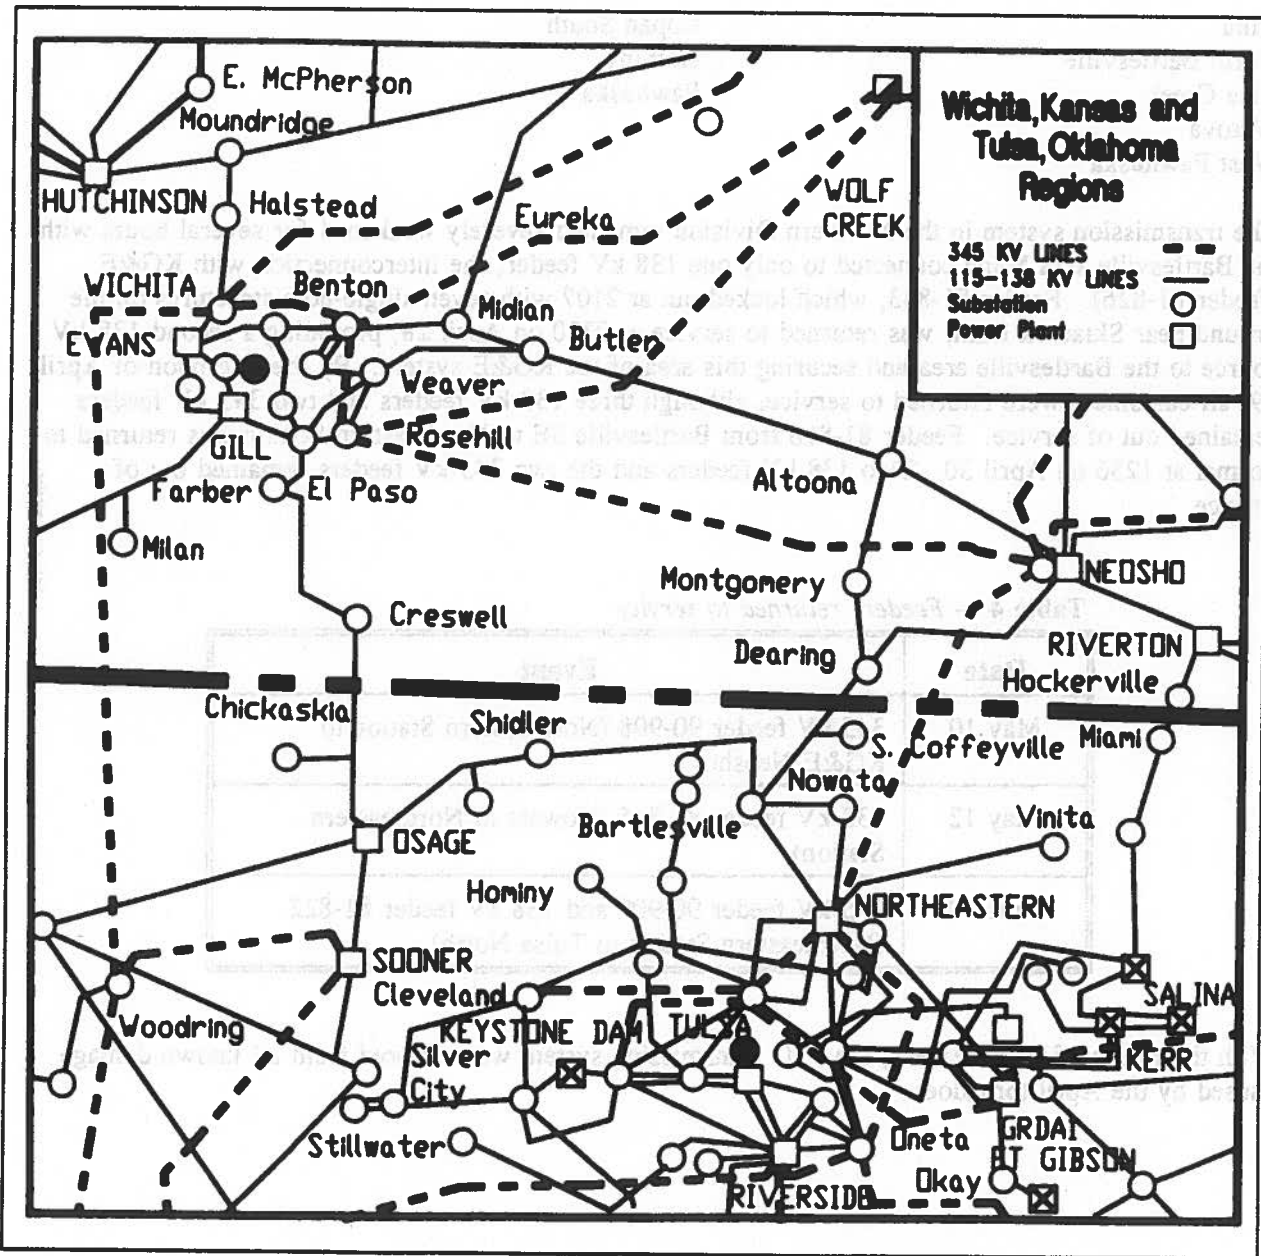
Figure 8 — Detail of transmission system in Wichita, Kansas, and Tulsa, Oklahoma areas

Friday evening, April 26, 1991, a series of tornadoes and severe weather developed in North Central Oklahoma and moved toward the northeast. (Figure 8)

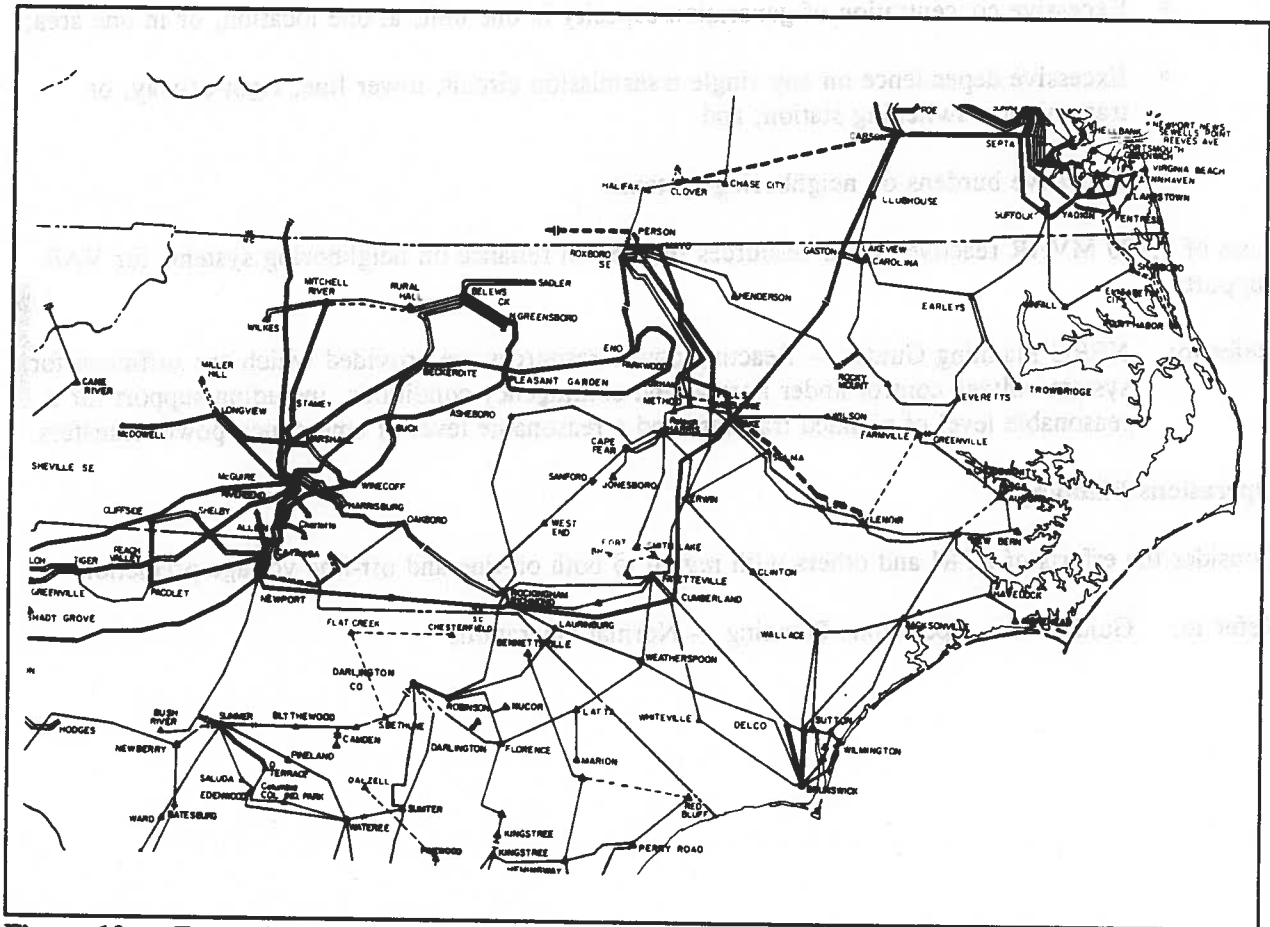
Figure 10 — Transmission system in North Carolina

On July 24, 1991 beginning at 1352 EDT, loss of the second Belews Creek unit (two-unit plant) resulted in an approximate 8% voltage drop in portions of the northern 30% of the Duke Power Company transmission system (Figure 10). The total affected area of North Carolina included Hickory, Winston-Salem, Greensboro, and Durham, involving approximately 490,000 customers, which represent approximately 4,400 MW of load. Winston-Salem and Greensboro were the more significantly affected areas, and the voltage data given below refers specifically to these areas.

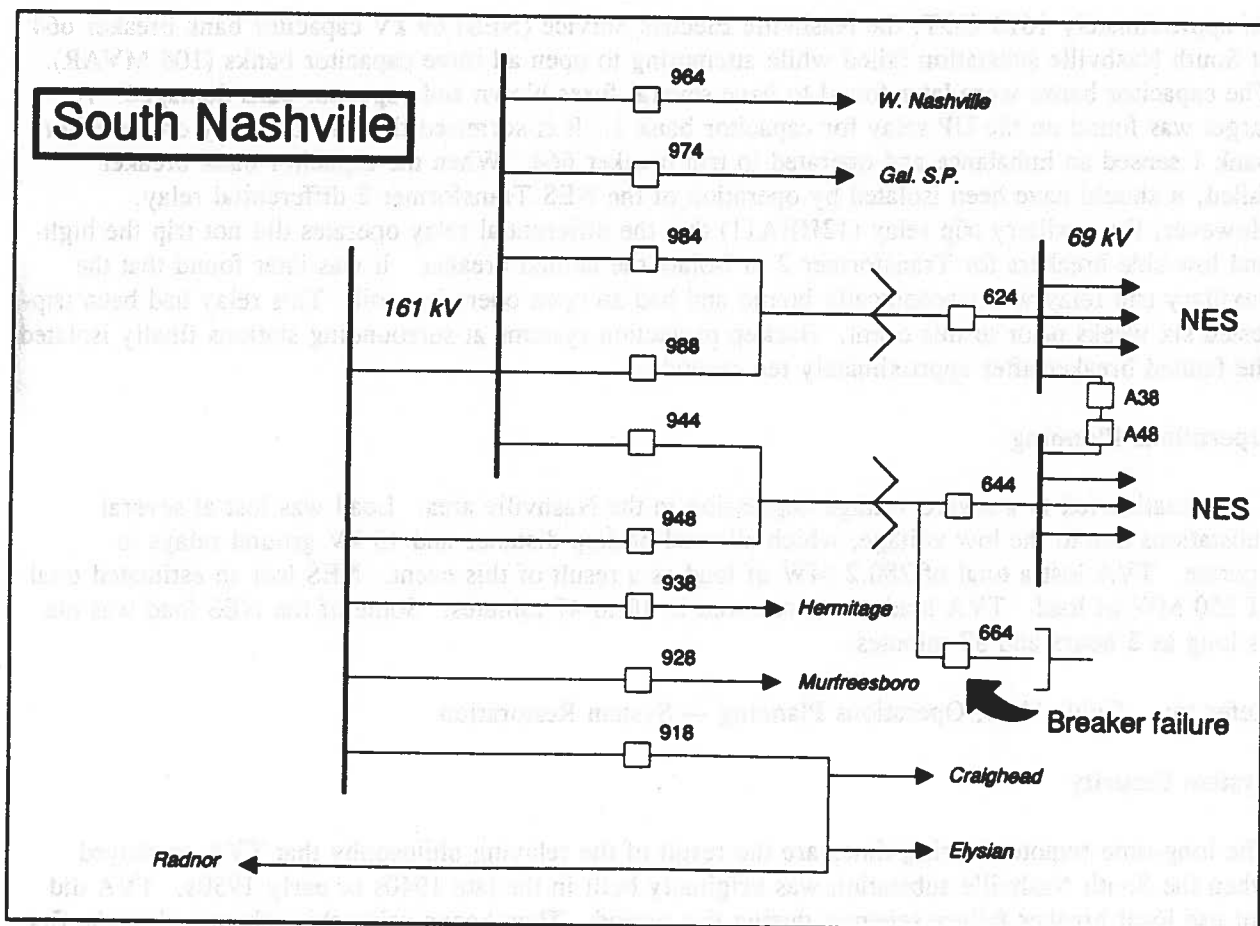
Figure 11 — South Nashville Substation

South Nashville 161 kV substation is in the center of the Tennessee Valley Authority (TVA) transmission system and serves a portion of the municipal load of Nashville, Tennessee (Figure 11). On the afternoon of August 8, 1991, a thunderstorm began moving through the Nashville area. Breaker failure occurred upon removal of three 69 kV capacitor banks that were in service, causing a fault at South Nashville 161 kV substation.

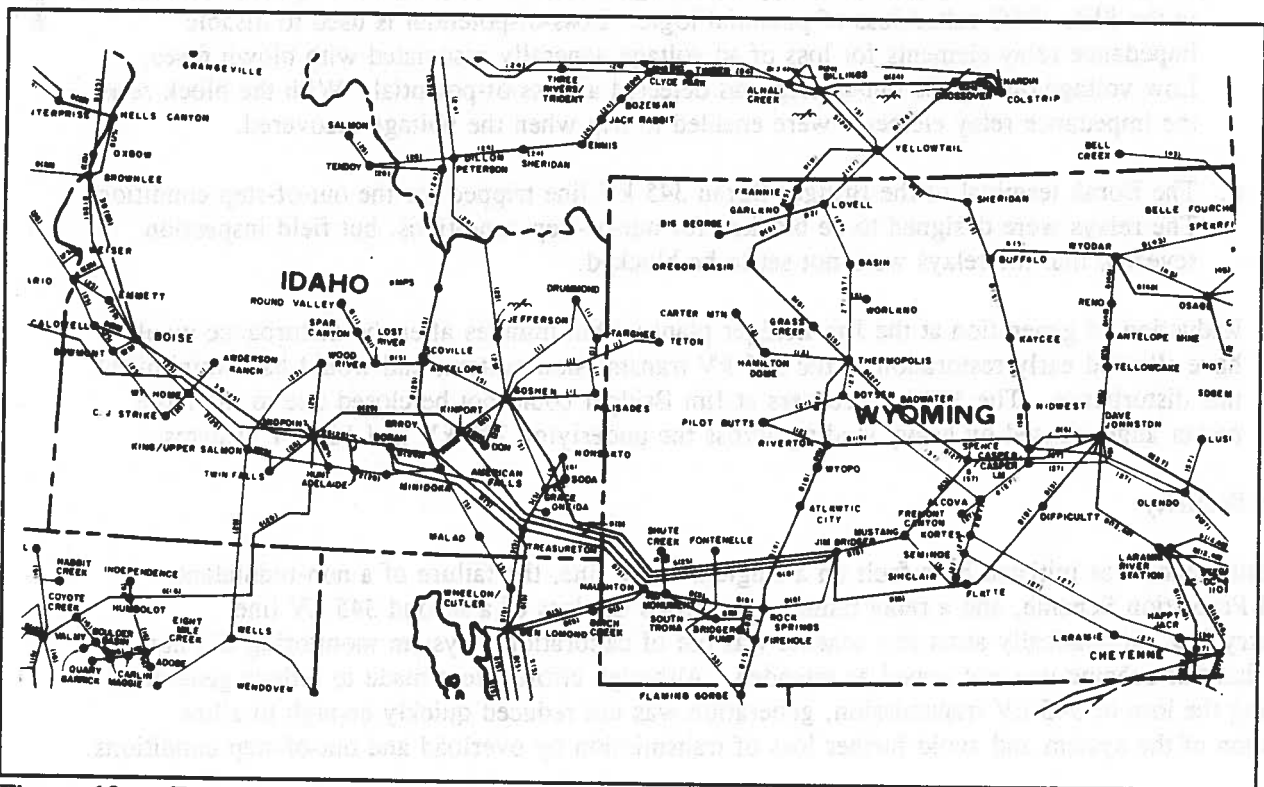
Figure 12 — Transmission system in Idaho and Wyoming

The disturbance began with a single phase-to-ground fault on the Jim Bridger-Kinport 345 kV line, which cleared in two and one-half cycles (Figure 12). Although the Jim Bridger flow to the west was approximately 2,060 MW, the RAS-B (Remedial Action Scheme-B) Generator Tripping Scheme failed to trip generation for loss of this 345 kV line. Approximately 20 cycles later, the Goshen terminal of the Goshen-Kinport 345 kV line relayed open. The Kinport terminal did not open because it failed to receive a transfer trip signal from Goshen. With the two 345 kV lines open and the Jim Bridger plant at full output, the 161 kV transmission lines connected to the Goshen Substation were loaded above their thermal ratings. After a one-minute delay, the Kinport terminal of the Jim Bridger-Kinport 345 kV line reclosed automatically. Due to the heavy system loadings and loss of transmission, the phase angle was measured at approximately 60 degrees across the open breaker at Jim Bridger. Closing of this breaker is blocked at 40 degrees. Procedures were immediately implemented to reduce generation at Jim Bridger to reduce system overloading and low voltage problems. Approximately six minutes after the initial outage, the Goshen-Blackfoot 161 kV line tripped, followed by the Goshen-Grace 161 kV line. At this time, the Jim Bridger plant was still generating over 1,900 MW. At eight minutes after the initial outage, the Antelope 230/116 kV transformer tripped. Next, an out-of-step condition caused the Jim Bridger-Borah 345 kV line to trip. The RAS-B Generator Dropping Scheme then recognized the loss of two 345 kV lines out of Jim Bridger and correctly tripped Jim Bridger generator Units #1 and #2.

Guide III.B., Transmission — Overload, Voltage Control requires that systems take all appropriate action up to and including shedding of firm load in order to keep the transmission facilities within acceptable operating limits. Appropriate action was initiated to reduce generation at the Jim Bridger plant. After analysis of this disturbance, it was decided to develop emergency procedures to rapidly reduce generation following a contingency. It is also planned to determine if the allowable closing angle Jim Bridger can be increased to facilitate earlier restoration of the 345 kV transmission system. Currently, the closing of circuit breakers at Jim Bridger is blocked when the phase angle exceeds 40 degrees.

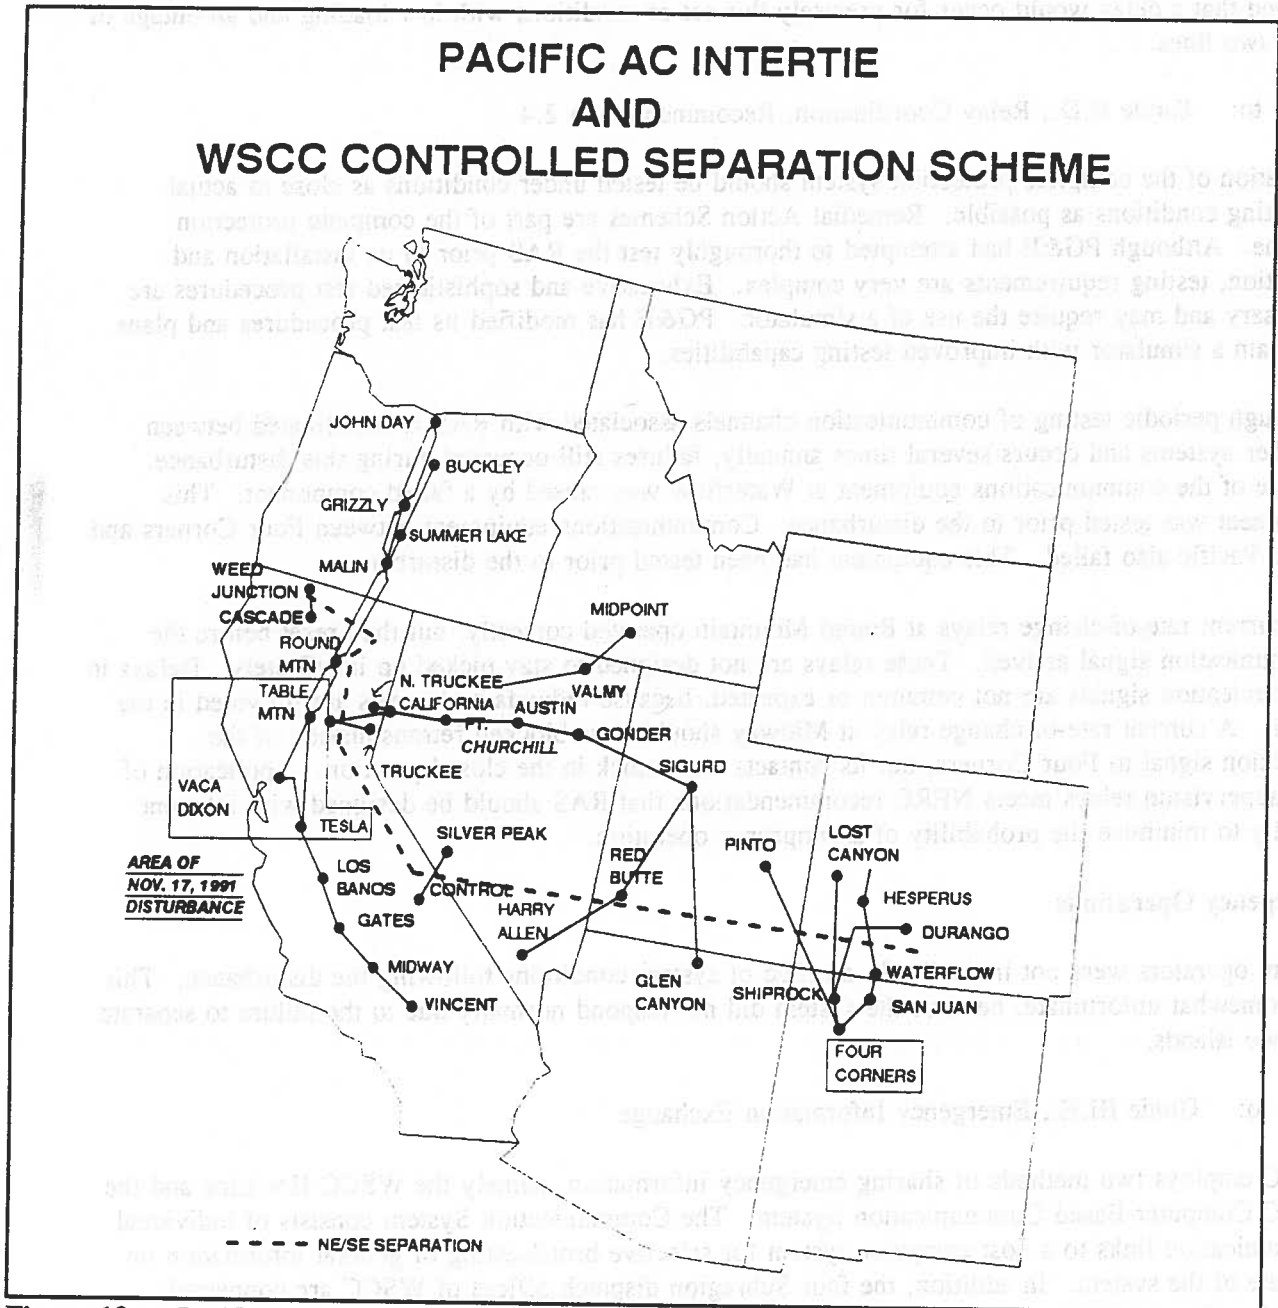
Figure 13 — Pacific AC Intertie and WSCC Controlled Separation Scheme

The 500 kV Pacific AC Intertie (PACI) was interrupted on Sunday, November 17, 1991, at approximately 1205 PST, when the Vaca Dixon-Tesla 500 kV line relayed due to a static wire falling into a conductor (Figure 13). Prior to losing this line, the Table Mountain-Tesla 500 kV line was out of service for planned work. Whenever a total separation of the PACI occurs, a Remedial Action Scheme (RAS), also referred to as a Special Protection System, is supposed to initiate controlled separation of the WSCC grid into a northern and a southern island. However, in this disturbance, initiation of the remedial action was delayed approximately three minutes and seven seconds due to a software problem in a PG&E programmable logic controller located in San Francisco. Figure 14 shows the system configuration of the Pacific AC Intertie and the WSCC Controlled Separation Scheme.
