NORTH AMERICAN ELECTRIC
RELIABILITY CORPORATION

Vegetation-Related Transmission Outage Report

2017 Annual Report

May 8, 2018

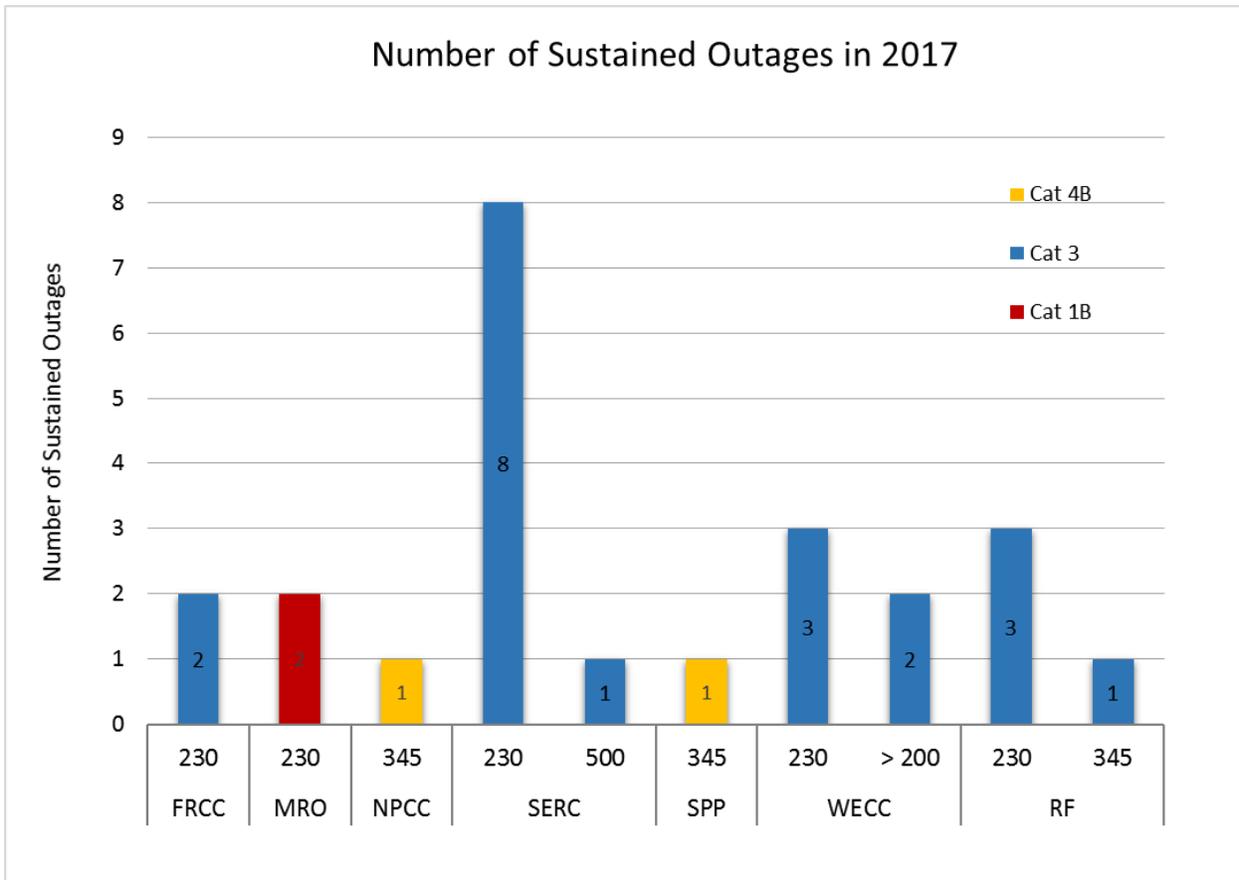
The 2017 Sustained Outages are broken down by RE, voltage class, and outage category in Figure 1.1 below. SERC saw the most outages within its geographical footprint with nine outages overall. SERC’s large footprint combined with a longer growth season is a likely reason this RE often experiences more Sustained Outages than others.

Figure 1.1: Vegetation-Related Outages by Region, Voltage Class, and Outage Category

The Category 3 outages were isolated weather-related events that did not indicate any trend toward a rise in risk to the reliability of BPS.

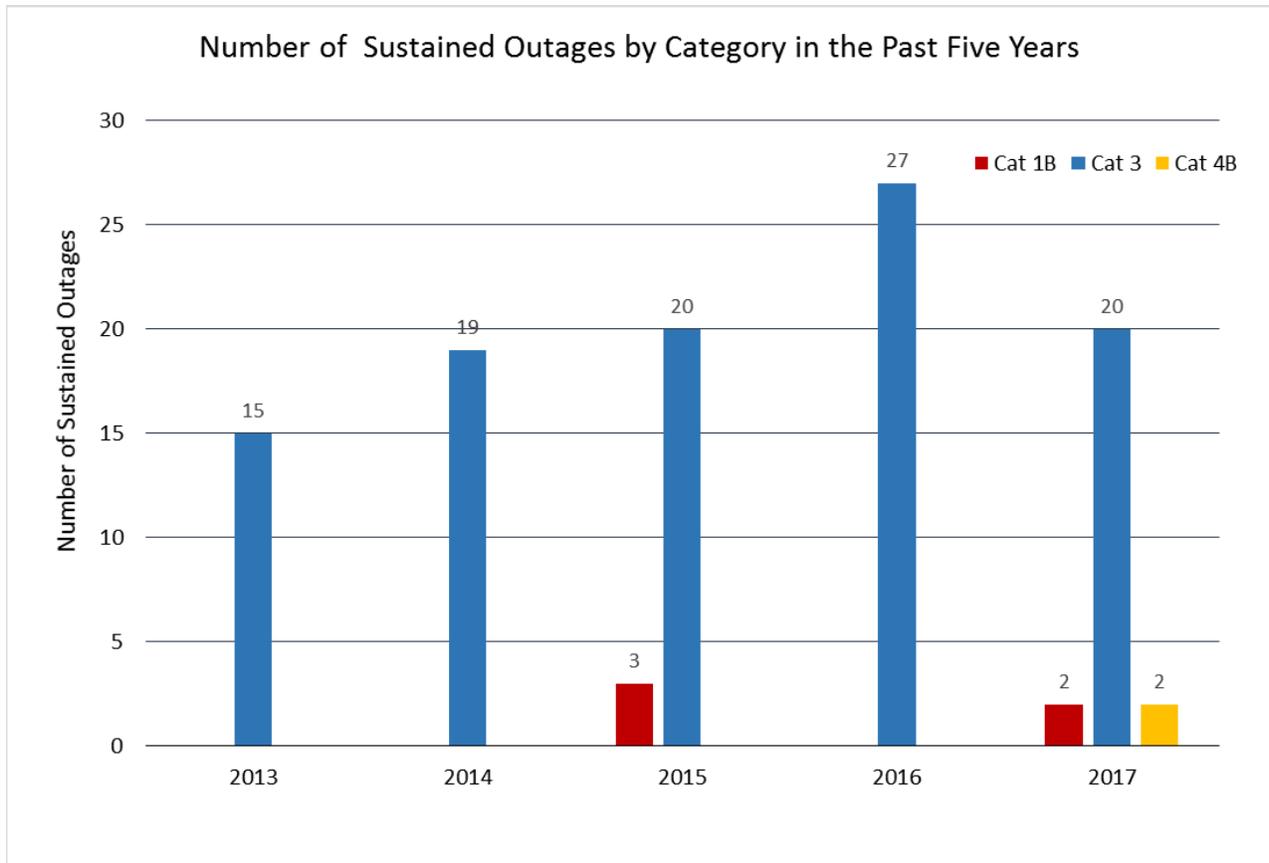
Figure 1.2: Vegetation-Related Outages by Outage Category from 2013 to 2017

The increase in the number of vegetation-related outages due to fallen trees from outside the ROW (Category 3) and the recent FAC-003 violations with real-time observations have resulted in inclusion of FAC-003 on the ERO Enterprise Compliance Monitoring and Enforcement Program (CMEP) Implementation Plan in the past including the 2018 plan.⁶
